Subject: Concord Steam Facility Condition Survey Follow Up Report

References: Electrical Safety Report, Revision 1, August 5, 2016 by Nowland Services, PLLC

RE: Division of Public Works Design and Construction Report, December 9, 2016
Concord Steam Plant
Concord, NH

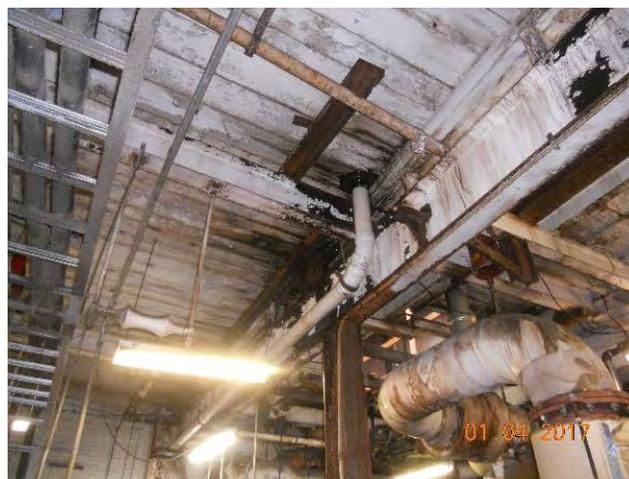
Turbine Room West: The original condition survey found an area in the roof with deteriorated wood plank and beams. Our follow up inspection found that the deteriorated wood decking in the false ceiling was removed as requested. In addition, to reinforce some deteriorated wood timber, W6X15 beams were added, framed on top of the W12X30 support beams. The photo below documents this installation. This was installed in lieu of the original recommendation of the installation of a new W12 beam. The framing that was installed is structurally adequate to support the deteriorated wood plank.

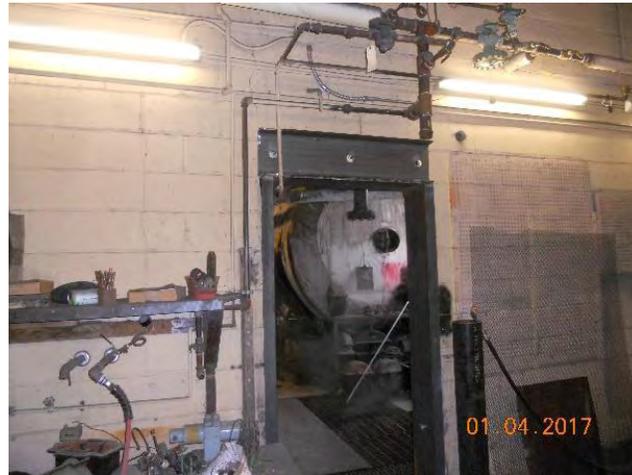
Fan Room: A door access through a masonry wall was found to be defective. Steel framed support channels were added to reinforce the opening as recommended in the original report. The photo below documents this installation.

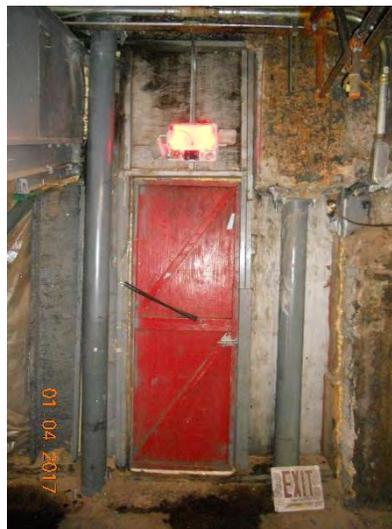
Support of Coal Bunker Wall Opening: A door opening which was cut through a thick concrete wall of the old coal bunker was found not to have proper support. The photo below shows two heavy gage pipe columns which were added to support the wall header above the door.
