Subject: White Rock Pressure Reduction Valve Test

Four Pressure Reduction Valves (PRVs) were installed at the White Rock Water System in 1992 due to large elevation changes throughout the system; the system ranges in elevation from 615' to around 325'. Before PRVs were installed, the pressure at the low point (45 Rocky Point Dr.) was 171 psi with a pump house discharge pressure of 45 psi.

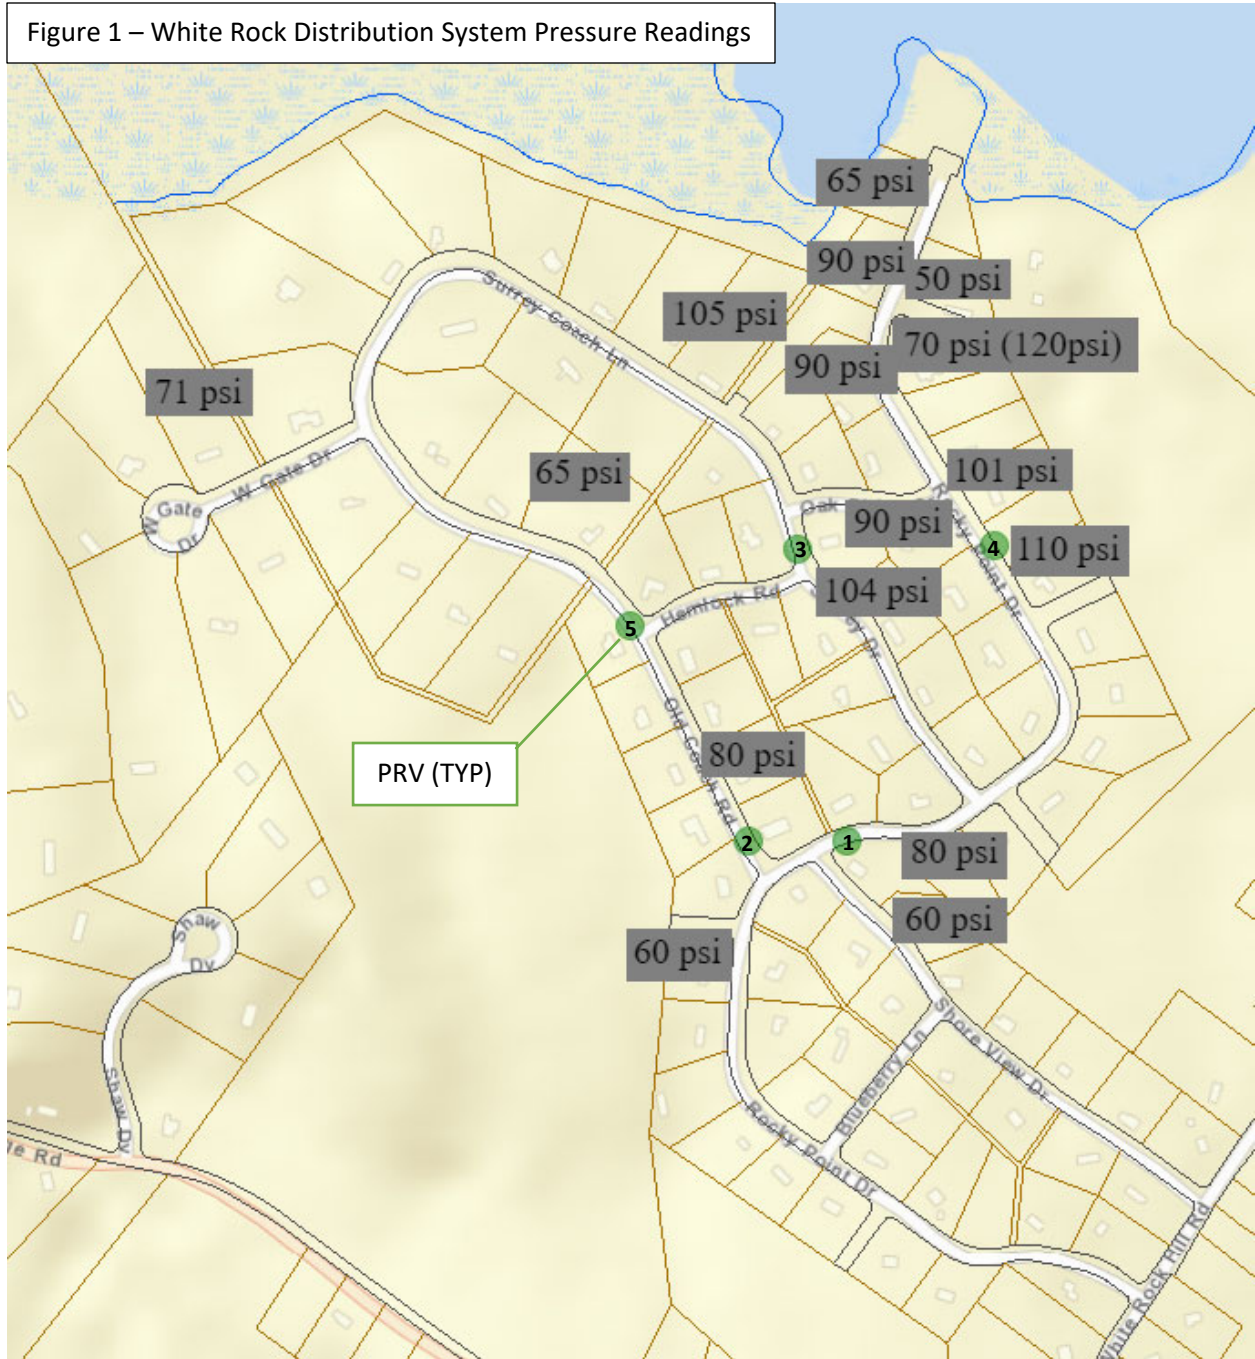
Figure 1 – White Rock Distribution System Pressure Readings

In 1992, the pressures were tested at 9 different houses to determine the effectiveness of each PRV. These locations were selected to provide a picture of the water pressure throughout the distribution system. These same houses were tested on June 18, 2020 to determine the condition of each PRV. Table 1 compares the pressure readings from 1992 and 2020. The table also provides the approximate elevation at each location. Figure 1 shows a layout of the distribution system and the location of each PRV.

Given the low reading at 45 Rocky Point Dr (65 psi at the bottom of the system), additional pressure readings were collected on August 5, 2020. Pressures were recorded at an additional six locations and are included in both Table 1 and Figure 1. When collecting the reading at 44 Rocky River Point Drive, the home owner stated that he had a pressure regulator inside his home. The pressure regulator had gauges on either side, 120 psi coming from the distribution system and 70 after the regulator.

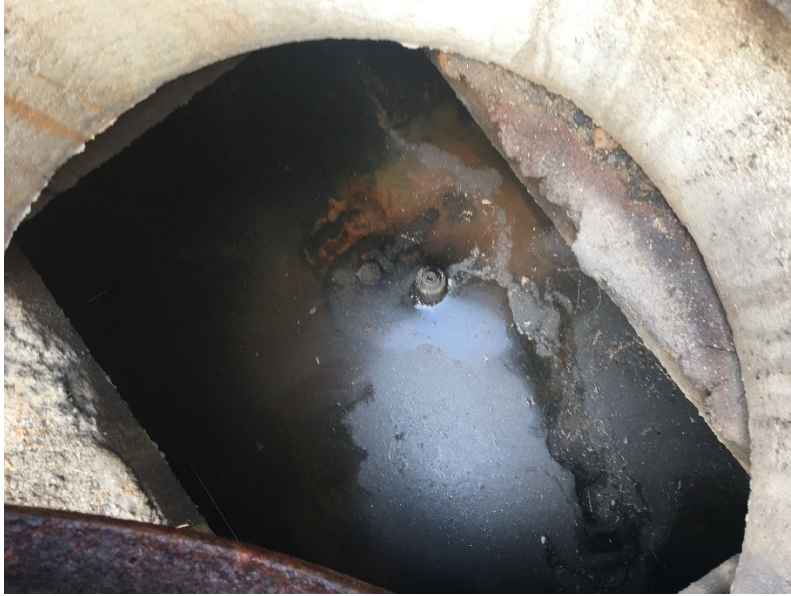
PRV #1

Based on the results shown, it appears that neither of the two PRVs at the top of the system are working. The down stream sample locations are both 20 psi higher than the houses upstream of the PRVs in question; they are also over 25 psi higher when compared to the pressure recorded in 1992. That 25 psi difference is observed throughout the system downstream of the two PRVs when comparing the 1992 and 2020 pressure readings.

In conclusion, the pressures in the system have increased by over 25 psi in some locations in the distribution system compared to when the PRVs were first installed. Based on the readings throughout the system, it is apparent the PRVs 1 and 2 have failed. The system now has several houses with pressures well over 100 psi. It is recommended that PRVs 1 and 2 be replaced and the other three monitored annually.
