# Bellows Falls Reliability Report 2022

Docket No. DE 21-004

May 2, 2022

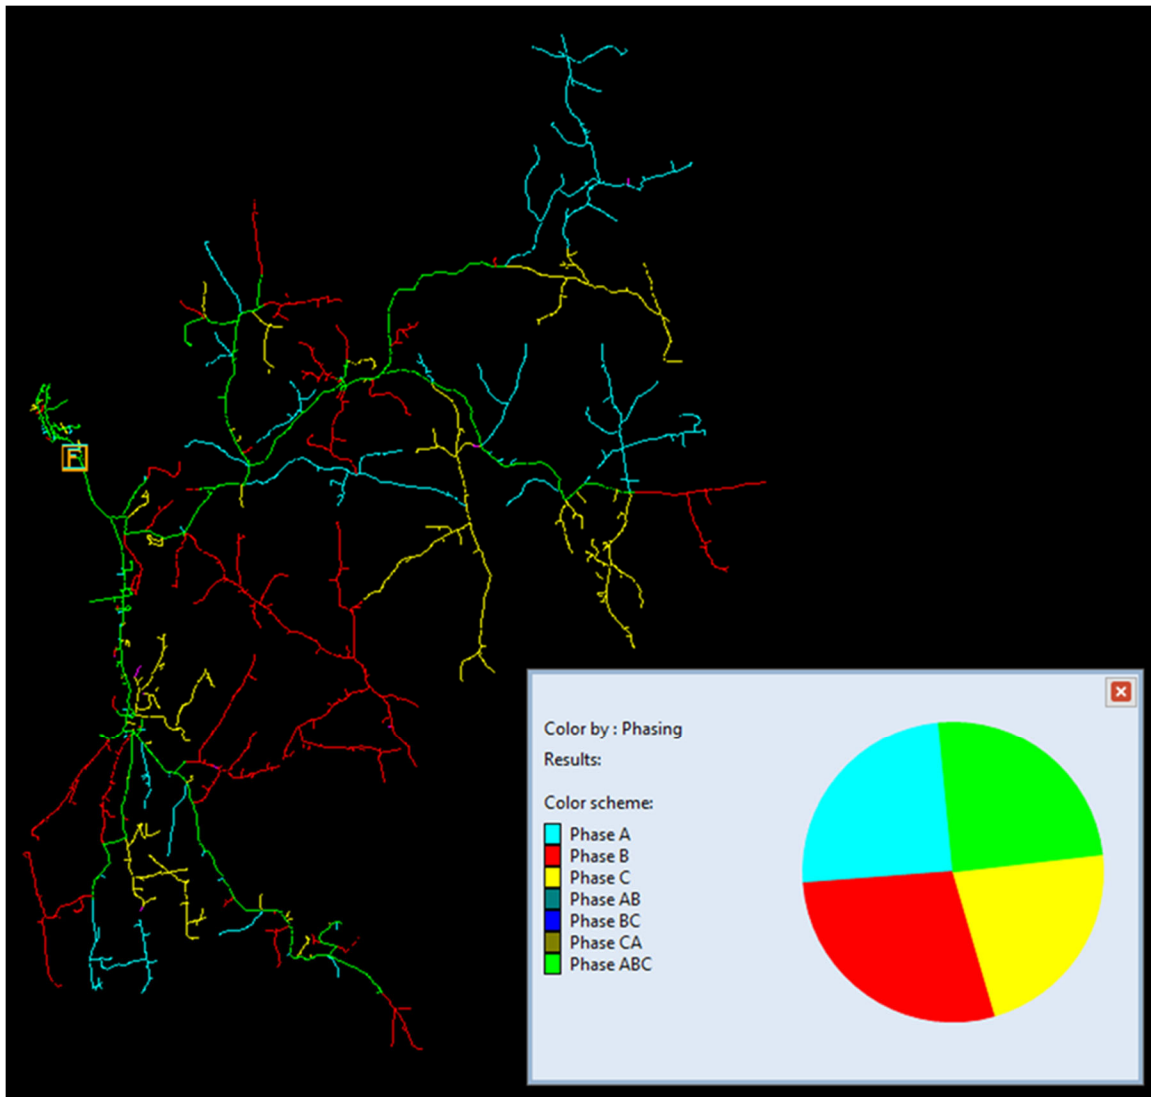
Figure 4: 12L1 and 12L2 Circuits by Phase

Figure 4 below provides the two circuits by phase. The Green color represents 3-phase circuit mainline for both the 12L1 and 12L2. There are no 3-phase ties between the 12L1 and 12L2. The limited number of single-phase circuit ties between 12L1 and 12L2 can result in increased customer restoration times should a main line permanent fault occur.

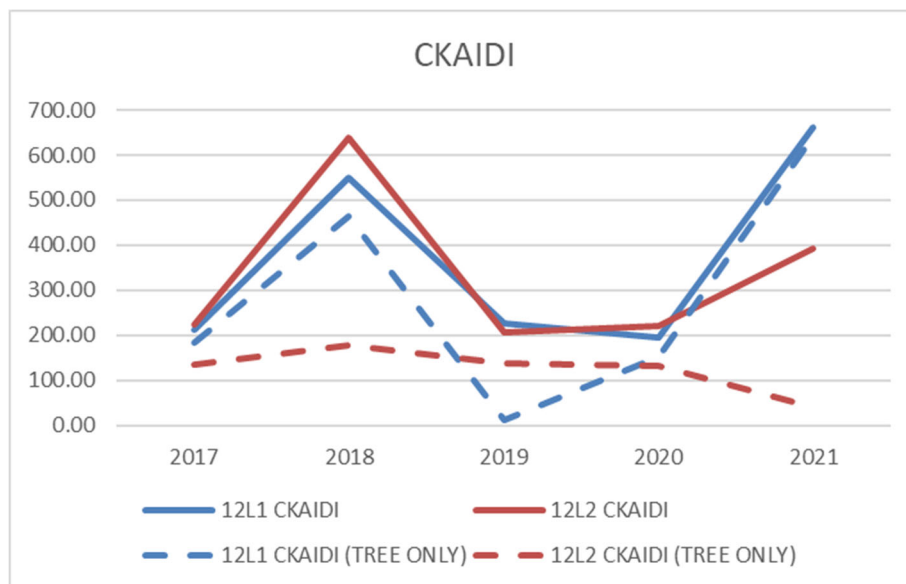
**Table 6: Five Year CKAIDI 12L1 and 12L2**

Below are CKAIDI and CKAIFI tables for the 12L1 and 12L2. The dotted line shows the portion of the total value that was vegetation-related. Outages caused by fallen trees can be large contributors to CKAIDI due to the level of damage and the time it takes to remove the tree and make repairs. Note that the 4-year cycle circuit vegetation trimming was conducted on the 12L1 in 2018, and on the 12L2 in 2017. CKAIDI and CKAIFI on the 12L1 showed some improvements to tree-related outages after trim cycle was conducted. The 12L1 is a much larger circuit, with twice the customers as the 12L2. The 12L2 circuit has tree-resistant wire from the Vilas Bridge substation up to where it branches off to the three-phase branches to the south. The 12L1 still has pockets of bare wire on the main line and is more radial than the 12L2.

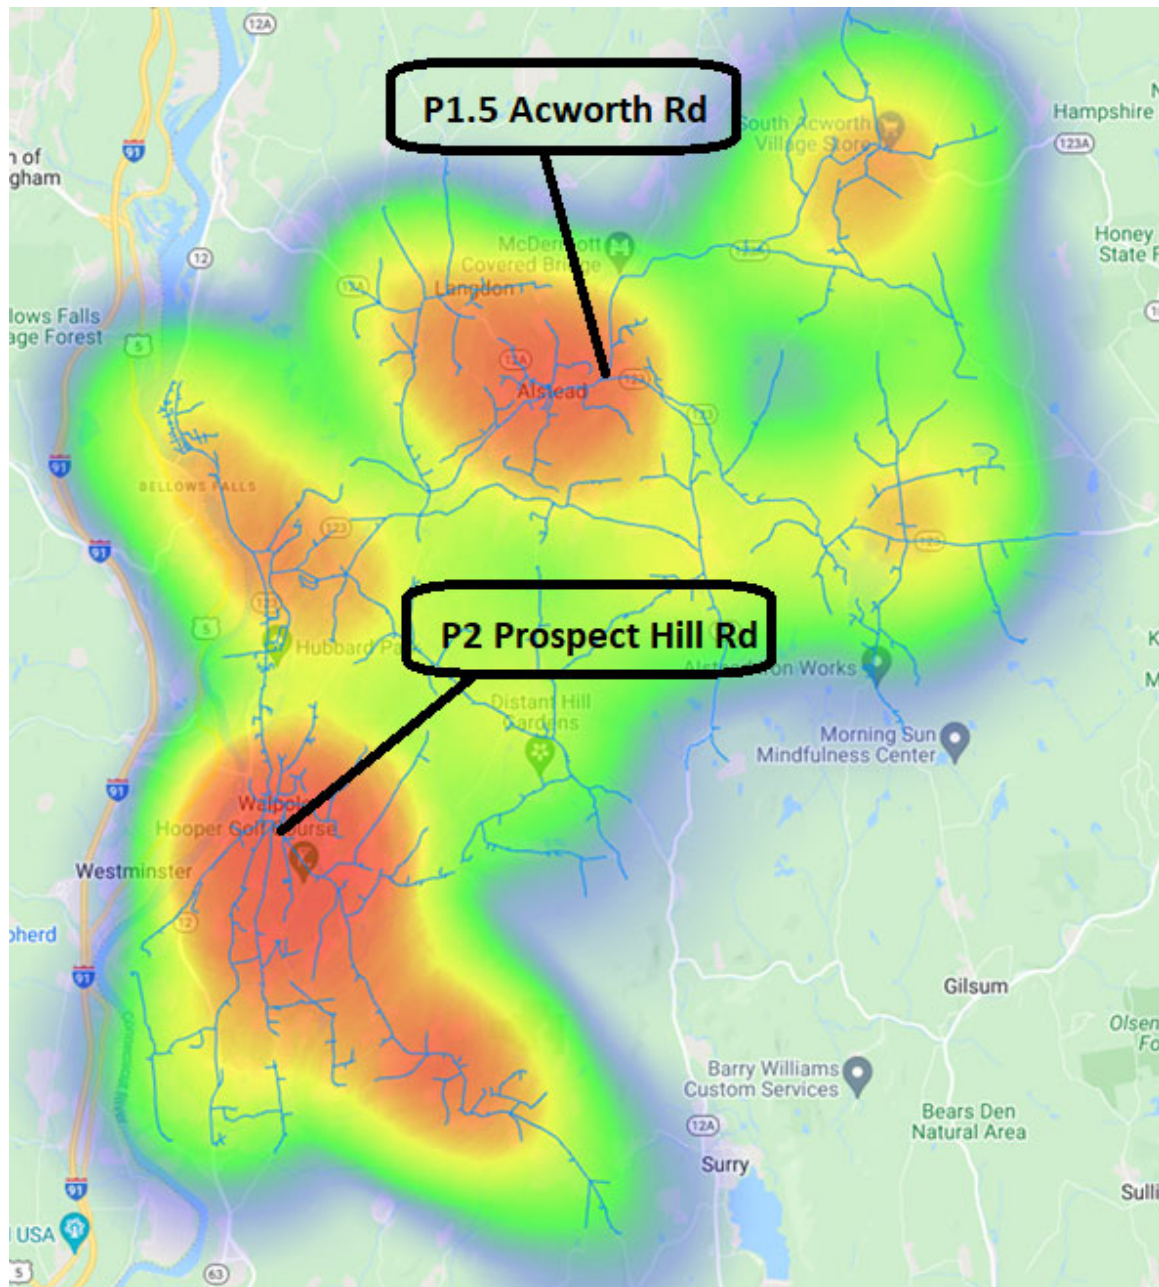
Figure 5: Five Year Outage Heatmap

In the figure below, 2017 through 2021 outage data is plotted on a map utilizing the Hexagon platform that shows the pockets through a heatmap of poor performance in the Bellows Falls area. The heatmap below shows one large and dark pocket on 12L1 and one on the 12L2. The pocket on the 12L1 is fed from a pole top recloser at pole 1.5 Acworth Road., Alstead. The 12L2 area is fed from a pole top recloser at pole 2 Prospect Hill Road., Walpole. There have been multiple, and quite lengthy, outages at these two locations over the years. Both locations are radial and are still fed with bare primary conductor.

This project replaces primary overhead bare conductors with spacer cable in areas prone to tree contact. The scope of this strategy includes the replacement of at least 1.5 miles of bare wires on the 12L2 circuit along Watkins Hill Road in Walpole, which is considered a pocket of poor performance on this circuit.
