**IR 21-024**  
**Department of Energy, Division of Enforcement**

**INVESTIGATION REPORT**  
**OF**  
**WATER PRESSURE REDUCTION MATTER**  
**IN ROSEBROOK WATER SYSTEM**  
**August 31, 2021**  
**Abenaki Water Company, Inc – Carroll, New Hampshire**

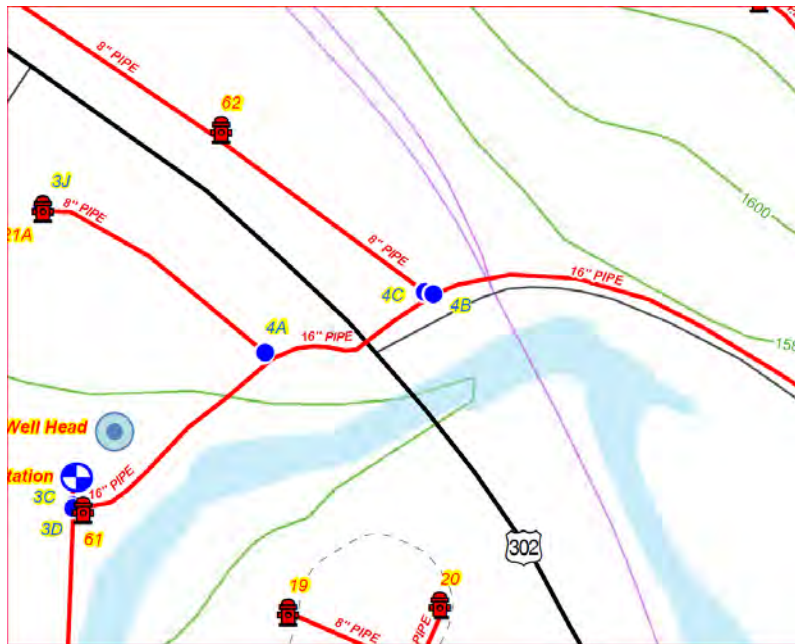
**Figure 2-1** indicates an area in which excavation was performed near the 16-inch diameter water main between valves marked 4A and 4B but no markings by AWC were shown. Puc 800 rules require markings of any underground water mains within the tolerance zone or method of providing positive response that there are no such facilities within the tolerance zone. AWC did neither.

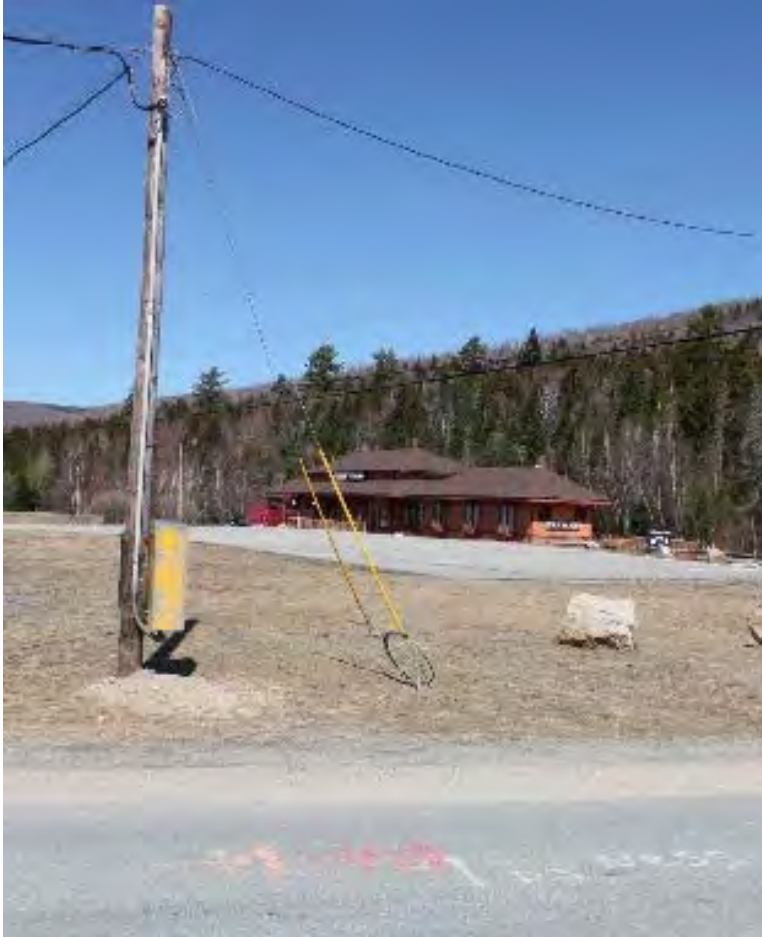
**Photo 2-1** indicates an area in which excavation was performed to install a pole as indicated by the fresh dirt with Dig Safe pre-marks to show the tolerance zone in white with no blue markings by AWC. Puc 800 rules require markings of any underground water mains within the defined tolerance zone of an excavation area.

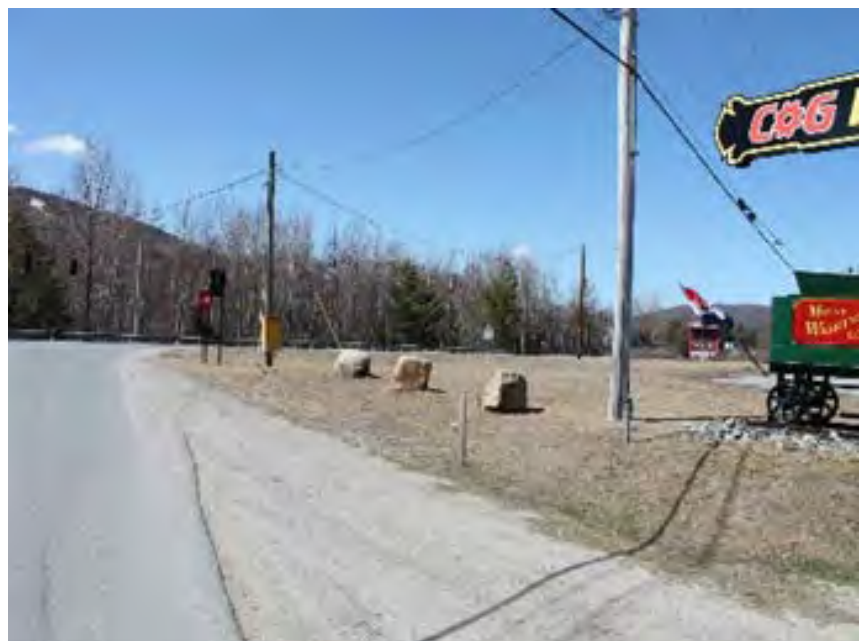
**Photo 2-2** indicates an area in which excavation was performed but no markings by AWC are shown. Puc 800 rules require markings of any underground water mains within established tolerance zones or provide positive response that no water mains are present within the tolerance zone.

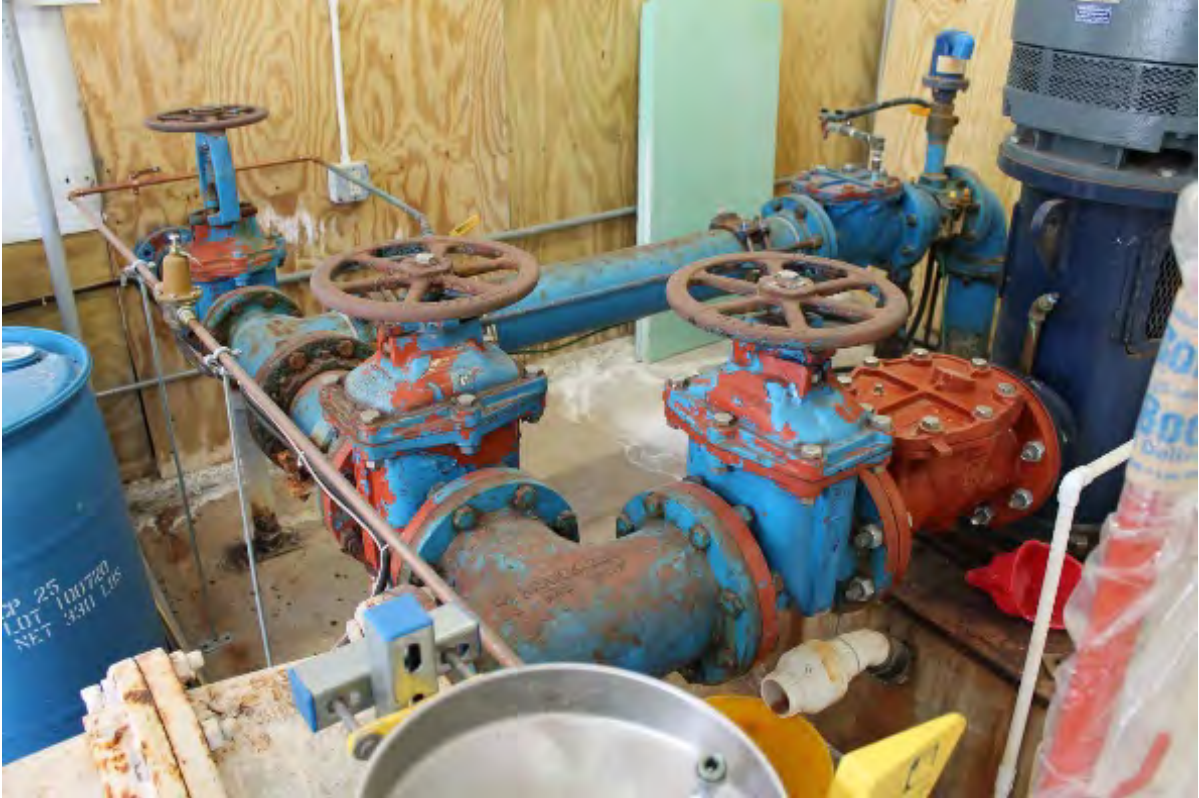
**Photo #5-01** Depicts corrosion of pump station piping components.

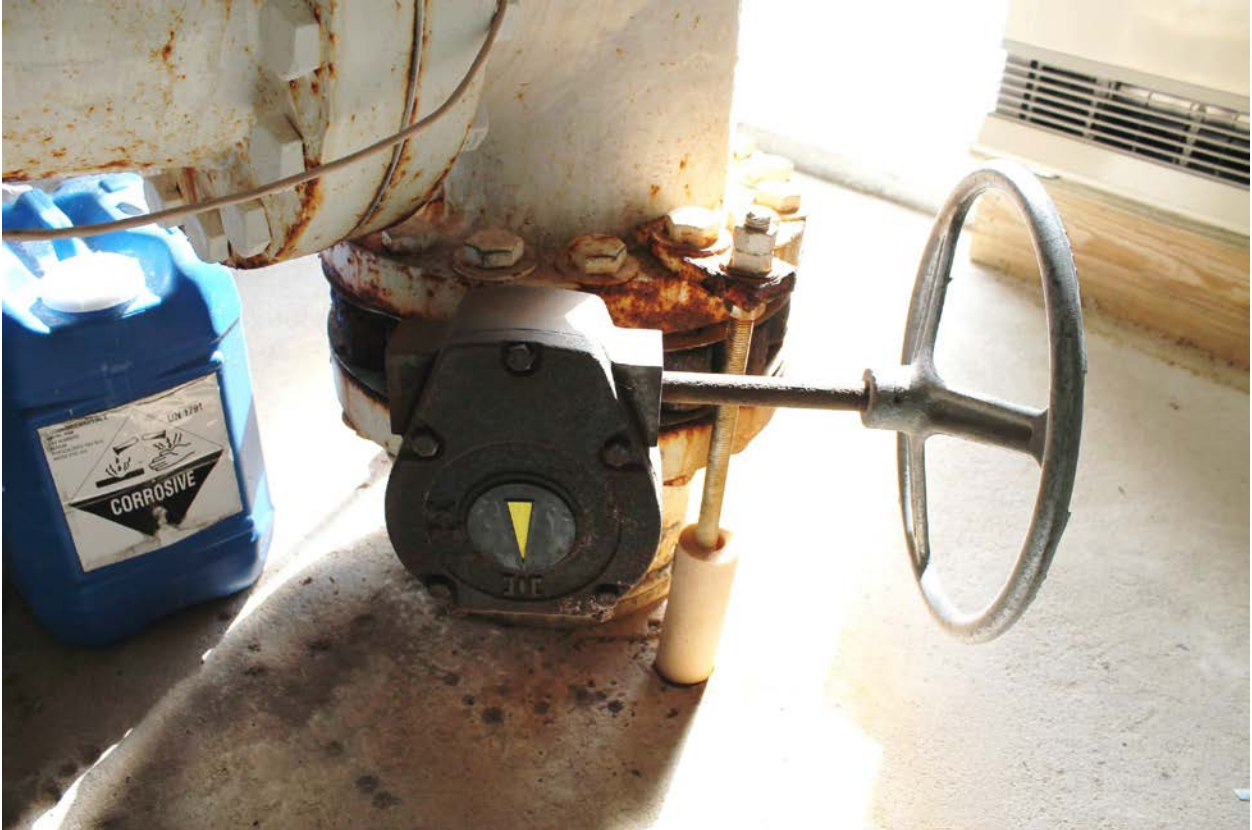
**Photo #5-02** Depicts main system shut off valve noting storage of corrosive chemicals.

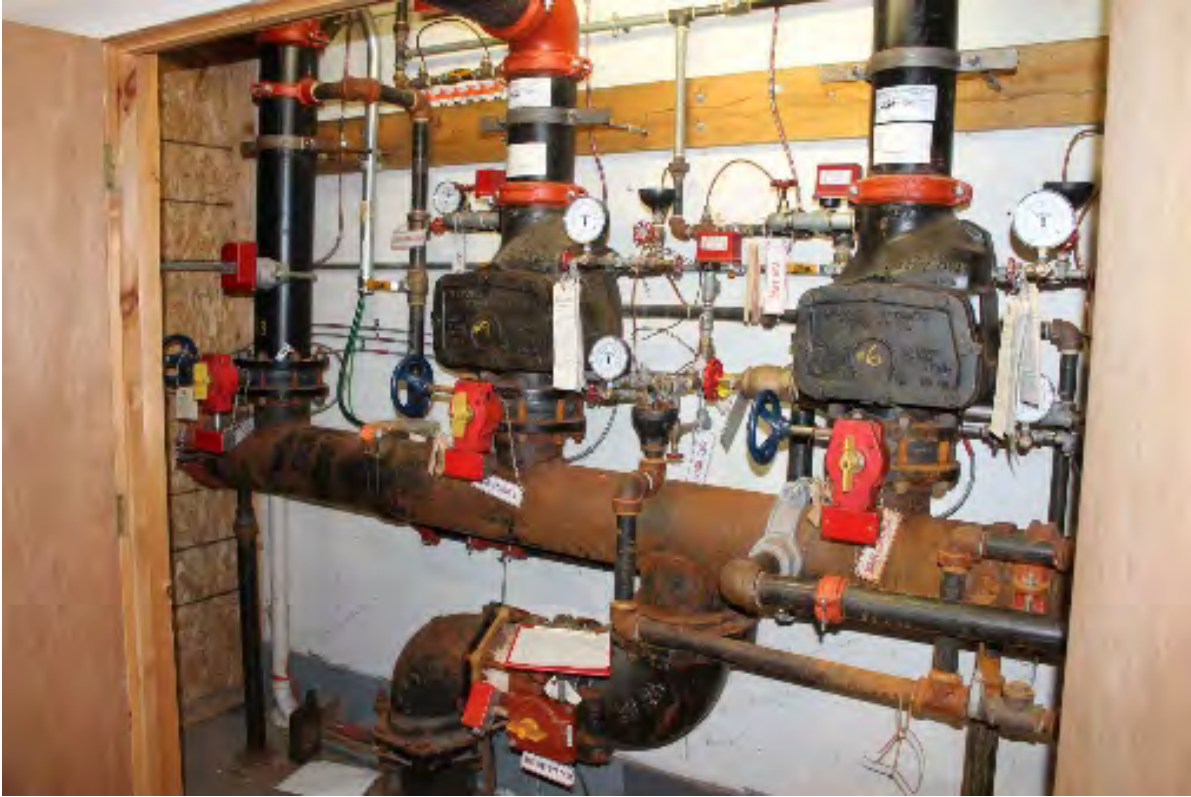
**Photo #5-03** View of several fire sprinkler system risers at Mt. Washington Hotel.

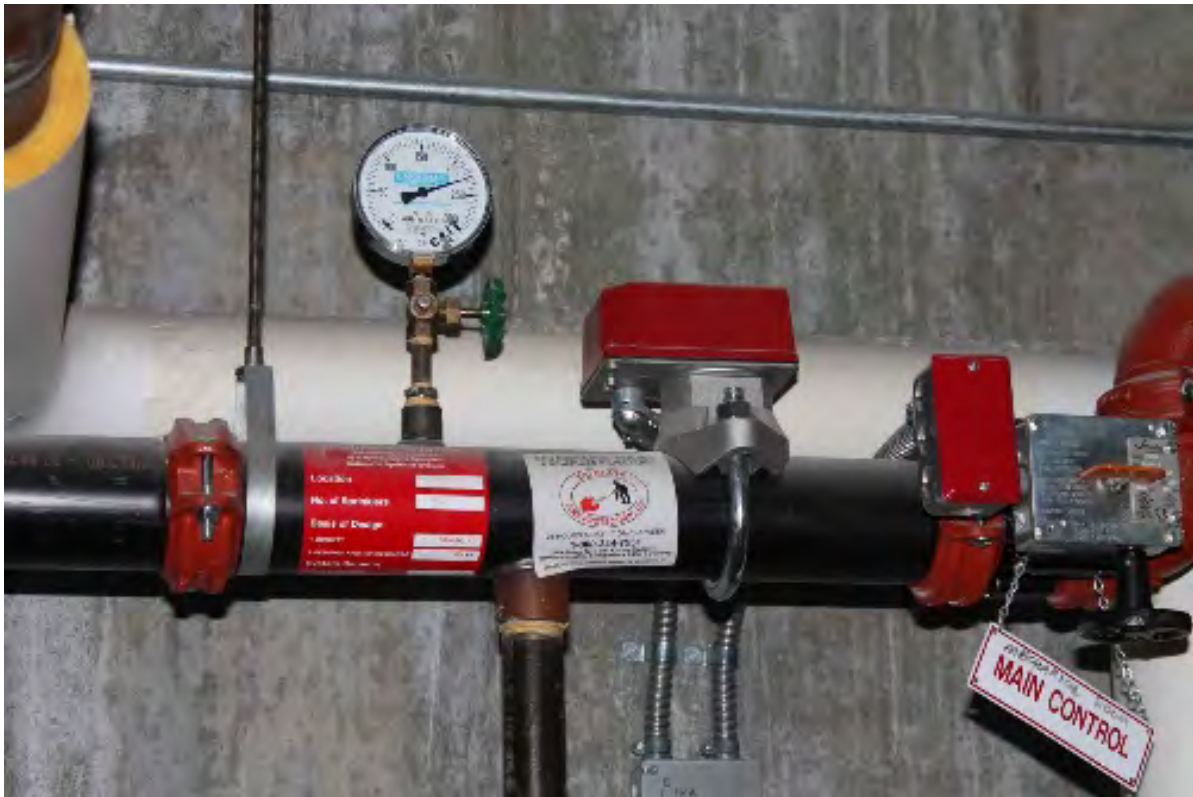
<sup>3</sup> Although AWS and its engineering consultant indicated that pressures ranged 150 -200 psi, Staff later observed pressures as high as 225 psi in the Mt Washington Hotel as shown in Element #5 Item 3 and photo #5-4.

**Photo #5-04** View of a Mt. Washington hotel fire sprinkler system pressure gauge noting 225 psi.

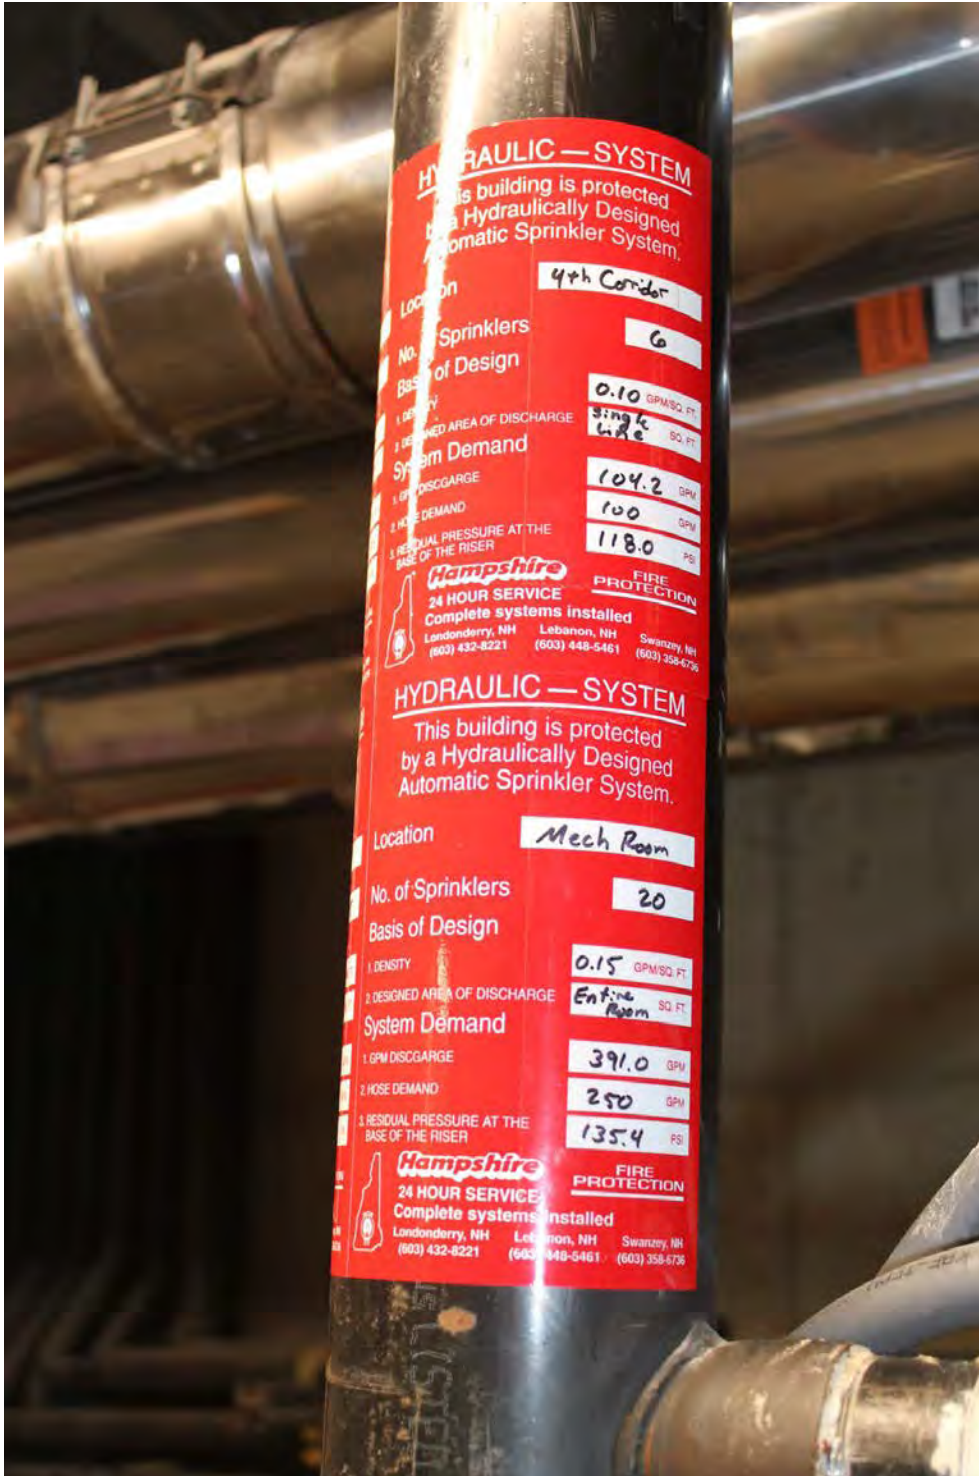
**Photo #5-05** View of hydraulic data plates on Mt. Washington hotel fire protection, noting a system demand of 135 psi.

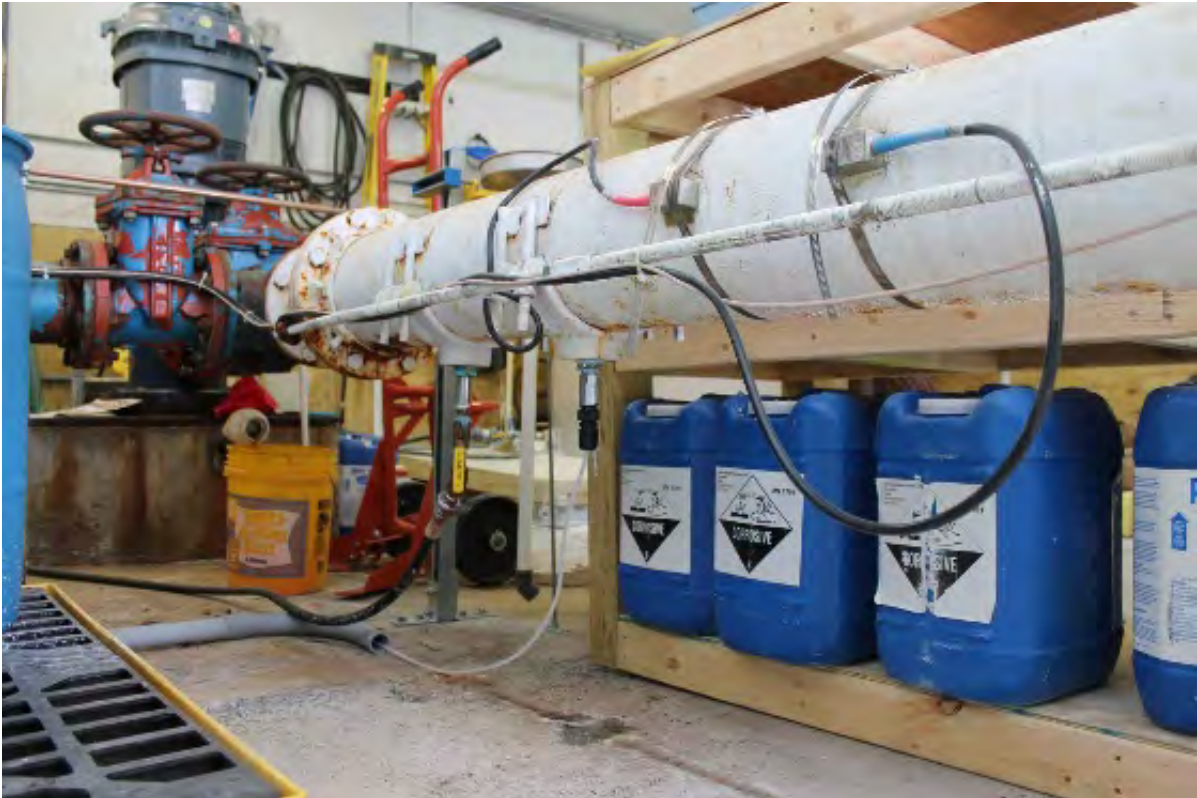
Examination of the pump station building revealed the area of greatest employee safety to be related to chemical injection equipment and water main control valves that displayed corrosion most likely resulting from equipment age, wear-and-tear, and the corrosive atmosphere from stored chemicals.

**Photo #5-06** View of pump station components with stored corrosive chemicals, creating corrosive atmospheric environment.

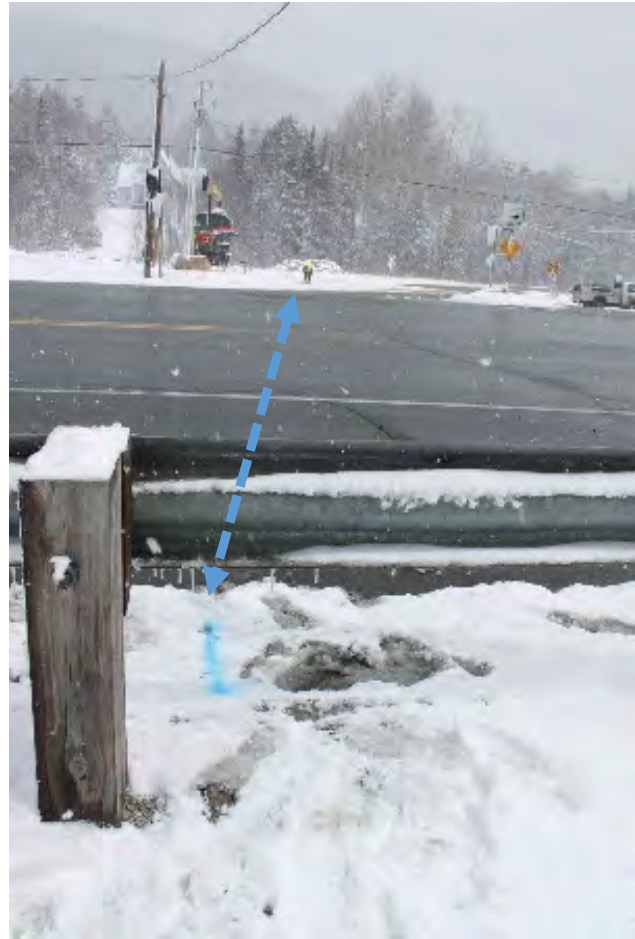
**Photo #5-07** Blue dotted line represents approximate location of 16" transmission main crossing US Route 302 toward Base Station Road. Recently erected utility poles were installed within immediate area of transmission main, as shown.

Results of this water utility mark-out process, which was not completed by AWC personnel as required prior to the bridge construction work in this area, resulted in the confirmation the installation of utility poles and anchoring systems clearly entered the water utility facility space. The significance of this issue cannot be understated as identified during this investigation.

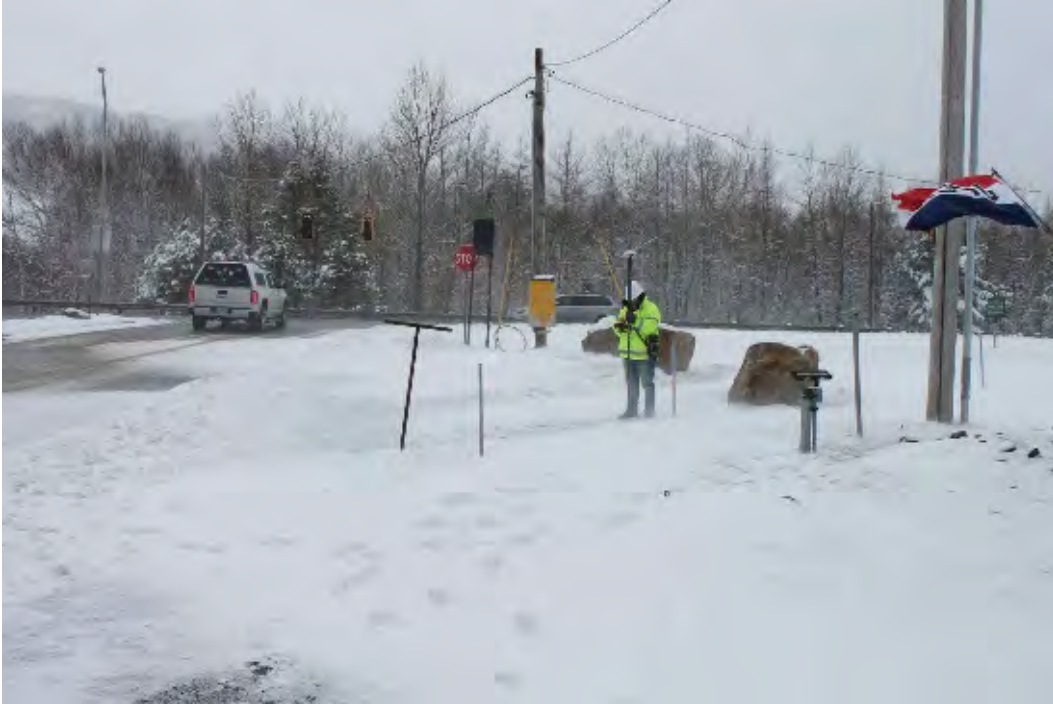
**Photo #5-08** View of Safety Staff personnel utilizing GPS data equipment to verify location of water infrastructure.

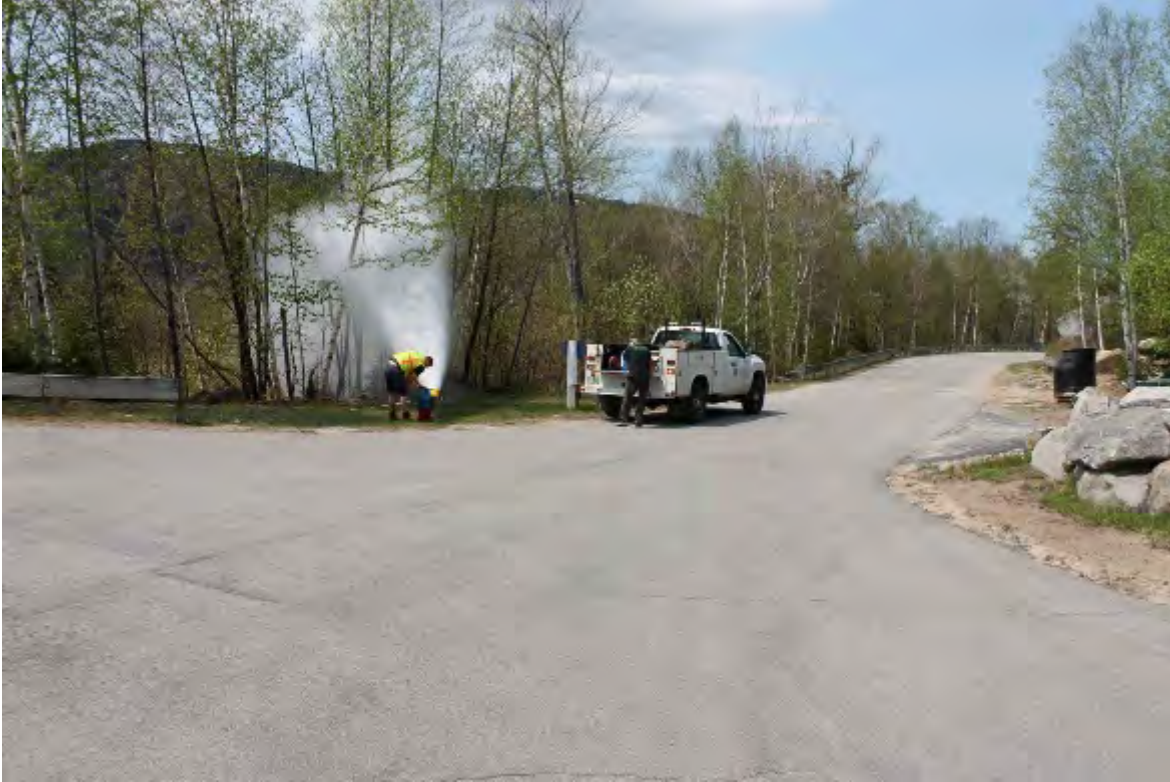
**Photo 5-9** View of fire hydrant flow testing as conducted by AWC personnel and their engineering consultant Horizons Engineering.

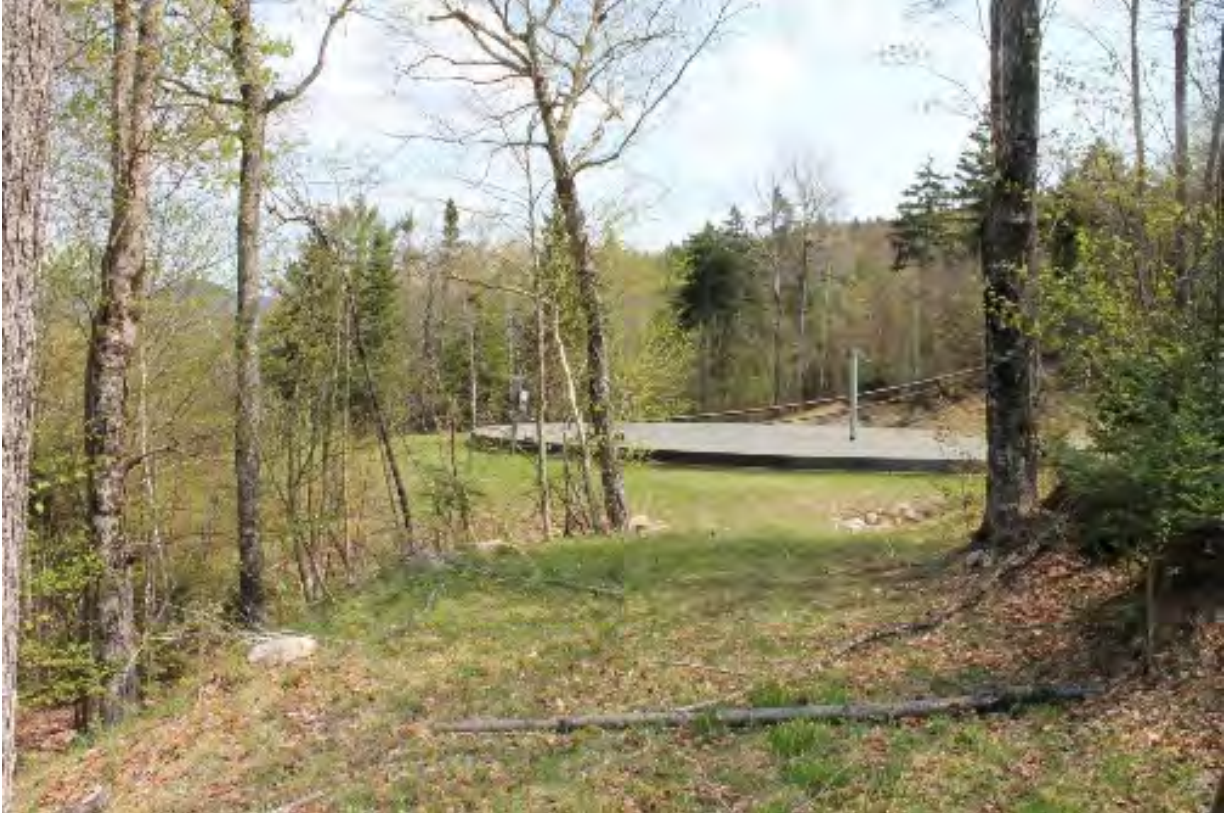
Safety Staff then continued to examine the location of the 650,000 gallon water storage tank located up within the ski slopes of the Bretton Woods Ski Resort. Observation of this area revealed the grade-level structural roof of this underground storage tank. The roof covering appeared to be intact; however, there was no security fencing either around or protecting any element of this water storage supply tank.

**Photo 5-10** View of underground storage tank located in area of Bretton Woods ski slope depicting lack of security fencing.
