National Transportation Safety Board

Natural Gas Pipeline Accident Manhattan, New York March 12, 2014

New England Pipeline
Safety Seminar
West Dover, VT
October 20, 2015

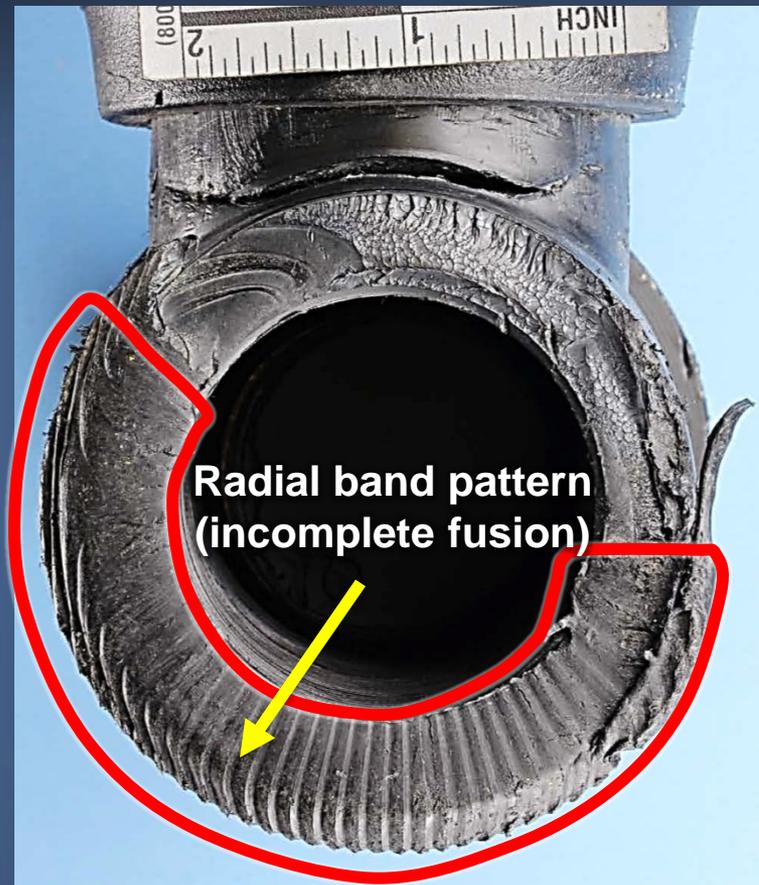
Fusion Joint – Incomplete Fusion

- Radial band pattern (60%)
- Is incomplete fusion
- Is a weld defect
- Weak bond strength
- Caused by contamination or inadequate surface preparation before fusion welding

- Large hole in the sewer dated back to 2006
- Service tee to gas main weld not properly cleaned – lack of fusion
- Supporting soil under the plastic gas main washed into the damaged sewer for many months

- City of New York - Improve sewer main integrity process
- Consolidated Edison - Revise plastic pipe fusion procedure
 - Cleaning methods
 - Improve final visual inspection

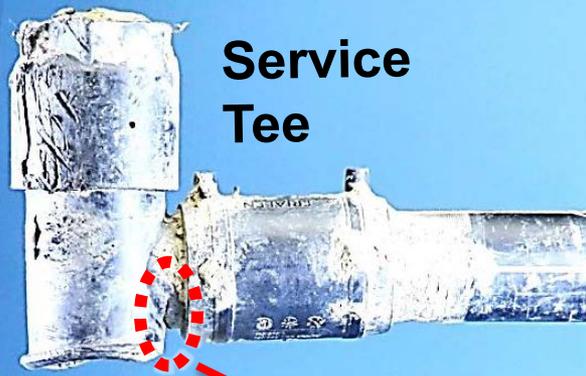
Service Tee – Crack at Outlet

- No evidence of pre-existing crack
- Rapid loading event from post-accident excavation

- Gas leak resulted when sagging gas main opened the defective weld
- Post-accident excavation work
 - Separated the service tee from the main
 - Cracked the branch outlet
- Water main cracked after the explosion

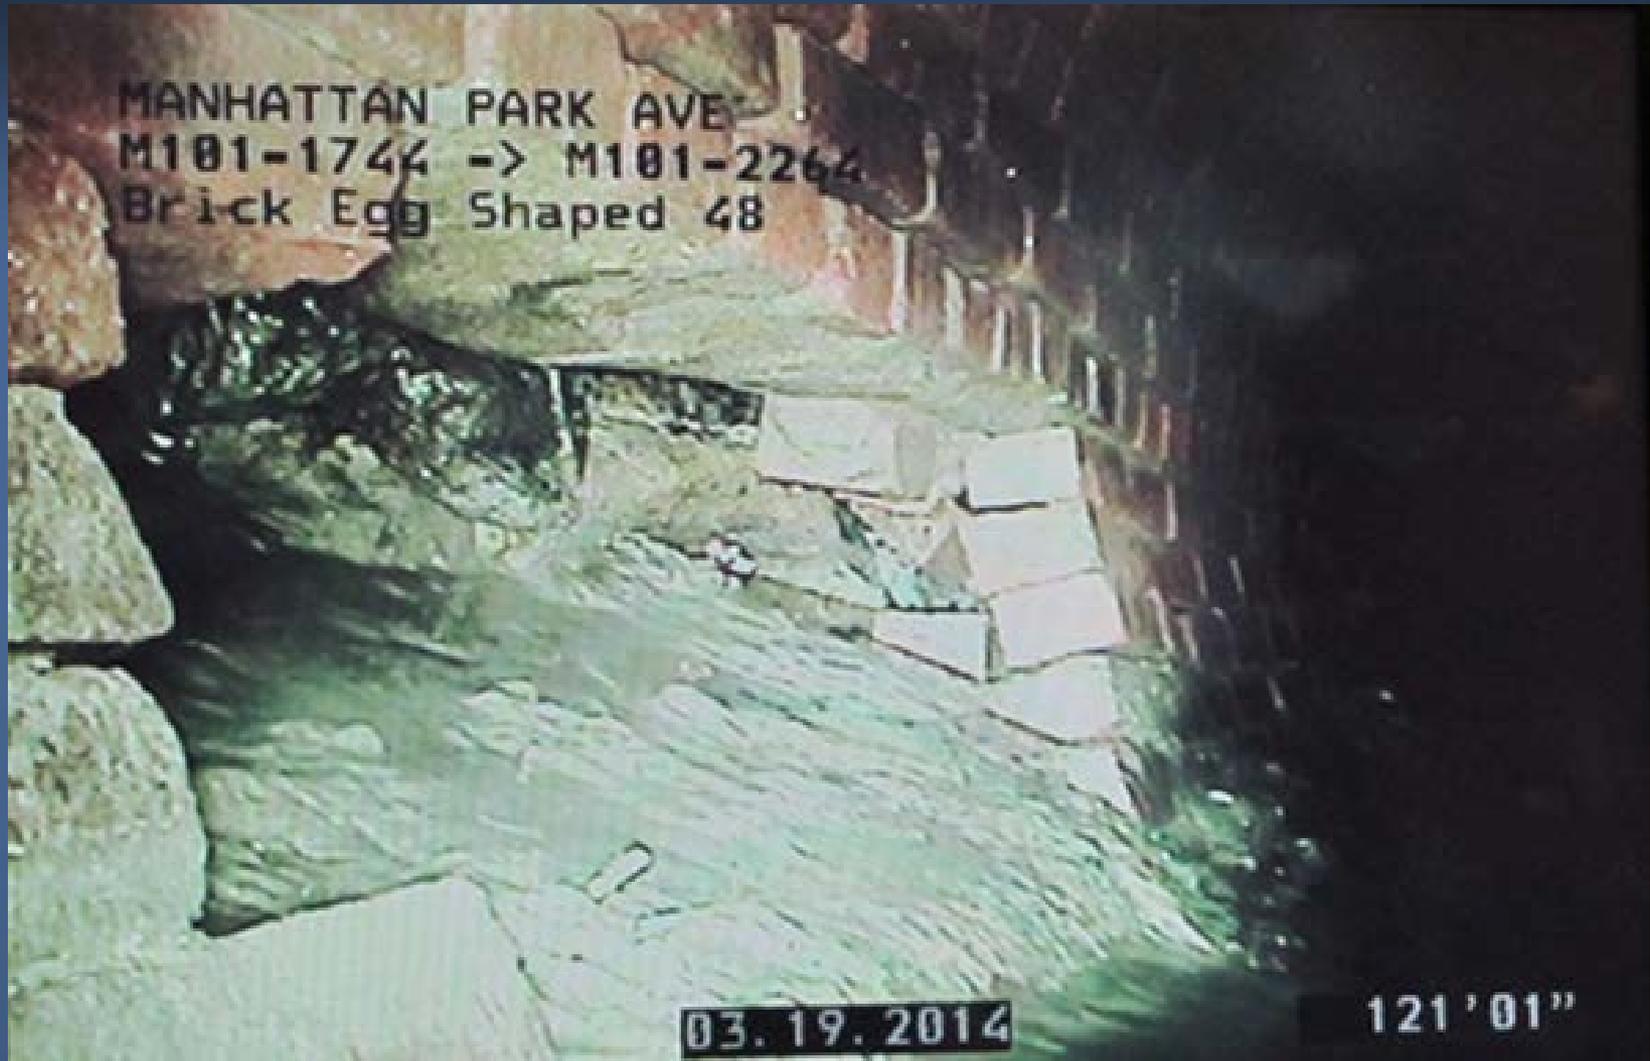
2014 Sewer Main Damage

- Defective service tee fusion weld leaked gas, which migrated into the building and ignited
- Unrepaired sewer line breach allowed groundwater to undermine the supporting soil under the gas main and overstress the defective weld
