UES Capital
Reliability Study
2024

Prepared By:
T. Vrettos
Unitil Service Corp.
11/5/2024

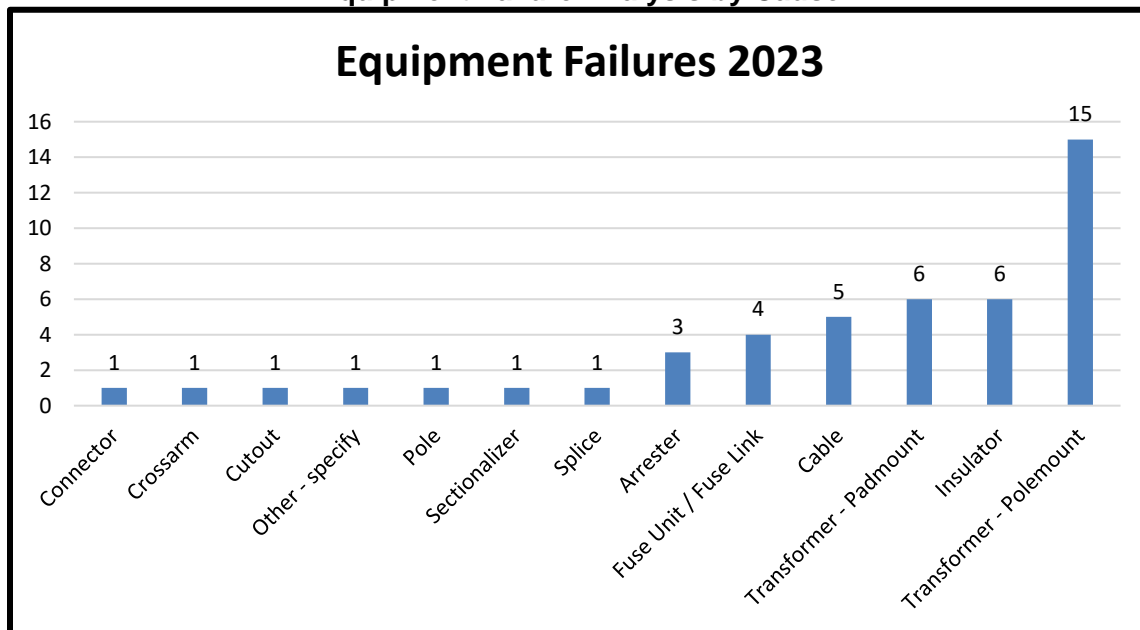
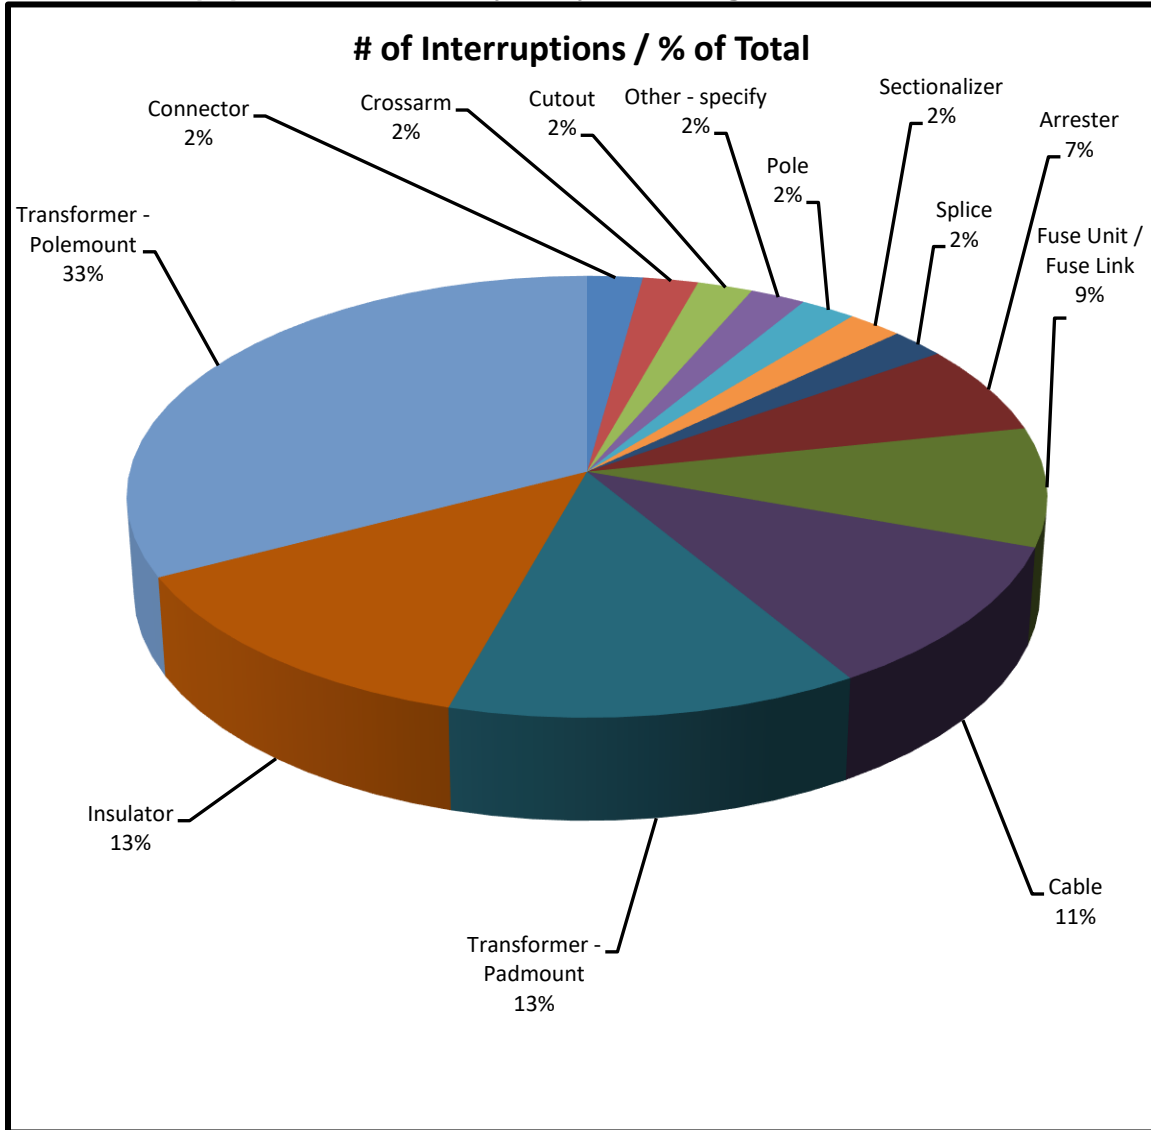
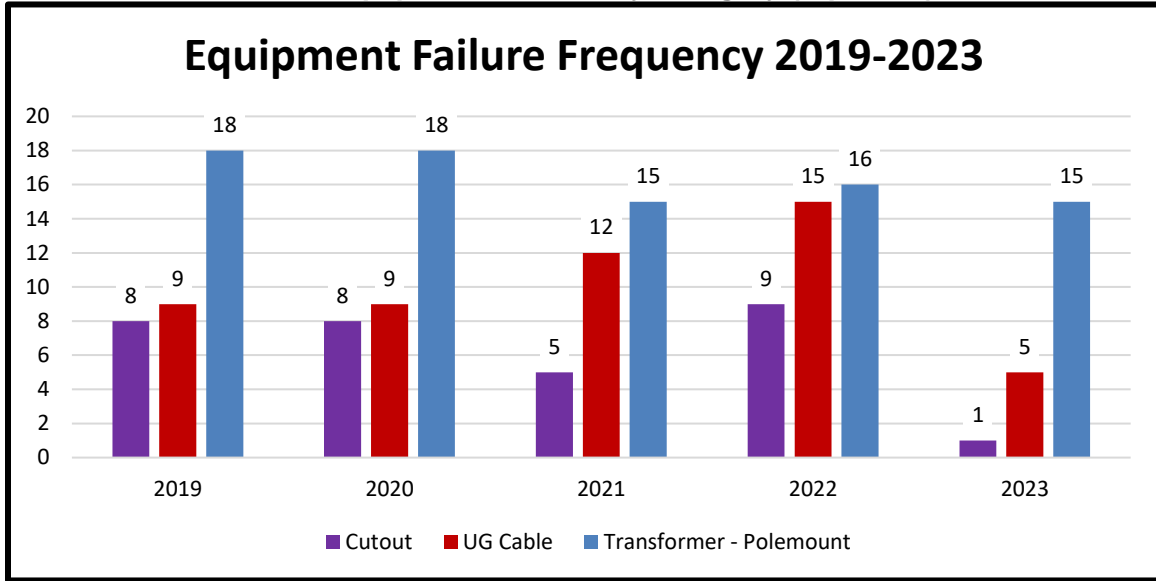
The top three equipment failures continue to be cutouts, underground cables, and polemount transformers. The polemount transformer failures, although high, do not show signs of decreasing over the last 5 years. Cutout failures also show signs of decreasing over the past year, likely due to the cutout replacement program. Operations and engineering will continue to review locations in which cable injection and replacement of direct buried cable could reduce the frequency of underground cable failures.
