November 25, 2013

Re: Northern Utilities, Inc.
Docket No. DG 13-321

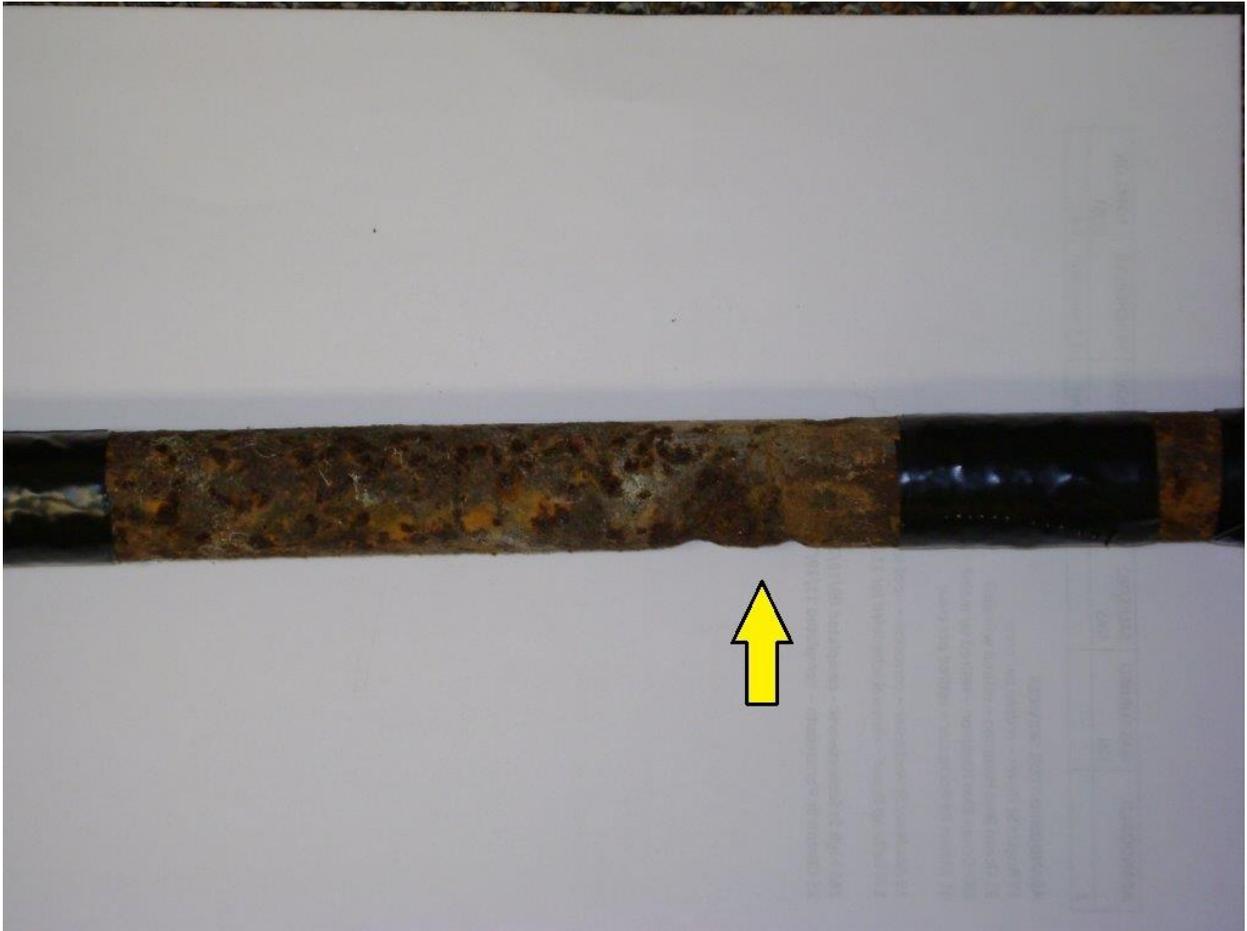
The service technician Red Tagged the service (Attachment L) and shut off the gas. A contractor repaired the customer's pipe on November 20, 2013 and service was restored after it passed a plumbing inspection. The Company has taken custody of the section of service pipe that was the source of the leak. Below is a photograph of the portion of the pipe that was encased in the foundation wall without any sleeving. Note the corrosion and loss of pipe material at the arrow. Photographs of the pipe are provided in Attachment M.

Finally, based on Company records, the account for 17 Spinnaker Way was established in May of 1993, and the account for 9 Charles Street was established in March of 1998. It is reasonable to assume that the customer piping at Spinnaker Way may be about five years *older* than the same type of piping at 9 Charles Street that corroded and leaked.
