Line T-198

Evaluation of Normal Flood Elevations

Crossings over the Ashuelot River and South Branch Ashuelot River

**Subject: Evaluation of Normal Flood Elevations
Communications Cable Crossings of the Ashuelot River**

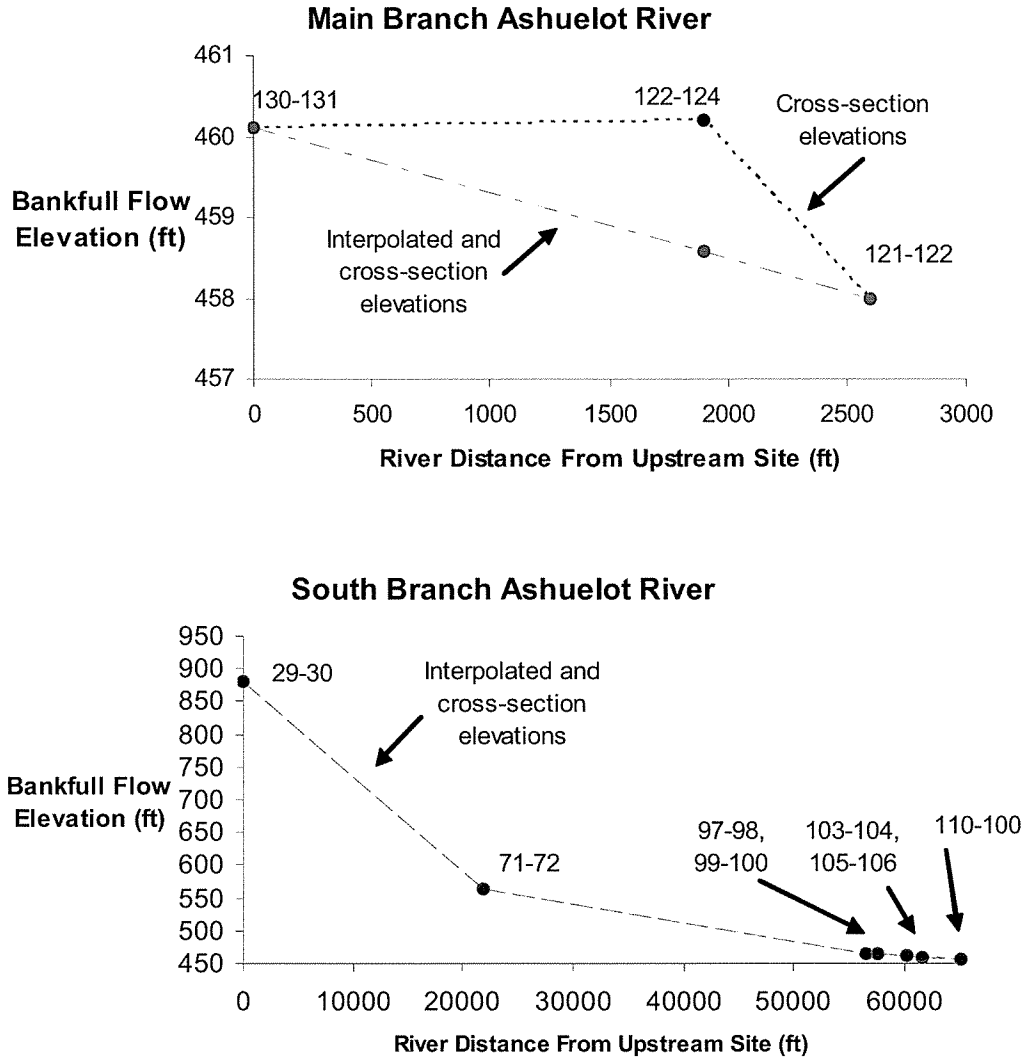
Figure 1. Bankfull Flow Elevations for Ashuelot and South Branch Ashuelot Rivers.

Based on our observations of the characteristics discussed above, we have determined that the bankfull flow that fills the channel to the top of bank is a conservative approximation of the normal flood level of the Ashuelot and South Branch Ashuelot Rivers at the crossings of the Monadnock-to-Emerald Street utility lines. A summary of the bankfull flow elevation results for each crossing is found in Table 1.

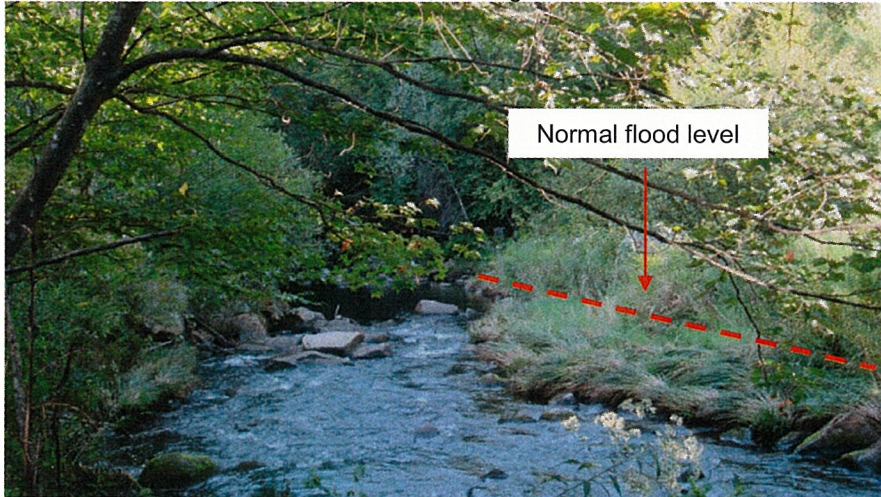
The top of bank within the active streamway (not depicted on provided cross-section drawings) can be considered the normal flood level, as the grassy vegetation within the active streamway suggests inundation up to the level portion of the channel bed. There is little erosion in this reach.

View across river toward Structure 29, looking northeast.

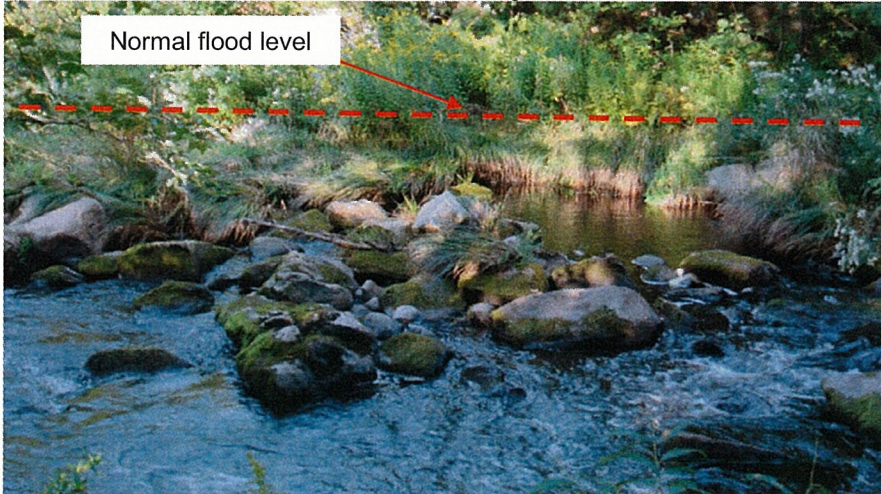
View across river toward Structure 29, looking east.

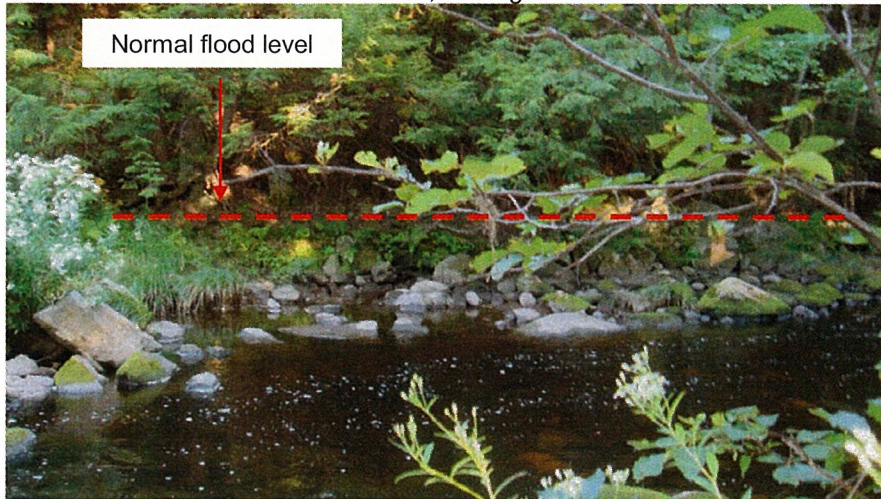
View across river toward Structure 29, looking southeast.

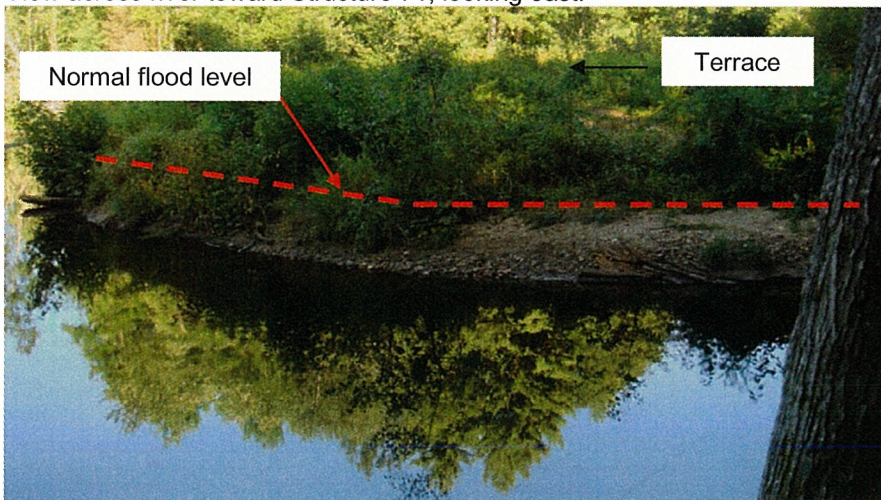
The stable, mature vegetation on the sand bar in inner bank suggests rare inundation above the top of bank; the sand deposits at higher elevations on this bank are likely due to the 10-year flood, which is above the top of bank. Thick vegetation is found along the outer edge of the bend (the side where Structure 72 is located), including on sand bars and the terrace. The flat terrace structures on the outer edge of bend are not depicted in cross section; they are vegetated but likely rarely inundated. Overhang of vegetation and slight erosion suggests that top of bank (considering presence of terrace) is normal flood level.

View across river toward Structure 71, looking east.

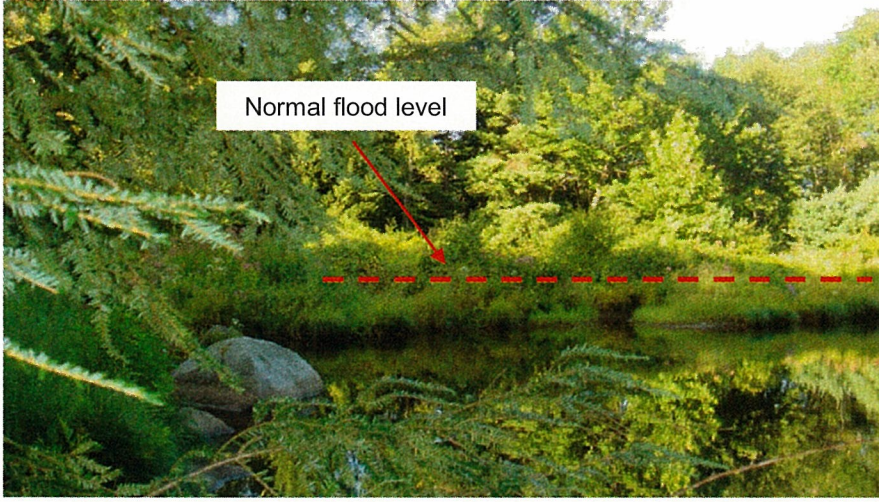
View across river toward Structure 72, looking northeast.

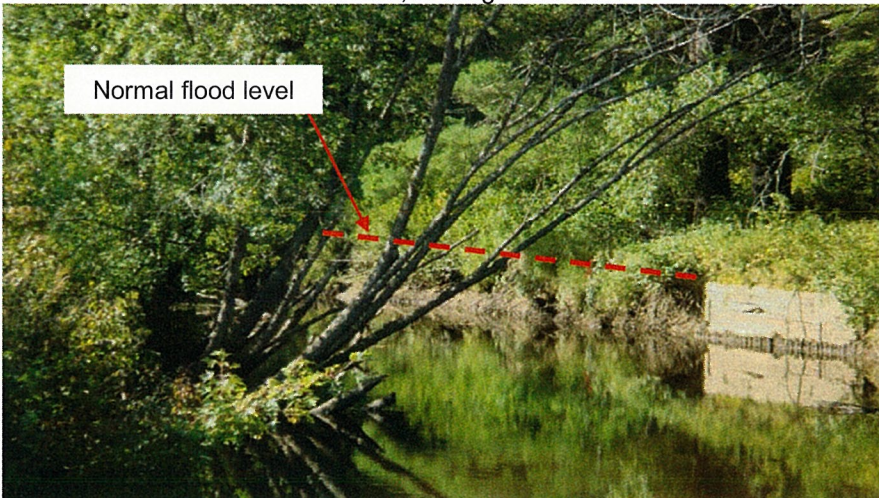
The north side of the bank at this crossing is vegetated with grass and goldenrod; the transition to goldenrod indicates the level of the top of bank. Evidence of bank erosion extend halfway up to the top of bank, and the south side of the bank is similarly eroded downstream of the Route 32 bridge crossing. Top of bank is a comfortable normal flood level at this location.

View across river near Structure 97, looking southwest.

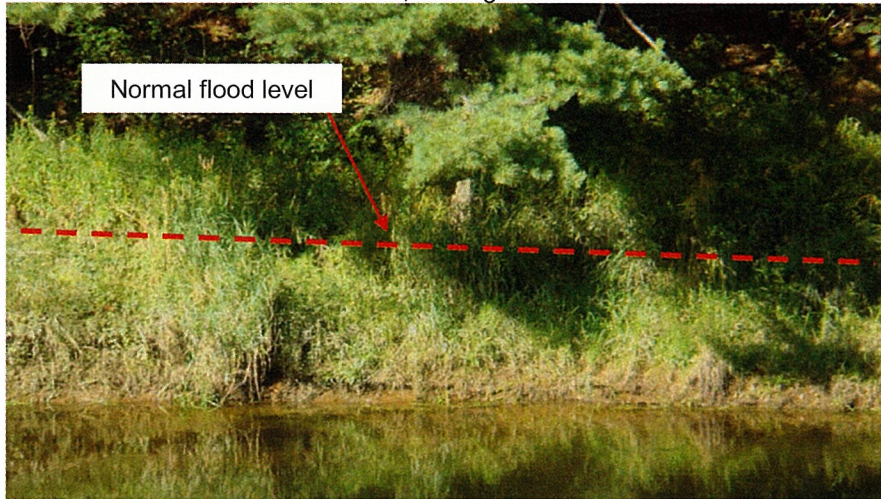
View across river near Structure 97, looking west.

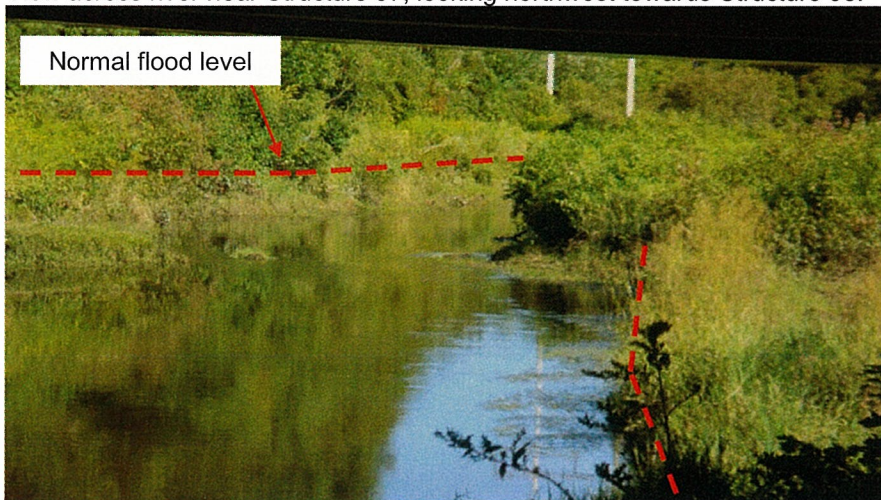
View across river near Structure 97, looking northwest towards Structure 98.

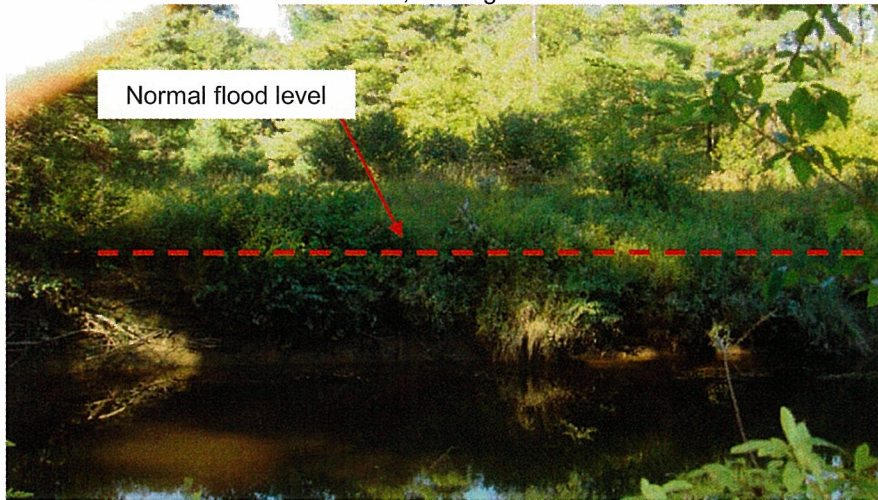
Both banks at this crossing are eroded to approximately $\frac{1}{2}$ - $\frac{3}{4}$ bank height; where they are not eroded, vegetation indicates frequent inundation to same level. The dense, established vegetation above the top of bank suggests infrequent interaction between the river and terrace. Top of bank is a conservative estimate of normal flood level for this crossing.

View across river near Structure 99, looking northeast.

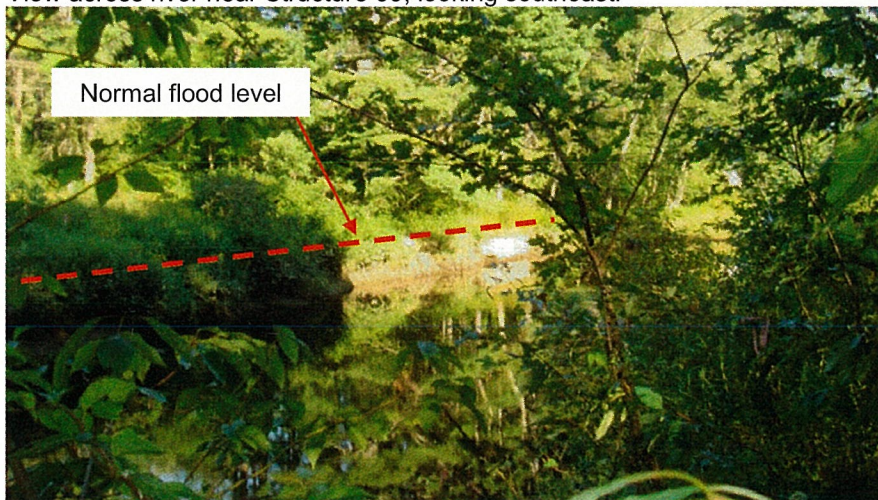
View across river near Structure 99, looking southeast.

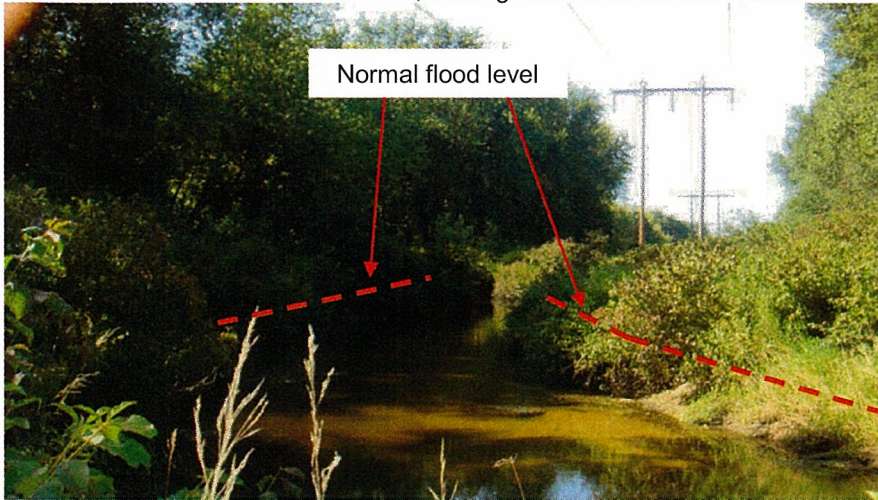
A significant sand bar exists on the inner bank; sediment deposits higher than the top of bank are likely from flows less frequent than baseflow, while those on the lower part of the bank result from flows that occur with higher frequency. The outer bank is eroded along the length of the bend. The damage suggests that flows typically reach $\frac{1}{2}$ - $\frac{3}{4}$ bankfull but infrequently exceed that level. Dense, established vegetation on the terrace of the outer bank indicates that the normal flood level is no higher than the top of bank.

View across river near Structure 110, looking northwest towards Structure 111.

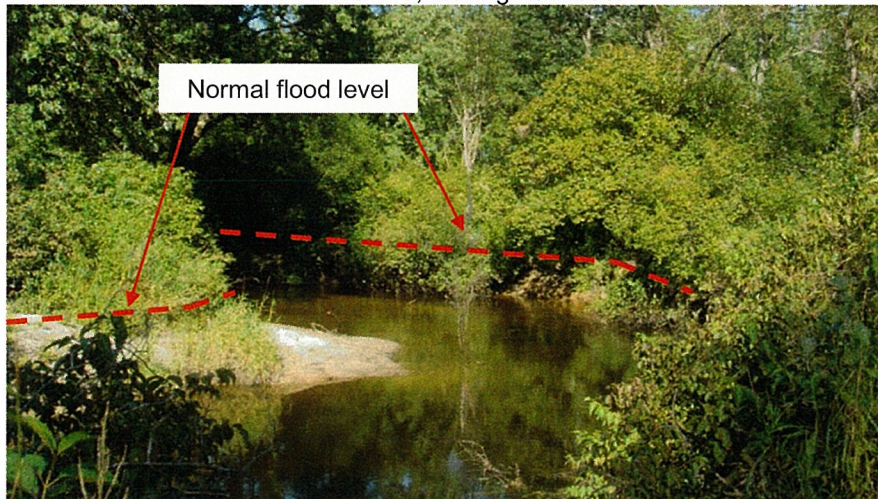
View across river near Structure 110, looking northeast.

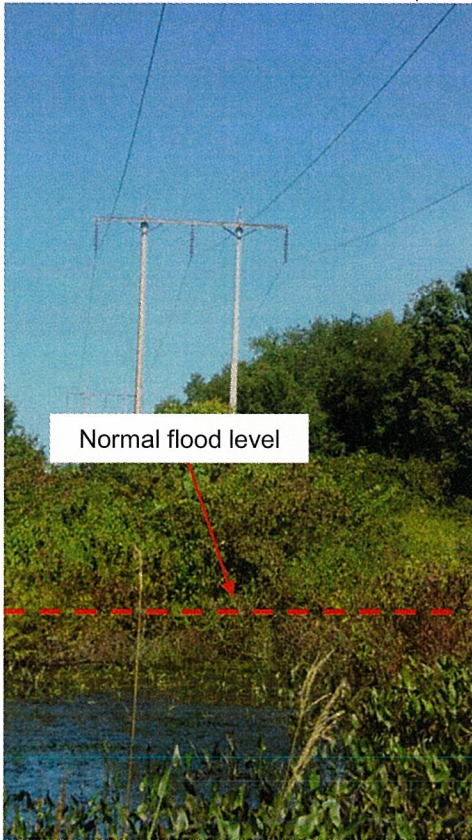
The Ashuelot River at this crossing is wide and swampy. The tributary entering from the northeast meanders within a wide, active streamway. Vegetation below the top of bank shows evidence of inundation, while established vegetation above bank indicates bankfull flow as the normal flood level. The wide and generally flat structure of this area provides room for lateral spreading and detention of water.

View across river near Structure 121, looking north towards Structure 122.

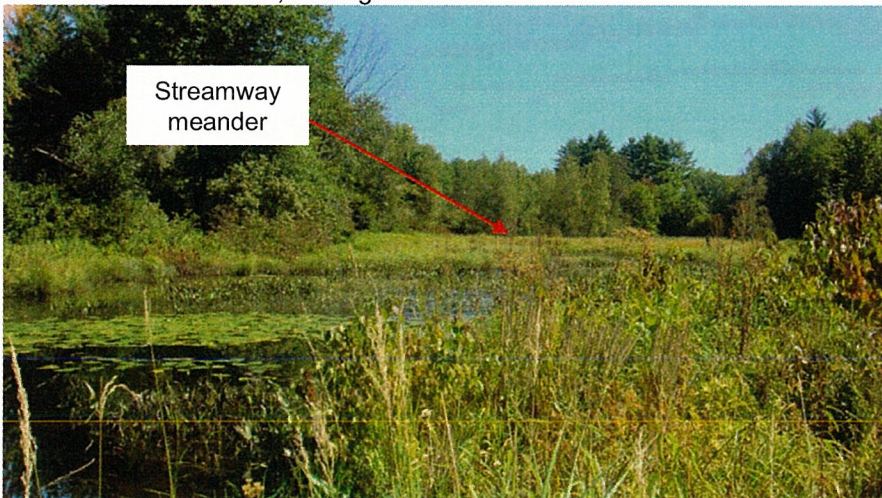
View near Structure 121, looking northeast.

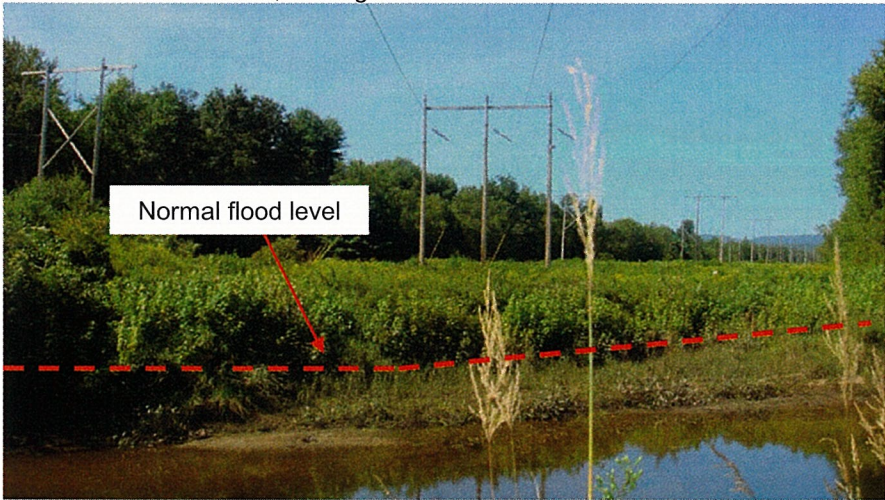
The sand bar on west bank of this reach, just north of the crossing, is large and shows frequent annual deposition. This and vegetation change from grass to shrubs indicates infrequent inundation beyond the top of bank. The banks at all other locations have been eroded up to $\frac{3}{4}$ of

the height of the top of bank. Vegetation indicates frequent annual inundation to the same level, but no frequent interaction between the terrace and stream. Bankfull flow is a conservative approximation of the normal flood level at this crossing.

View near Structure 130, looking north toward Structure 131.

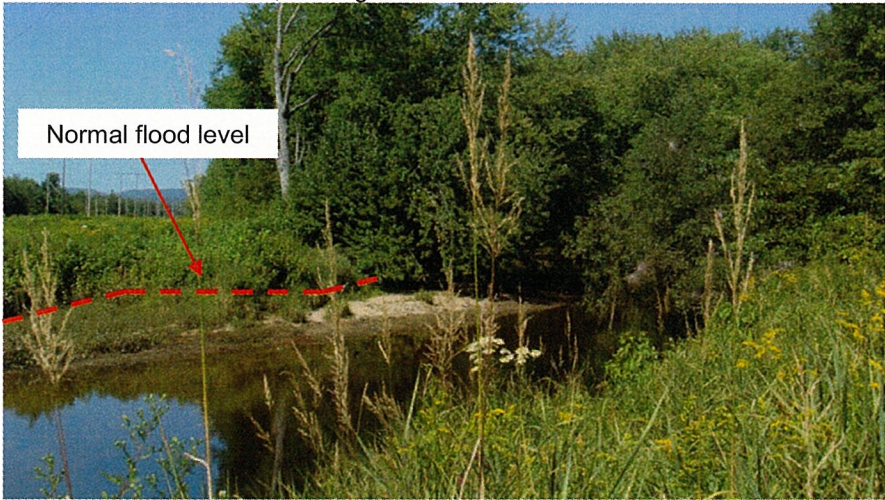
View near Structure 130, looking northeast.

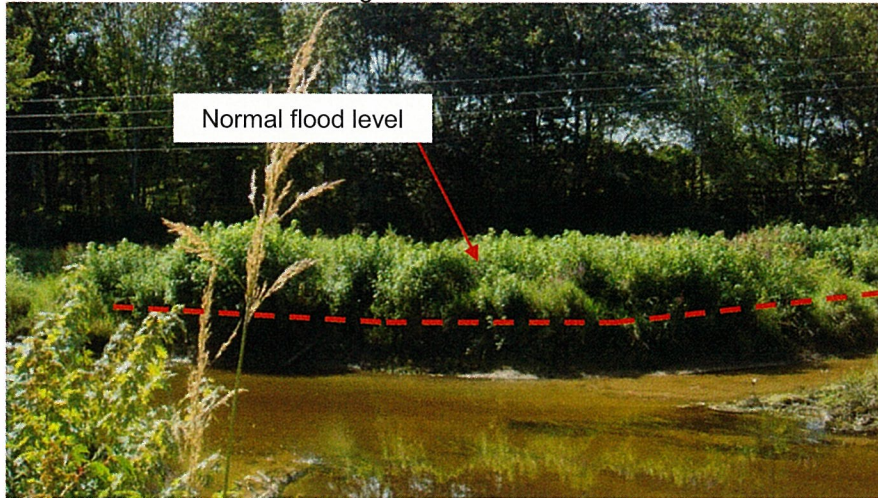
View near Structure 130, looking west.
