New Hampshire December 2008 Ice Storm Assessment Report

October 28, 2009

NEI ELECTRIC POWER ENGINEERING

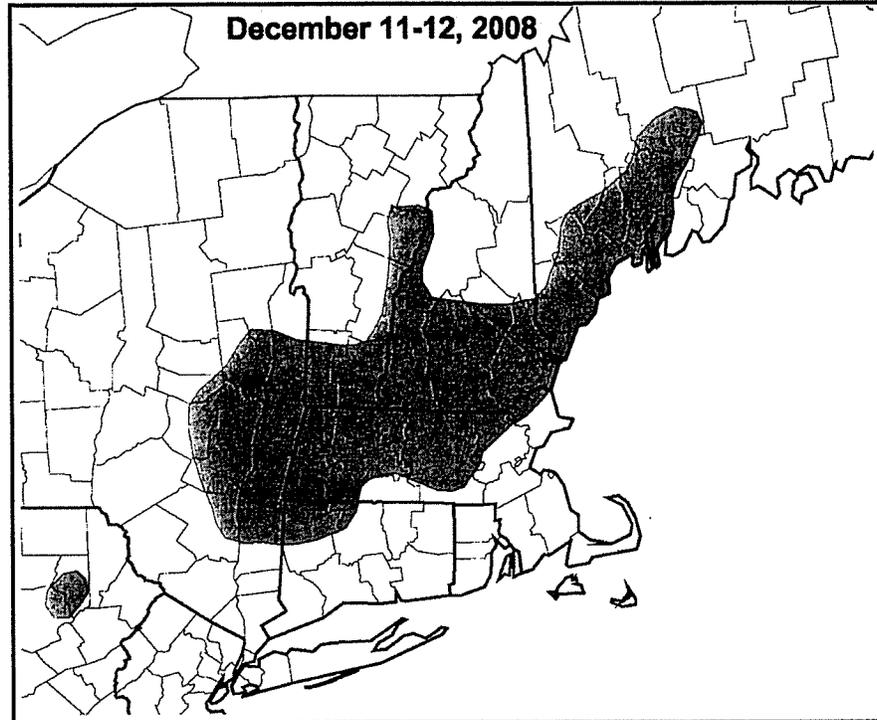
Figure I-1 – Map of the ice storm damage footprint.²

Late on Thursday, December 11, 2008, a major ice storm struck New England and Upstate New York. The storm continued into Friday, December 12, wreaking havoc along its path. Figure I-1 displays the geographical footprint of the damage caused by the storm. Thousands of trees were damaged when their branches became laden with ice as shown in Figure I-2, resulting in tree limbs breaking and entire trees uprooting. Many of the damaged trees and limbs fell onto houses, cars, or across roads, and others fell onto telecommunication and power lines. The mechanical shock caused by falling limbs and trees resulted in a tremendous amount of damage to the overhead electric power system infrastructure.

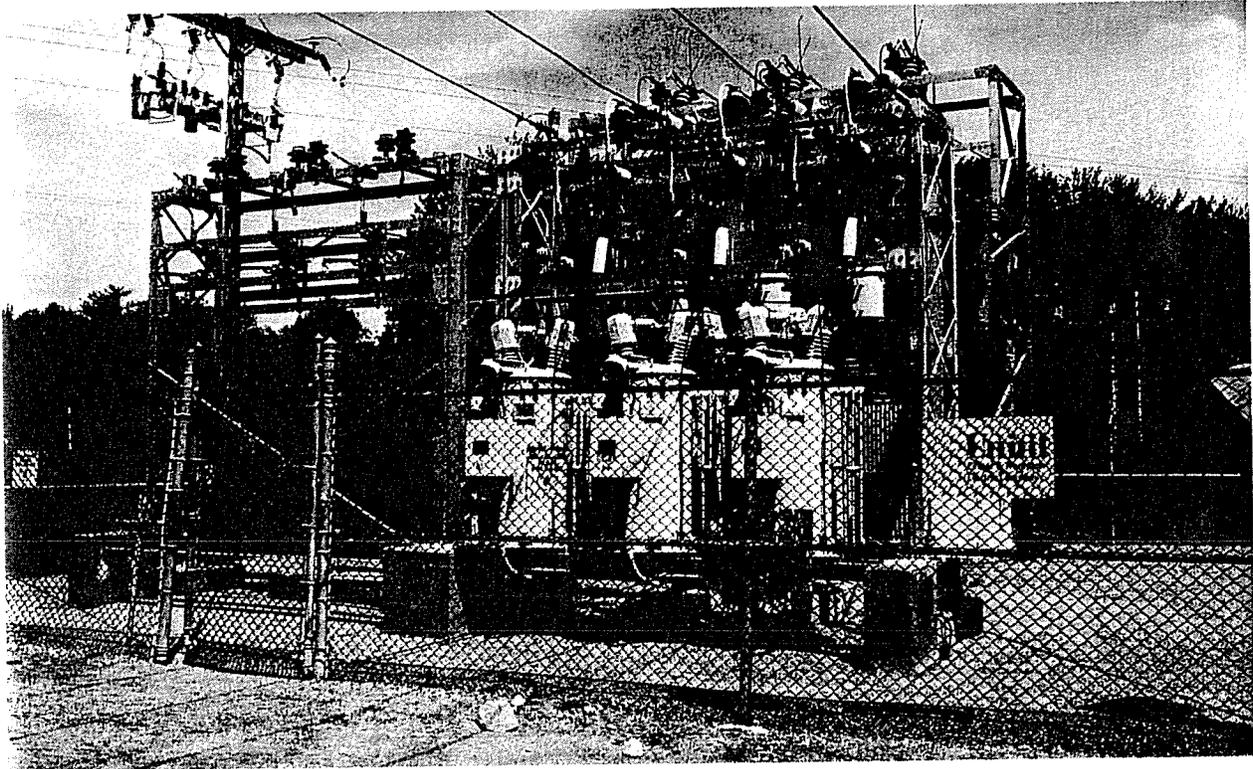
Figure IV-6 – 34.5kV to 13.8kV Unitil electric distribution substation located in East Kingston, New Hampshire. (Photo by NEI-Unitil System)

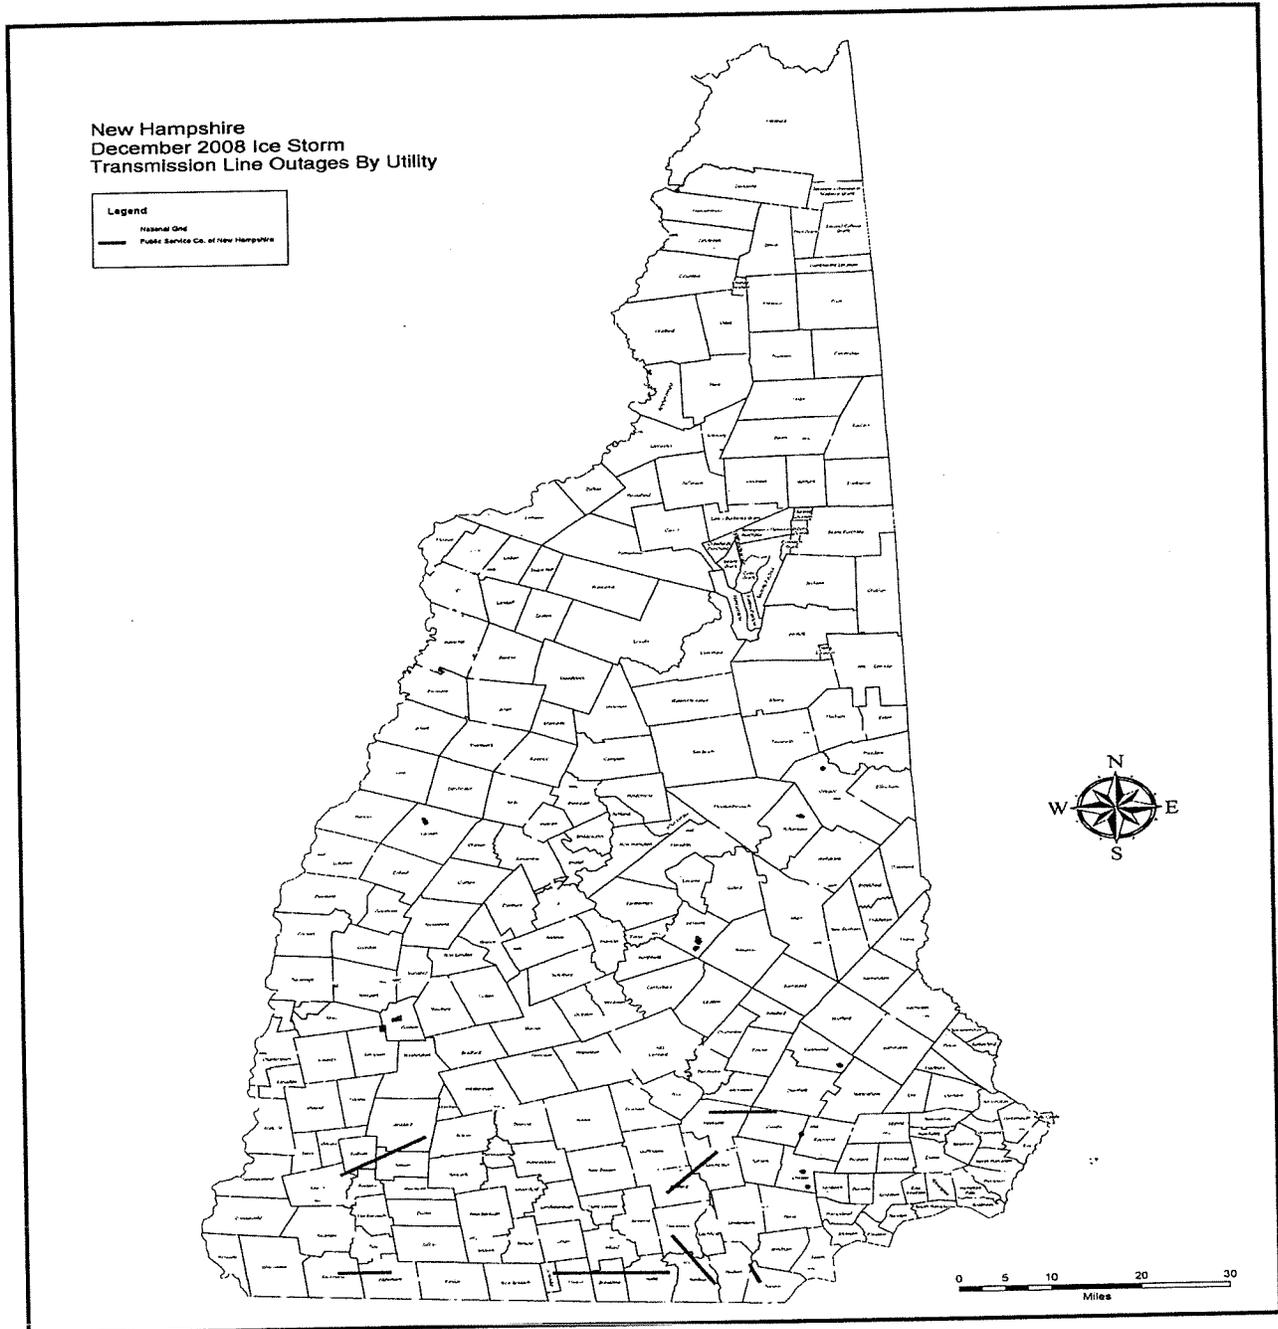
The following is a summary of each utility's transmission line outages including a map in Figure IV-8 that shows the locations of the transmission lines which tripped off during the storm.

Figure IV-8 – Transmission line outages due to the December 2008 ice storm.

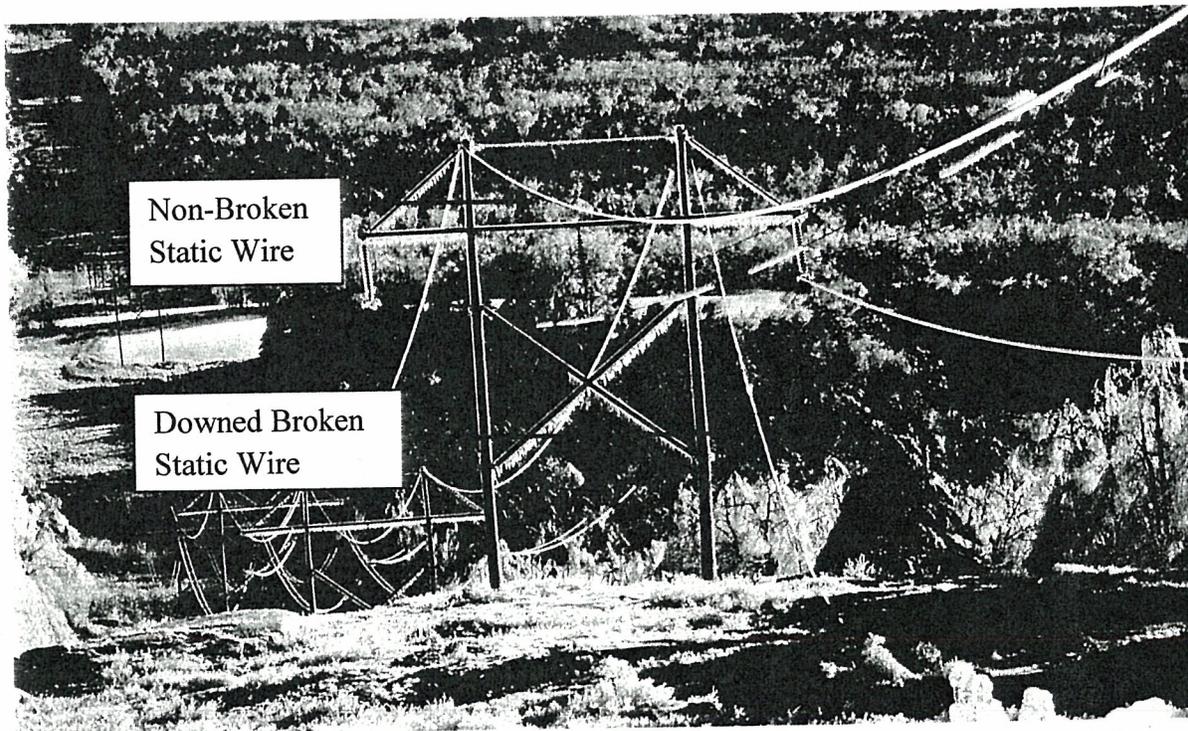
Figure IV-9 - PSNH 345kV line 367 - Static Wire Failure. (Photo courtesy of PSNH)

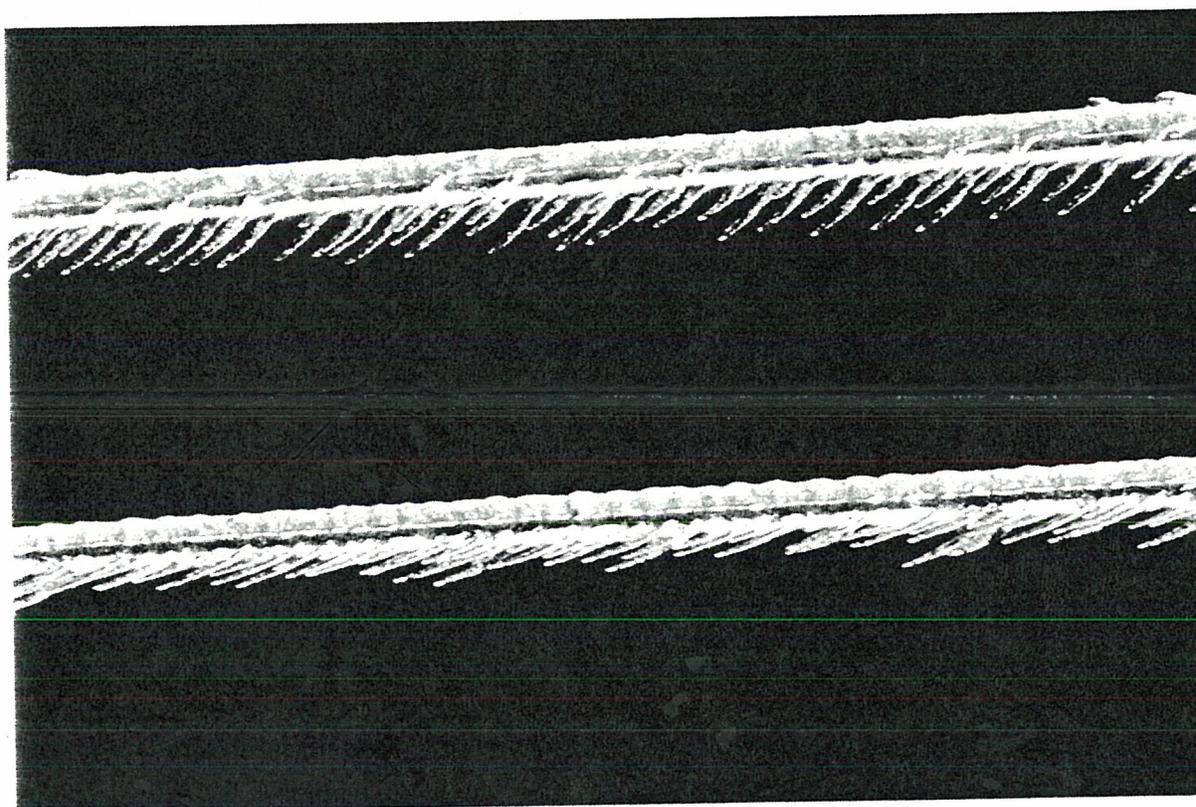
Figure IV-10 - Close-up of ice shown in Figure IV-9. (Photo courtesy of PSNH)

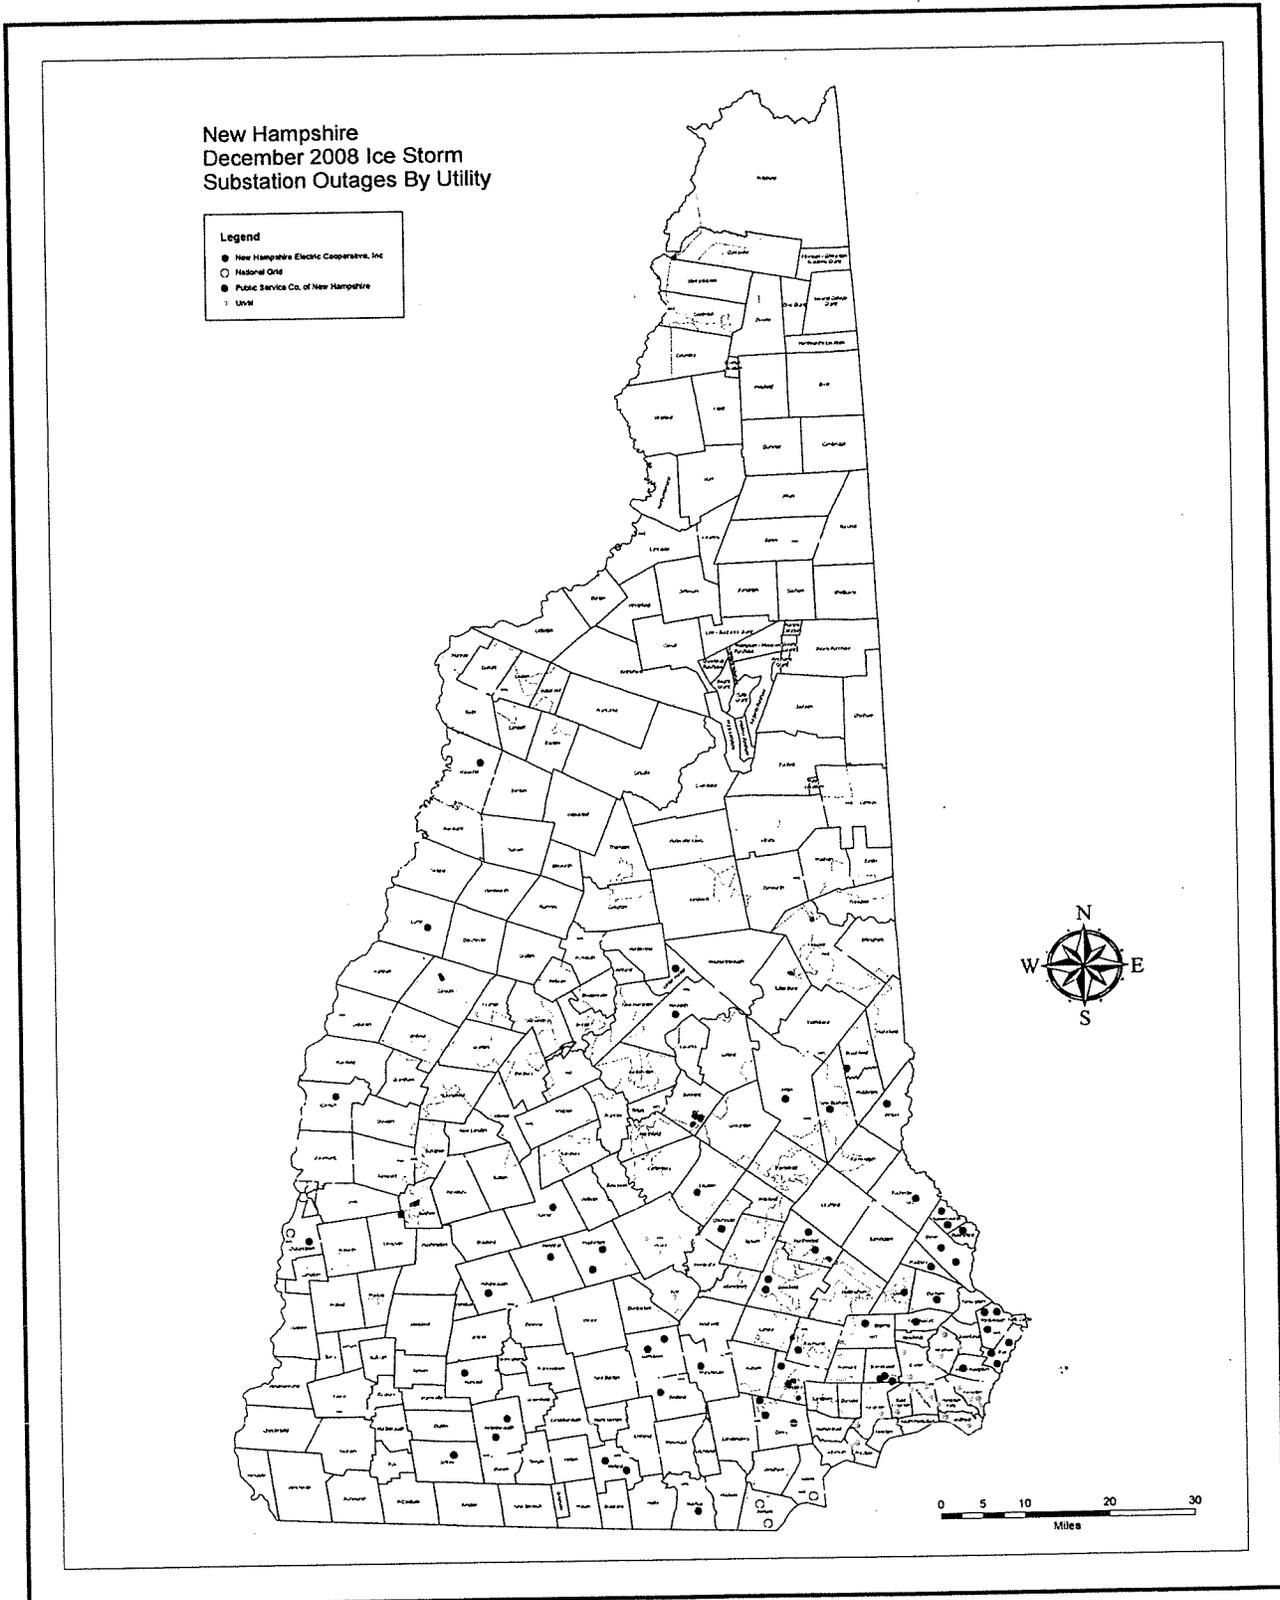
Figure IV-11 – Substation outages due to the December 2008 ice storm.

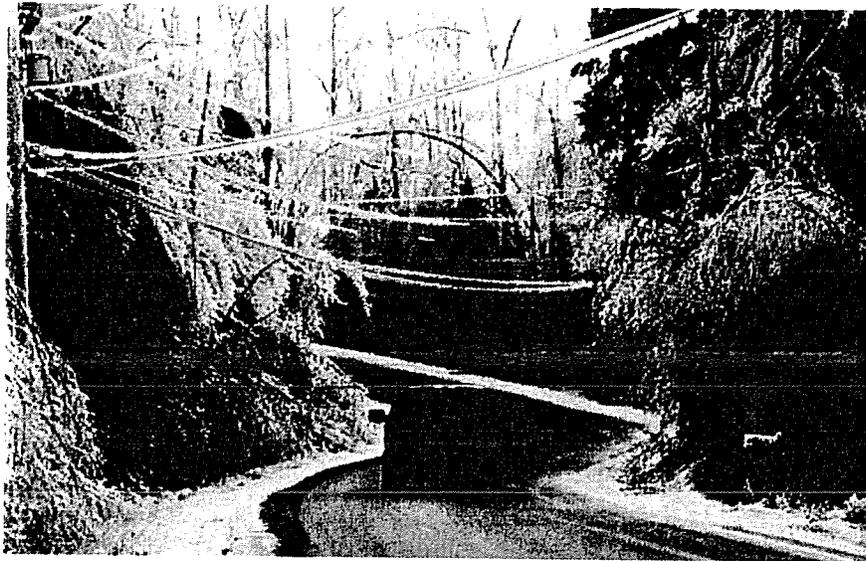
Figure V-2 - Ice loading on lines during December 2008 ice storm.
(Photo courtesy of PSNH, location unknown.)

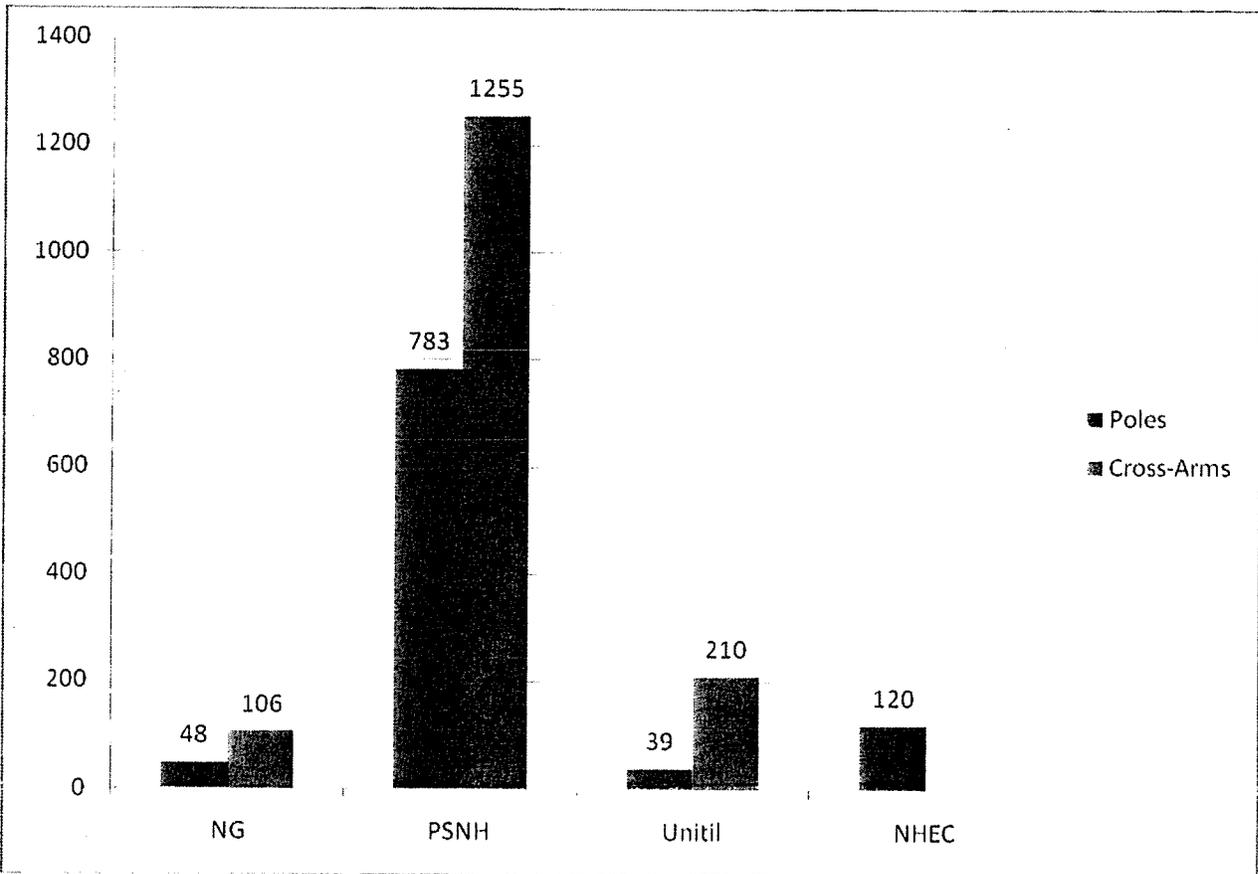
Figure V-3 shows the number of poles and cross arms each electric utility replaced in its distribution system due to damage from the December 2008 ice storm. It may be seen that each utility suffered significant damage to its distribution system. A few things to note when analyzing Figure V-3 are that NHEC did not provide the number of cross arms they replaced which is why none are shown, Unitil's numbers include some poles that were actually the responsibility of FairPoint, and the telecommunications companies are not shown in this chart.

Figure V-3 – Poles and cross arms replaced by each utility following the December 2008 ice storm.^{14 15 16 17}

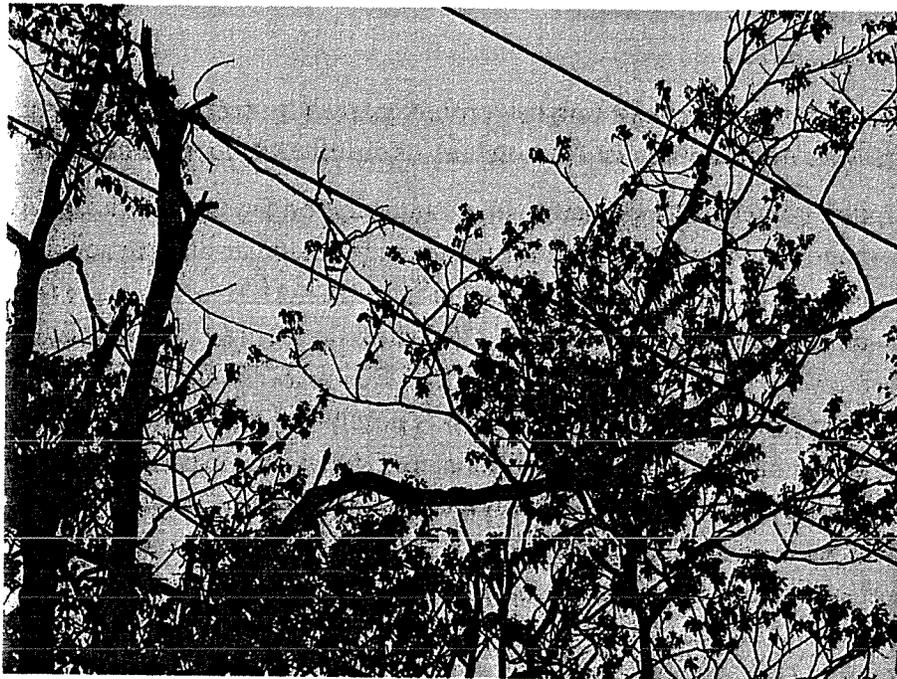
Figure V-5 - Small diameter immature trees broken above conductors in New Ipswich, NH. (Photo by NEI)

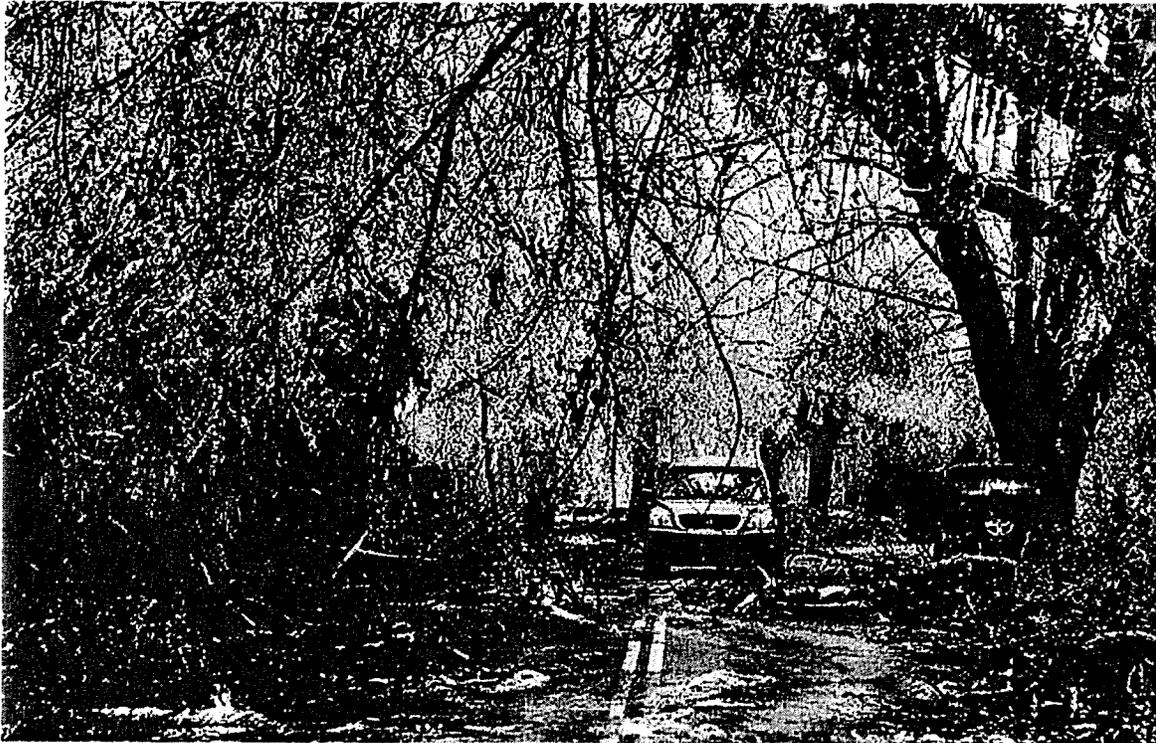
Figure V-7 - Effects of ice laden trees. (Photo source unknown)

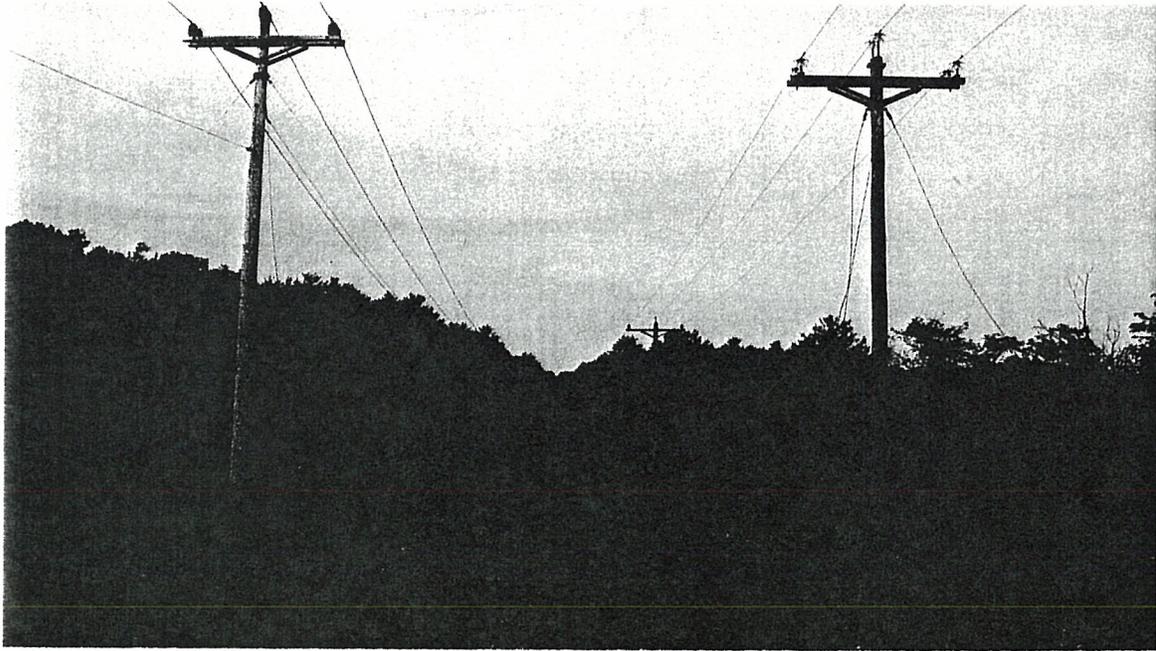
under this circuit is insufficient and if not improved could result in the trees growing into the lines or major damage if a fire were to occur in the ROW.

Figure V-9 - Example of 34.5 kV Unitil sub-transmission line ROW. (Photo by NEI)

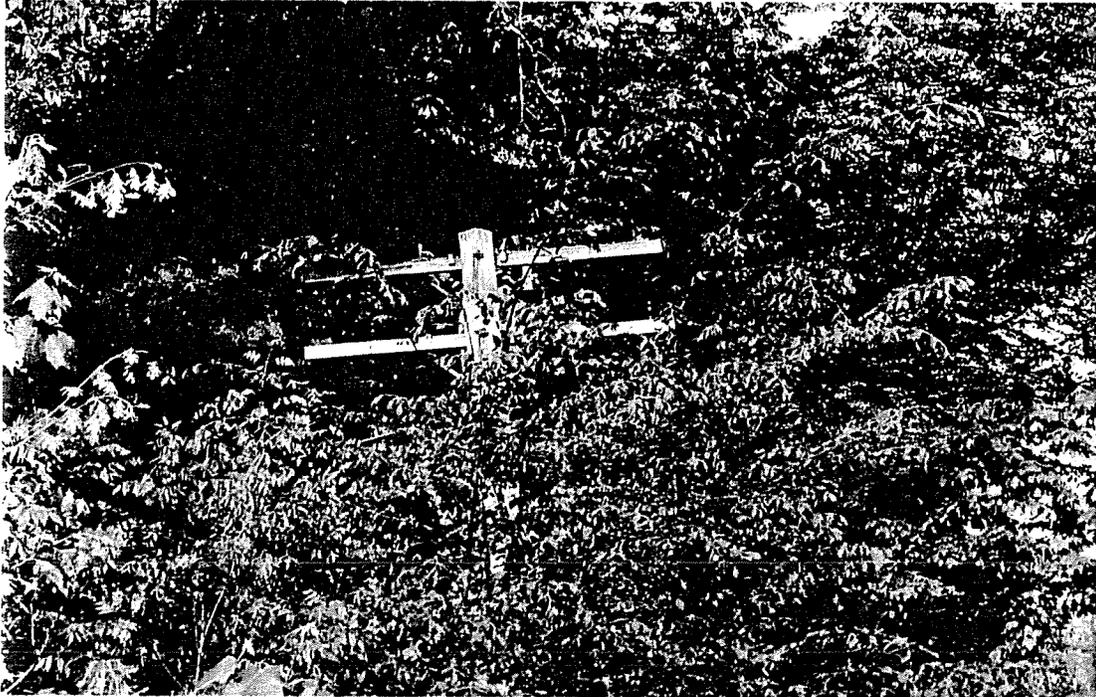
This growth is unsafe, violates the NESC, and is possibly damaging the conductors. While this photograph was taken on Unitil's system, it is not meant to single out Unitil. Similar situations occur on the systems of each utility.

Figure V-14 – NESC Rule 218 violation in Unitil service area.
(Photo by NEI)

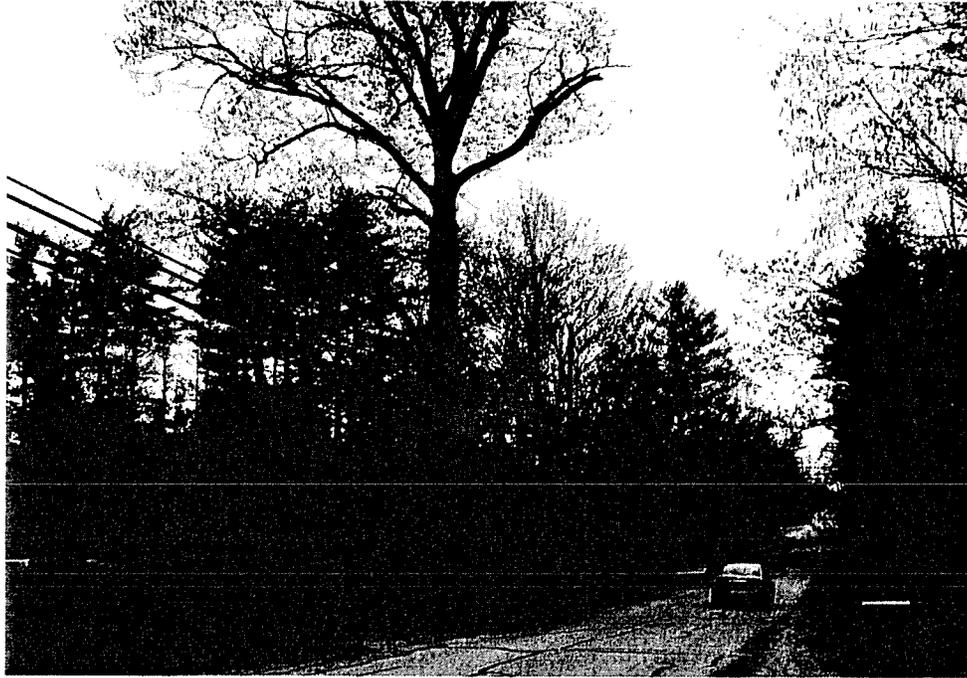
equipment most utilities have available. This particular tree was marked for removal as a "hazard tree." However, this was not done merely due to its proximity to the power line. In New Hampshire, placing the line at risk is not sufficient cause for a tree to be labeled as a hazard. To be classified as a hazard tree, it must also be either infected or dying in addition to its proximity to the line. Within the state, there are many large healthy trees which pose a hazard to power lines and should be considered for removal.

Figure V-15 - Mature oak to be removed in New Ipswich, New Hampshire. (Photo by NEI)

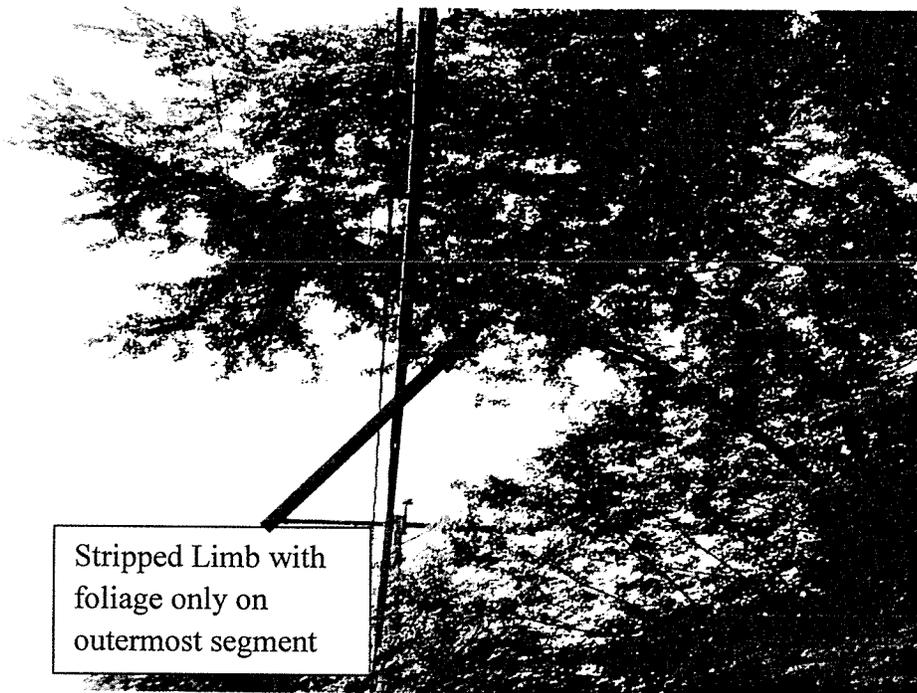
- The utility's trimmers should not strip foliage and side limbs from the part of the branch nearest the trunk and leave foliage at the outermost end of the branch. This practice, called "lion-tailing" and illustrated in Figure VII-1, leads to excess weight at the end of limbs and the reduction of limb diameter over time.

Figure VII-1 - Example of "lion-tailing." (Photo by NEI)

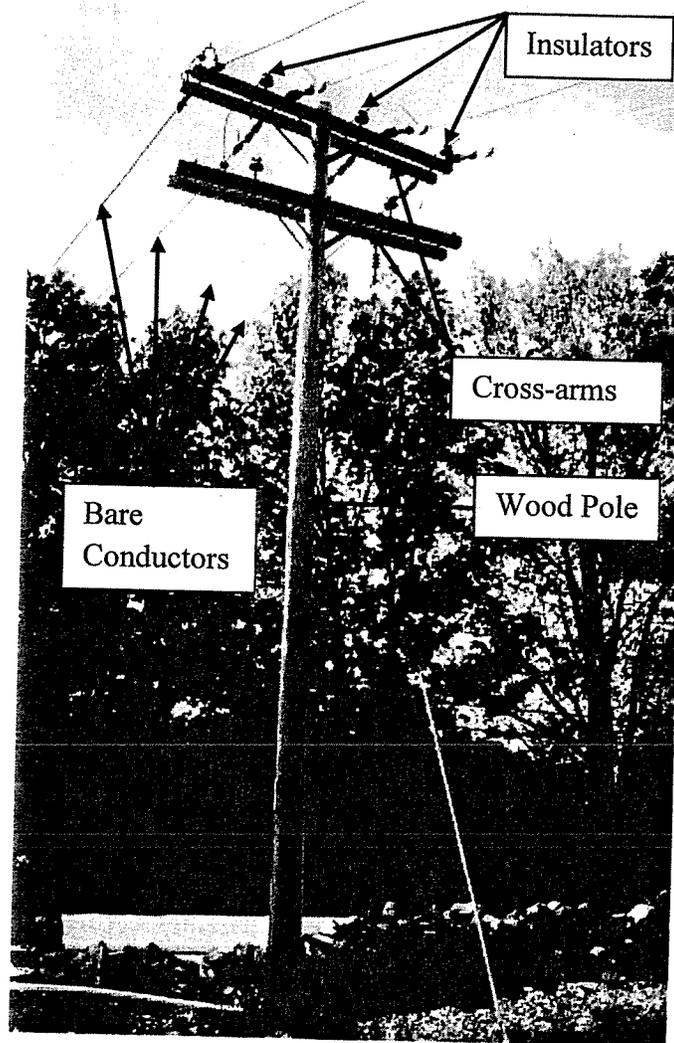
To better understand the requirements to convert an overhead distribution line to underground, one needs to understand the construction of both. The overhead distribution line typically uses two or more “bare” conductors (conductors covered with no rubber or plastic insulation). Air, which is a good insulator (dielectric), surrounds the conductor and allows the heat resulting from the electric current flow to easily dissipate into the surrounding atmosphere. This keeps the conductor below the temperature at which it would be damaged. Overhead type construction has been used for many decades. Due to the requirements of the Rural Utility Service, the construction methods are somewhat standardized and are similar in all parts of the United States. For this reason, bare conductors and installation hardware are widely available and relatively cost effective to install. In order to hold the bare conductors in the air, they are attached to wood, steel, or concrete poles at several hundred foot intervals. The conductors are insulated from the pole by being held in place by polymer or porcelain insulators. These can be mounted directly to the pole or on cross arms which are in turn mounted to it. Safety results from the height the conductors are mounted above the ground rather than the presence of rubber insulation on the conductors. Since air is used as the insulator, continuous rubber insulation on the conductor is not necessary. The result is that this type of construction is very cost efficient and highly durable. Figure B-1 illustrates a typical type of overhead distribution line construction.

Figure B-1-Typical distribution line bare consisting of conductors attached to insulators mounted on a cross-arm attached to a wooden distribution pole. (Photo by NEI-Location Unknown)

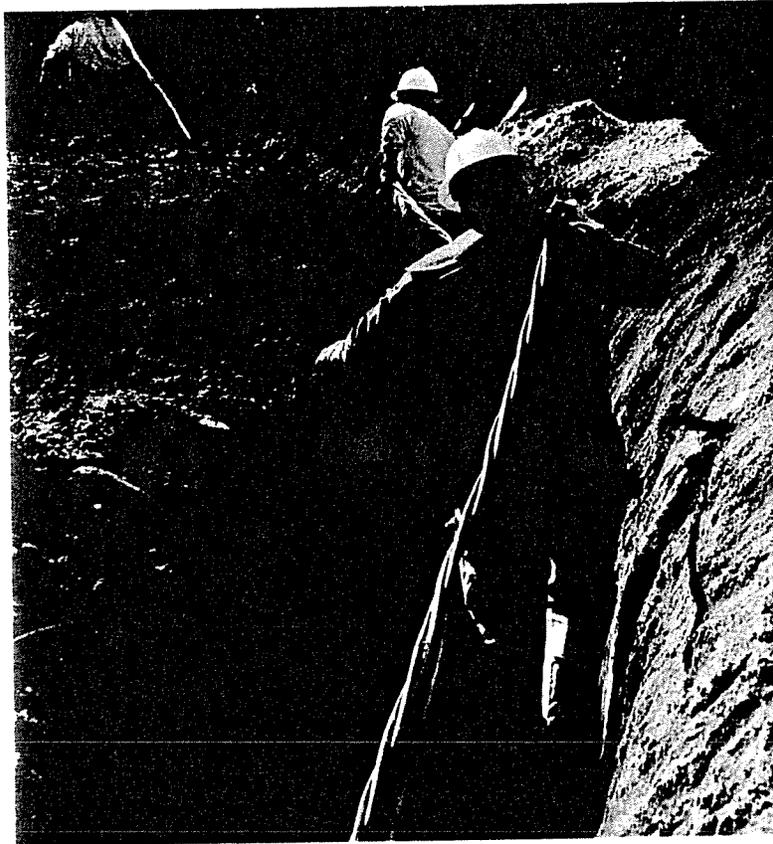
Placing an electrical conductor underground is a much more complex and costly undertaking. First of all, an un-insulated bare conductor cannot be placed underground. While overhead conductors are placed many feet apart from each other and located high above the ground, underground conductors are placed very close together and within a few inches of surrounding earth. It is common in some areas to directly bury conductors. In direct burial, a narrow trench is dug, sometimes only large enough to place the conductor in, and soil is placed directly around it. A direct bury installation is shown in Figure B-2.

Figure B-2-Installing direct buried cable. (Photo courtesy of Southwire)

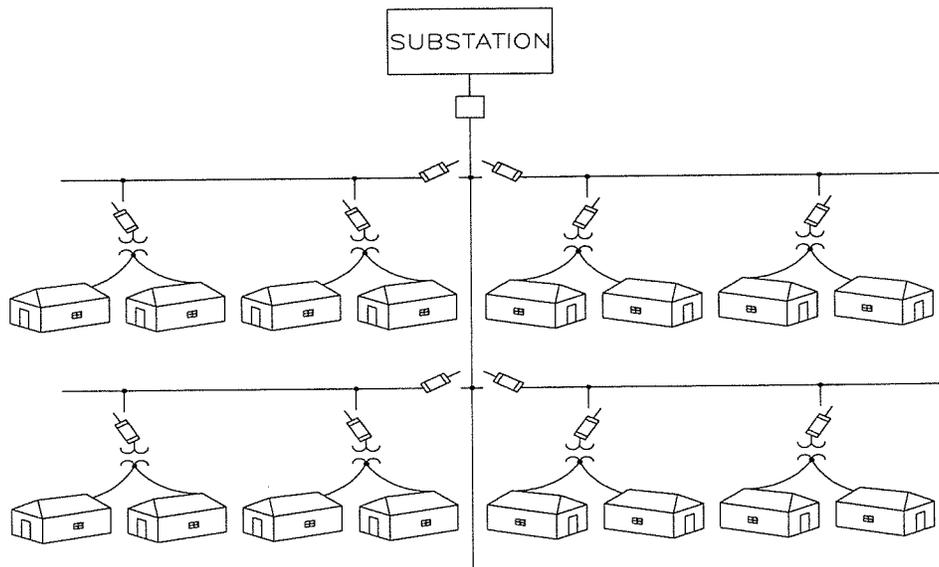
Most overhead distribution systems in the United States are radial systems and operate at 12.47kV³. A typical radial distribution system shown in Figure B-6 has only one path for current to flow from the source to the customer. If a line is disabled, the resulting outage for all of the customers on that line may persist until the line is replaced. This may take considerable time.

Figure B-6 - Typical radial distribution system.

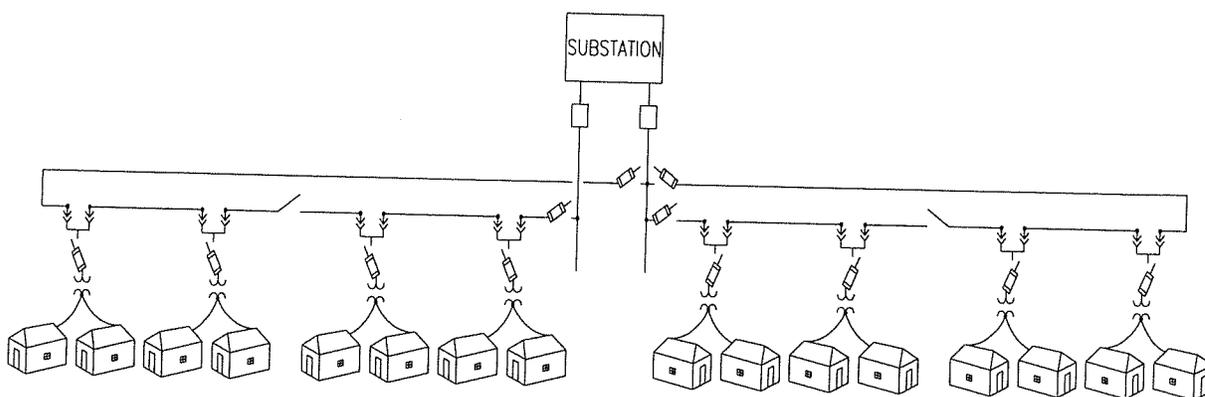
Figure B-7-Looped distribution system.

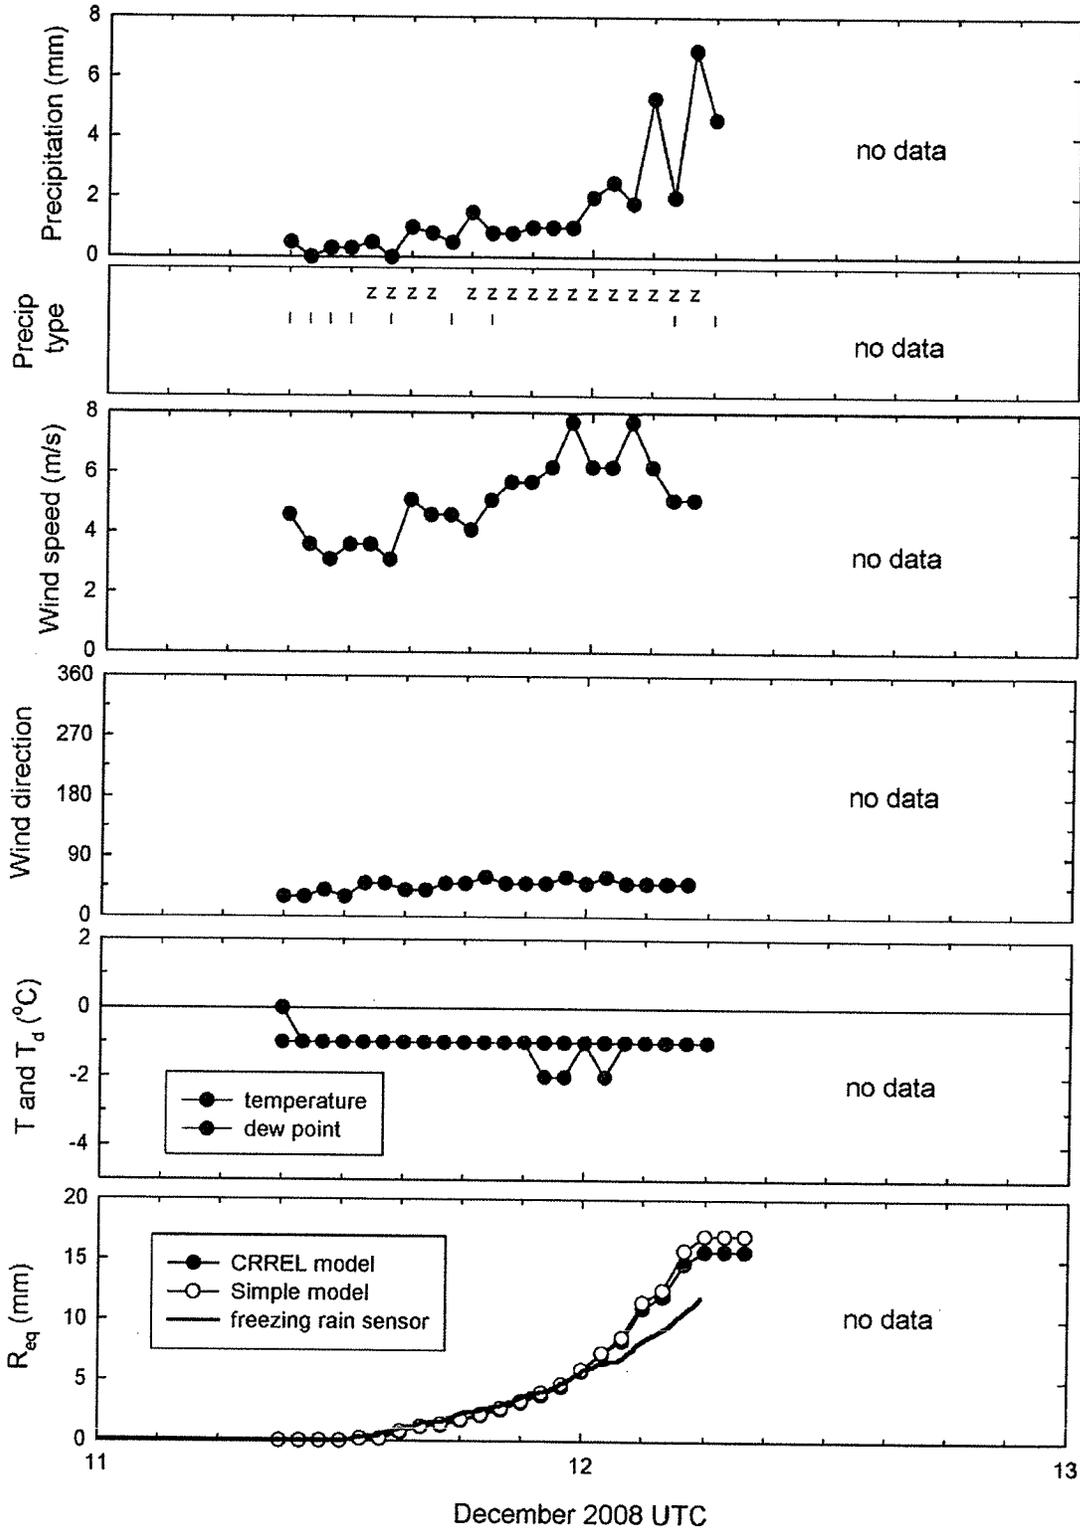
Figure D-4 - Storm time series for Worcester, Massachusetts. Equivalent radial ice thicknesses from the CRREL and Simple models and from the freezing rain sensor are in the bottom panel.

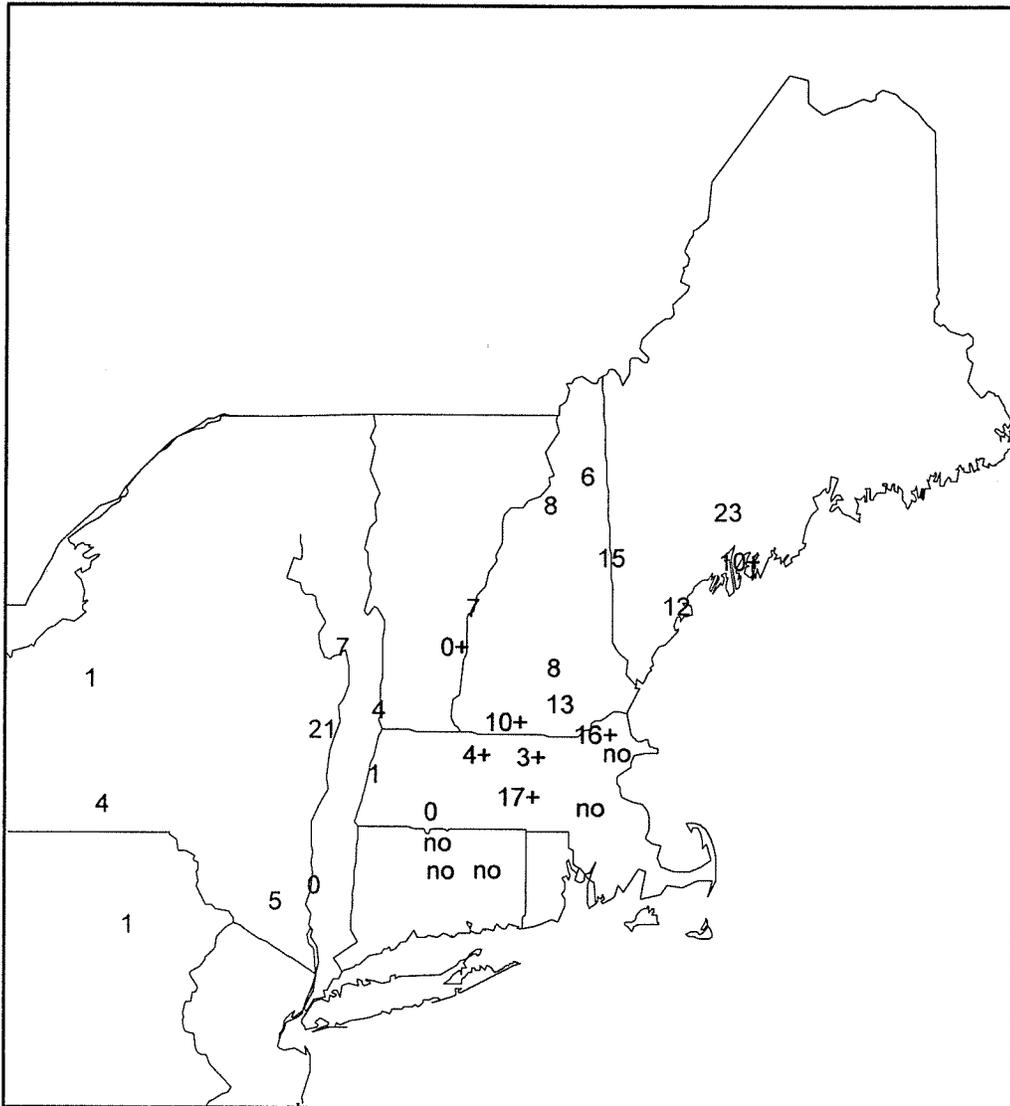
Figure D-7 - Equivalent radial ice thicknesses R_{eq} (mm) for December 11-12, 2008 at hourly weather stations from the Simple ice accretion model: “no” indicates that no freezing rain was observed; “+” indicates that weather data was not recorded for some hours of the storm so the mapped value is a lower bound.

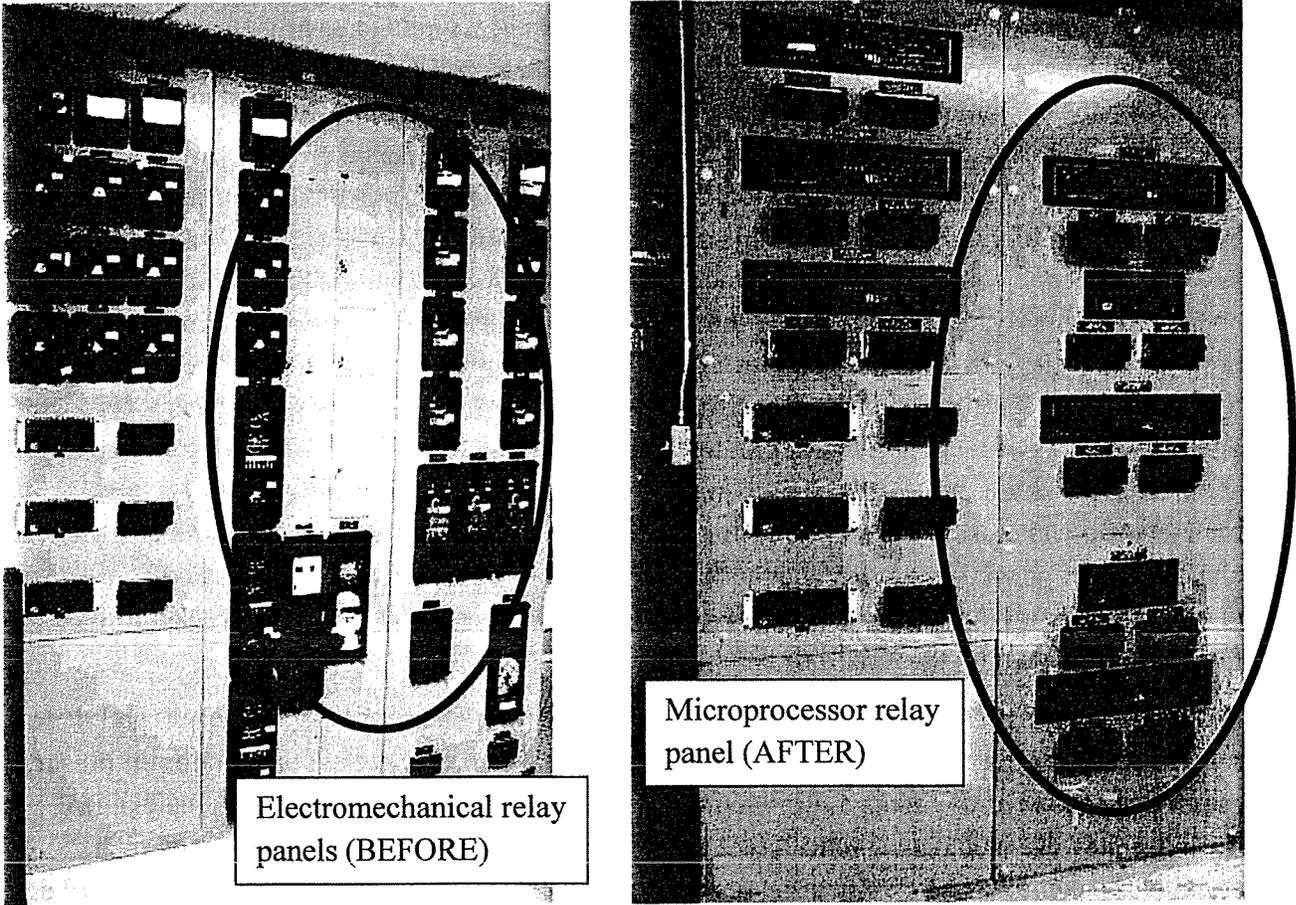
Figure E-2 – The electromechanical relays on left were replaced with the microprocessor based relays on the right. (Photos by NEI)

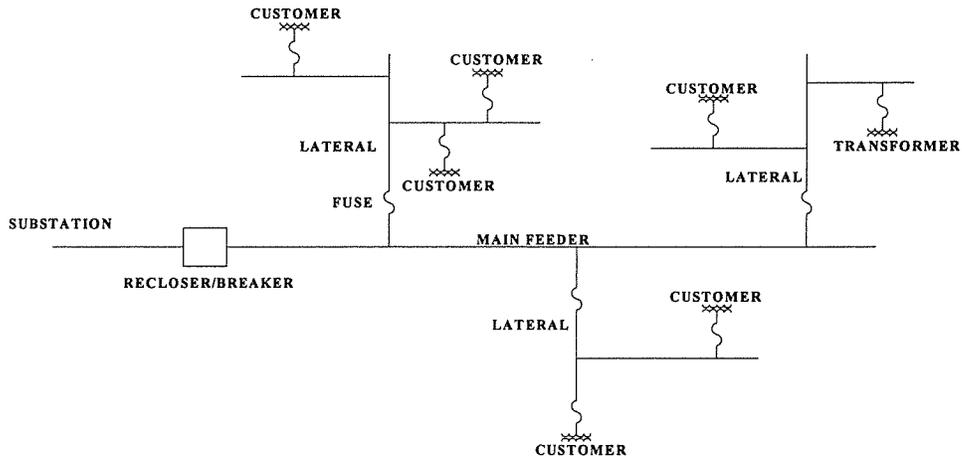
Figure E-3 - Typical radial distribution line⁷

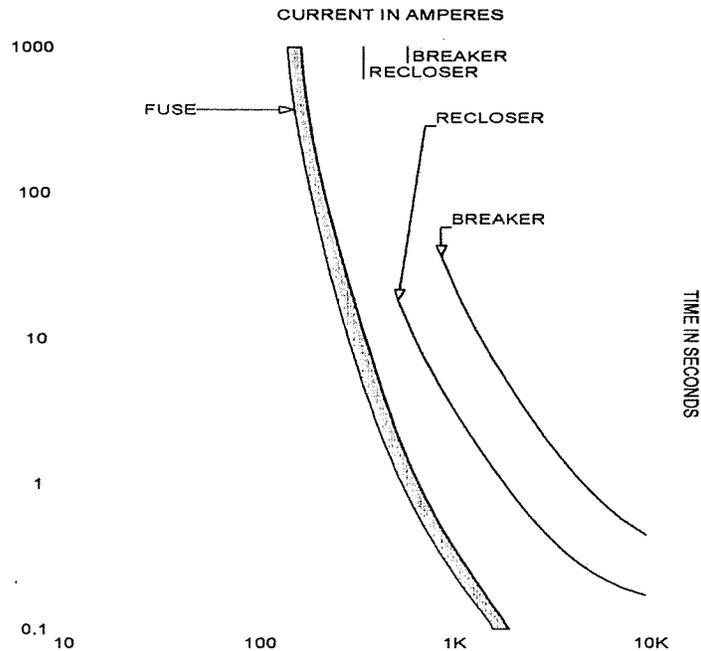
Figure E-4 -Typical inverse time curve for a fuse, circuit breaker, and recloser.

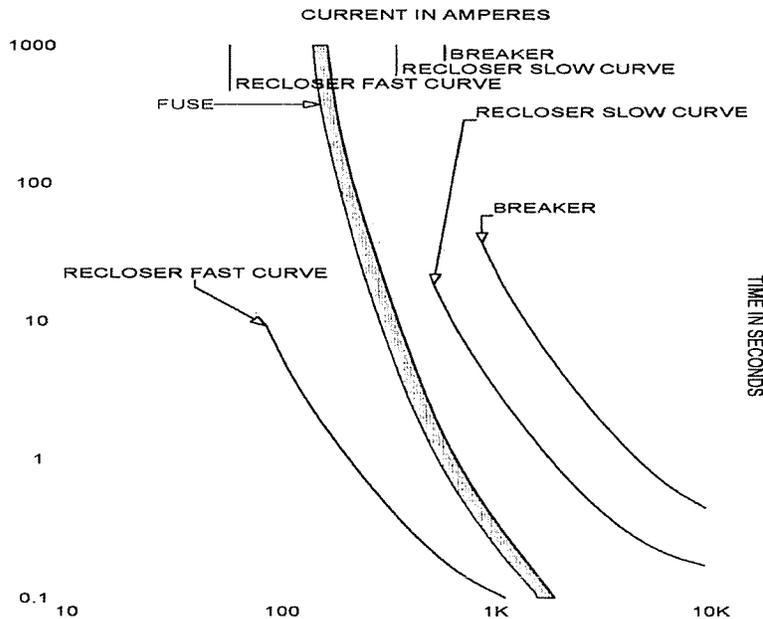
Figure E-5 - Coordination curves for fuse saving.
