New Hampshire December 2008 Ice Storm Assessment Report

October 28, 2009

NEI ELECTRIC POWER ENGINEERING

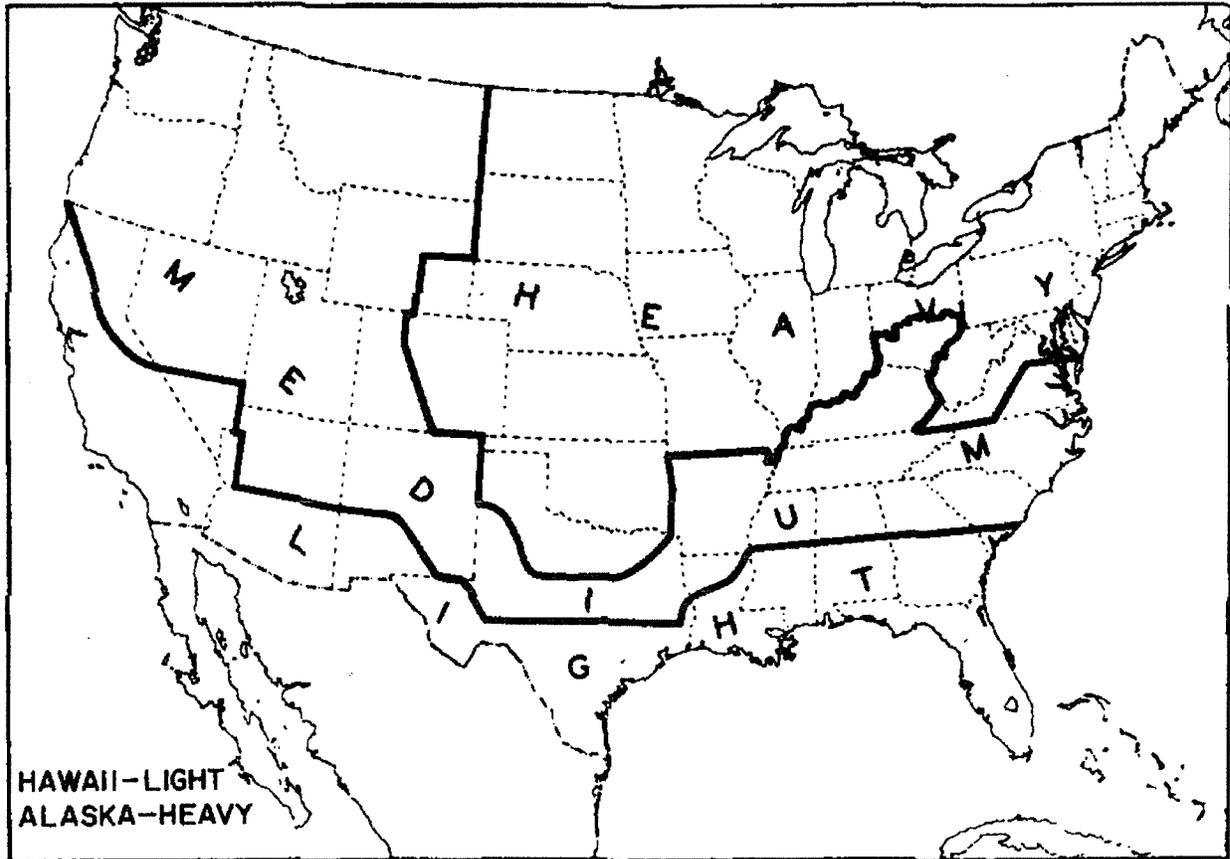
Figure F-1 - NESC loading map.
