**EnergyNorth Natural Gas, Inc. d/b/a National Grid NH
Cast Iron/Bare Steel Replacement Program
DG 10-139
Response to June 18, 2010 Hearing Record Request**

Marked as Exhibit 4

Marked as Exhibit 5

2009 New Hampshire Condition Bare Steel Main Replacement Program – Sample Analysis

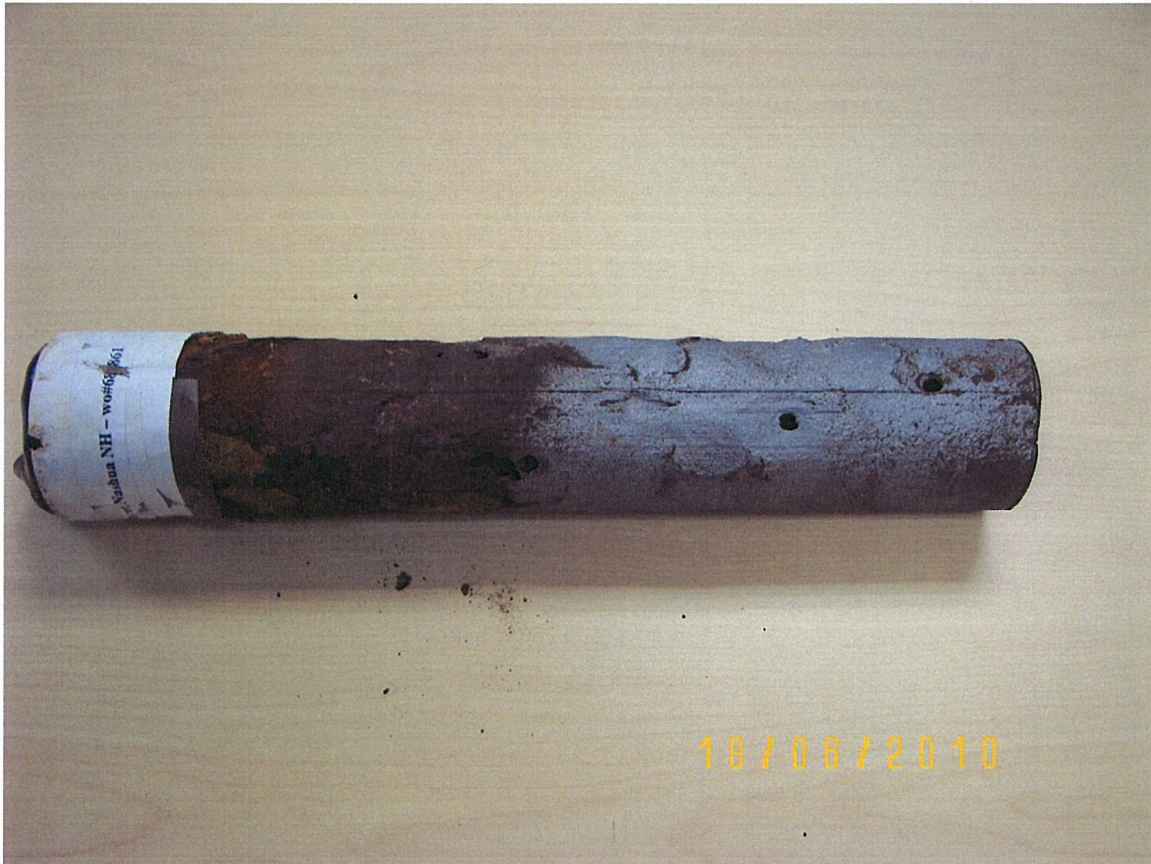
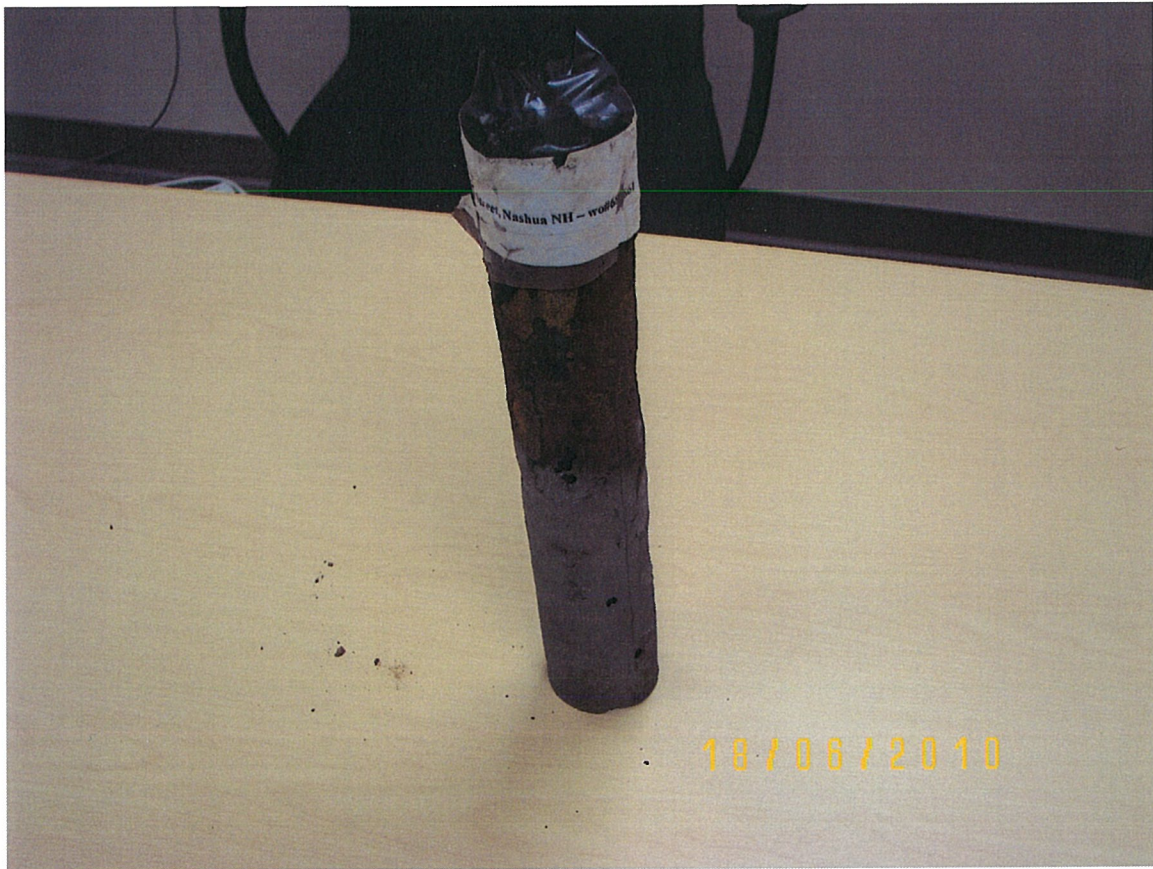
During the 2009 construction season, pursuant to work order # 681861, National Grid replaced a segment of 2 inch, low pressure bare steel main with a vintage date of 1908 on Blossom Street in Nashua. An 18-inch long segment of that pipe was removed, photographed and cataloged by National Grid. That cataloging, which includes information about the pipe, its condition and the surrounding soil, is contained on page 4 of 10 of the Sample Analysis report submitted as Exhibit 5 in this proceeding. The pipe segment was then delivered to Randall Knepper, Director of Safety for the Commission. Mr. Knepper retained the pipe in his possession and presented the pipe at the June 18, 2010 hearing in the above-referenced docket. Pursuant to instructions received from the Commission at the hearing, rather than “file” the pipe segment in evidence, representative photographs of the pipe have been taken and are included on pages 2 and 3 of this exhibit in lieu of the actual pipe.

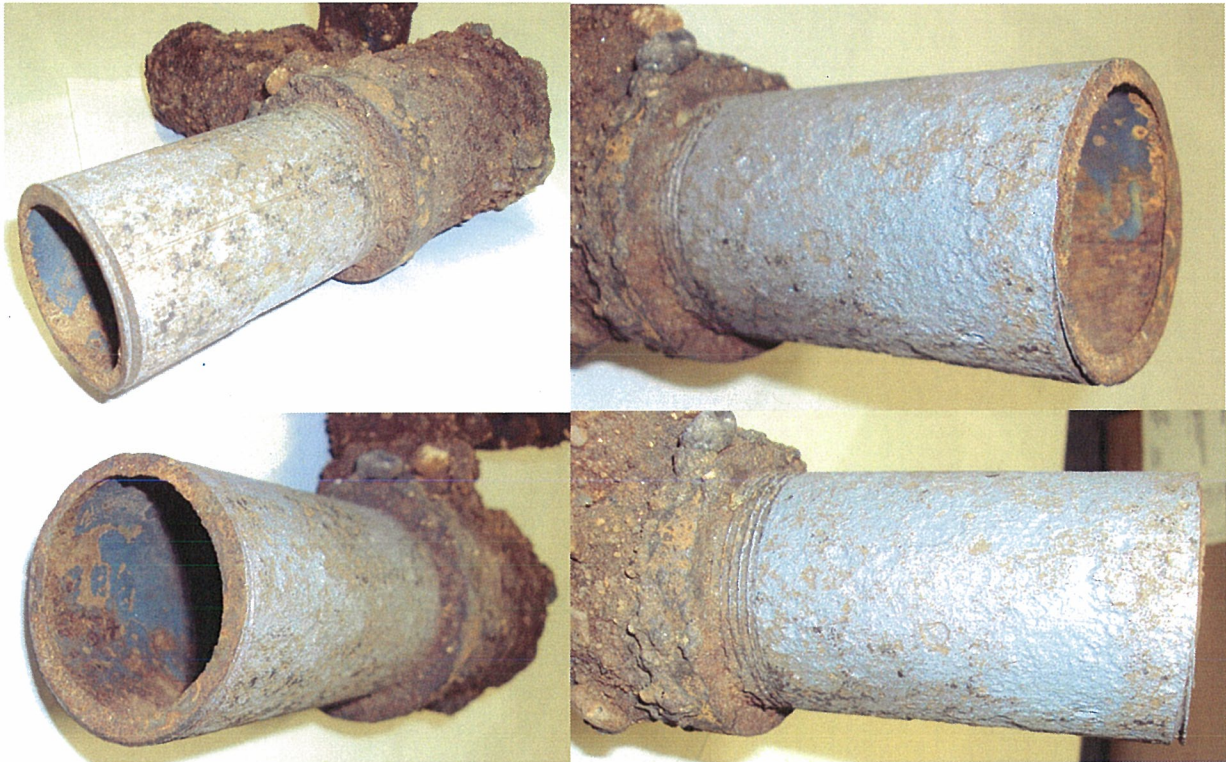
(6) **12-25 Buck Street, Nashua – wo#655576** – 2 inch, low pressure, installed in 1901, 1903, & 1911

- A soil sample was taken and analyzed. The pH was measured to be between 6 and 7, slightly alkaline to neutral. Testing for chlorides was negative. Testing for microbiological acid producing (APB) and sulfate reducing bacteria (SRB) were performed. The APB testing produced a reading of 100,000 bacteria colonies per ML. The testing for SRB produced a reading of 100 bacteria colonies per ML. The soil was observed to be a normal color and odorless.
- The pipe sample was observed to be in poor condition with some heavy pitting observed. A threaded coupling was also included as part of the pipe sample. Pit depths were not measured as the samples are available for continued visible review. Exposure of this segment should result in a recommendation for replacement.
- The following pictures were taken:

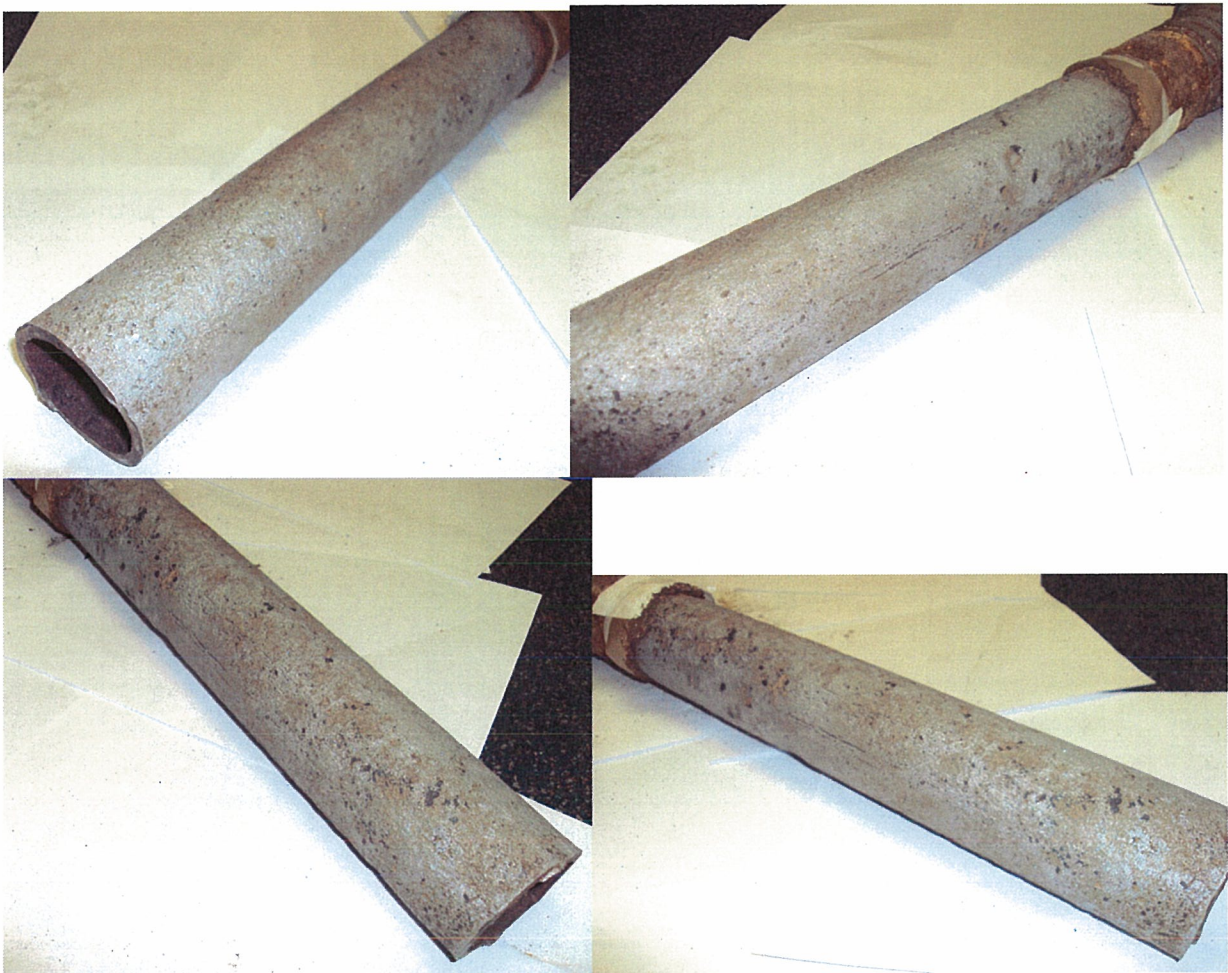
(7) **2-4 Fourth Street, Nashua – wo#642294** – 2 inch, low pressure, installed in 1926

- A soil sample was taken and analyzed. The pH was measured to be approximately 6, slightly acidic to neutral. Testing for chlorides was negative. Testing for microbiological acid producing (APB) and sulfate reducing bacteria (SRB) were performed. The APB testing produced a reading of 100,000 bacteria colonies per ML. The testing for SRB produced a reading of 100 bacteria colonies per ML. The soil was observed to be a normal color and odorless.
- The pipe sample was observed in poor condition with one area of significant deep pitting. Pit depths were not measured as the samples are available for continued visible review. Exposure of this main should result in a recommendation for replacement based on condition.
- The following pictures were taken:
