October 2017 Wind Event After Action Report

Unitil Energy Systems

Emergency Management

February 2018

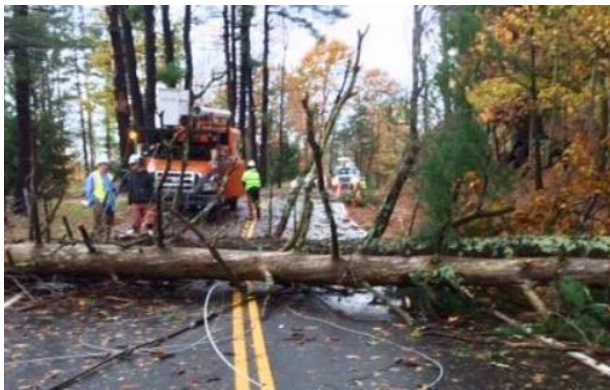
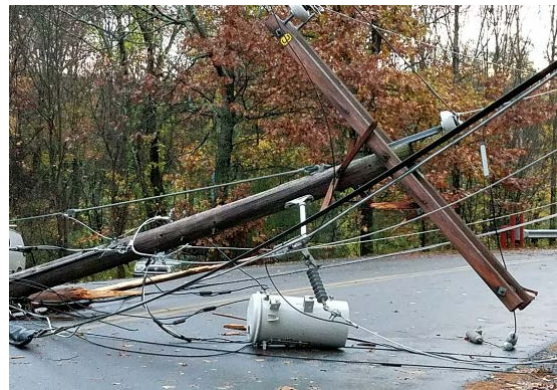
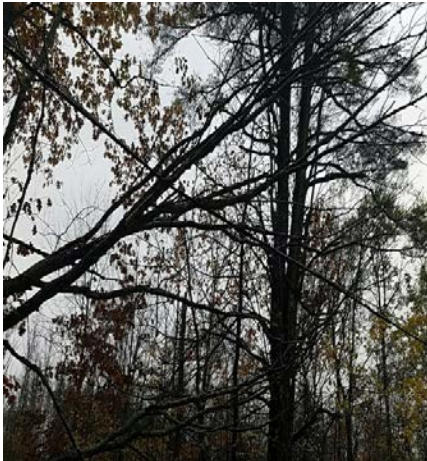
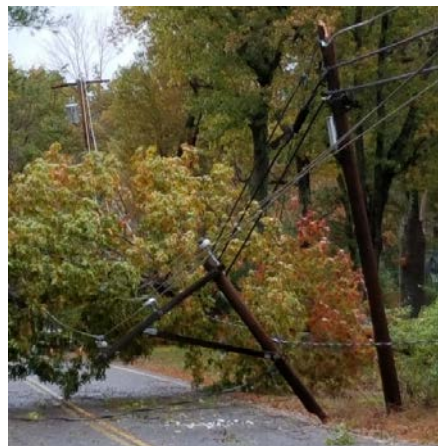
Figures 2 - 5 – Damage Photos (Oct Wind Event)

Scattered outages occurred across both of Unitil's NH service territories which were mostly attributed to tree damage and branches on powerlines. Peak interruptions occurred at approximately 5:19 AM on Monday, October 30th with 33,354 customers impacted (43% of Unitil's NH customers) with a cumulative total of 53,332 customers being impacted through the event.

The Company was challenged during the early phases of restoration due to ongoing hazardous winds that prevented line crews from safely raising the buckets¹. There were multiple periods when the wind exceeded the safe threshold preventing line work that delayed the response. This delay can be measured in hours across both DOCs. Once the winds dropped below hazardous levels, crews were capable to respond to outages, with power being restored to 95% of the customers by 5pm on Tuesday (Oct 31st) and the majority of customers (99%) by noon on Wednesday (Nov 1st) with any remaining customer taking service once electricians completed work.

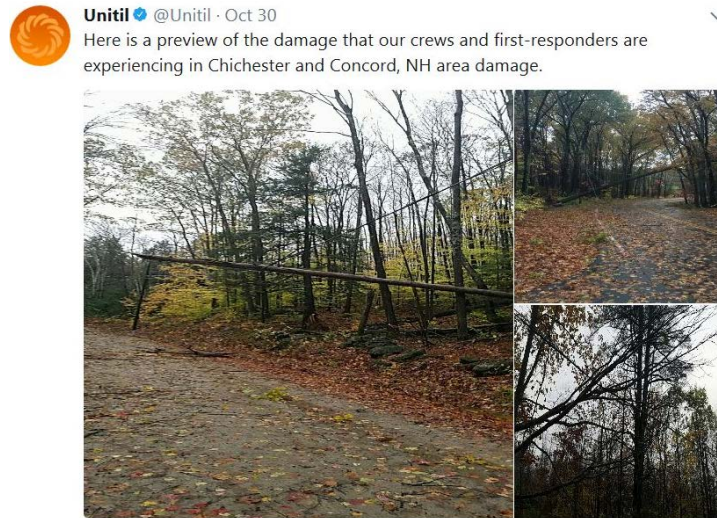
Figure 10 – iRestore Photo Social Media Use

The Company found this process, which it has incorporated into the wire-down response procedure, extremely useful in helping it determine the urgency of response and the right resources to send based on the type of damage. The Company received 30 reports through the iRestore application during the wind event and used some of these pictures on social media as talking points to explain customer damage as shown in the following image.

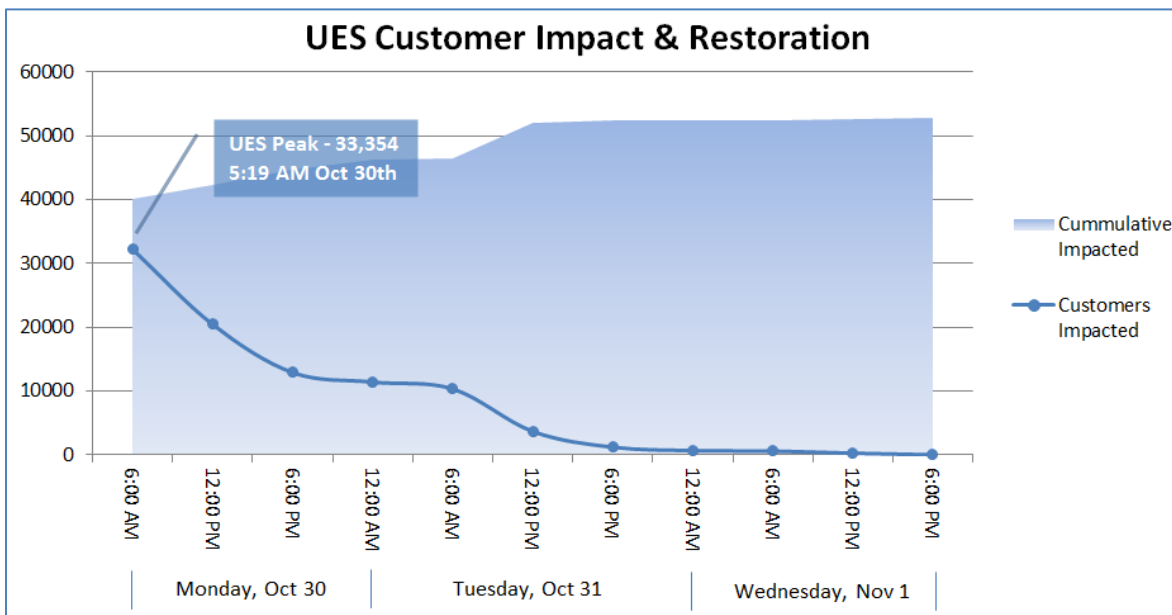
Figure 11 - UES Restoration Curve

Though subjective, the Company believes the Storm Resiliency Trimming Program reduced the number of tree related outages and had an overall positive impact on the time to restore customers. Once the winds dropped below hazardous levels, crews responded to outages with power being restored to the majority of customers (95%) by 6 AM on Wednesday (Nov 1st) and the remaining customer restored throughout the remainder of the day. The majority of damage was caused by tree limbs and debris coming into contact with electrical equipment. The first outage occurred on Oct. 29th at 7:50 PM and the last customer was restored at Nov. 1st at 5:54PM; however the majority of impacted customers (95%) were restored by 6 AM on Nov 1st.

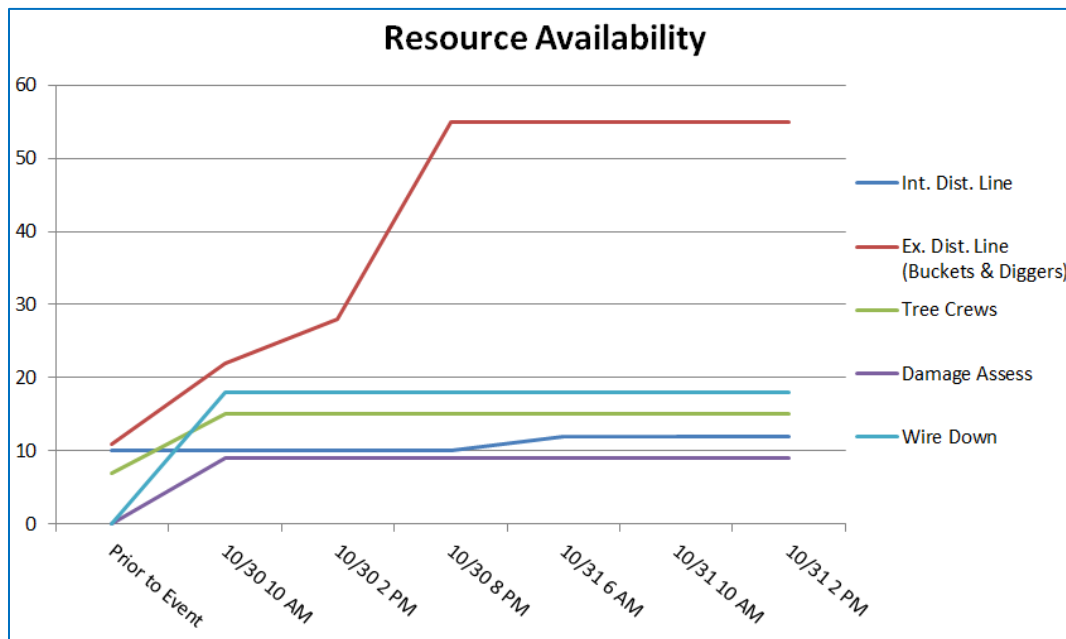
Figure 12 – Resource Availability Overview

Table 2 details the amount of resources at peak (max) for the event while Figure 12 displays the availability of resources over the event.

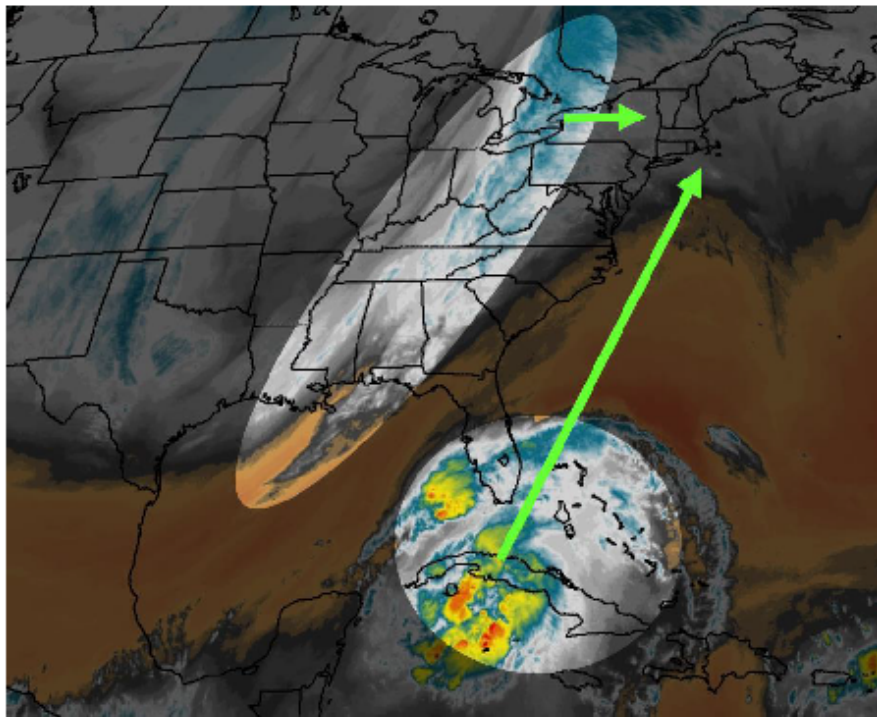
Figure 1: Infrared satellite image from October 29, 2017

On October 29th and 30th, 2017 a strong low pressure system moving in from the Great Lakes region, along with the remnants of Tropical Storm Philippe combined to produce a long duration event of strong wind gusts, significant rain, and thunderstorms. See Figure 1. There were two periods of significant wind gusts, the first between 8pm ET Oct. 29th through 5am ET Oct. 30th in which wind gusts of 45-70 mph were reported. The second period of wind occurred between 9am-6pm Oct. 30th where wind gusts of 40-55 mph were reported. Periods of moderate to heavy rain, along with embedded thunderstorms, also occurred from the morning of Oct. 29th through midday of Oct. 30th. Rainfall amounts of 1.50-5.00" were recorded. Another culminating factor to this event was the fact that many of the trees across the Northeast still had leaves on trees, along with a fairly saturated ground from a rain storm days prior to this event.
