**IR 21-024**  
**Department of Energy, Division of Enforcement**

**INVESTIGATION REPORT**  
**OF**  
**WATER PRESSURE REDUCTION MATTER**  
**IN ROSEBROOK WATER SYSTEM**  
**August 31, 2021**  
**Abenaki Water Company, Inc – Carroll, New Hampshire**

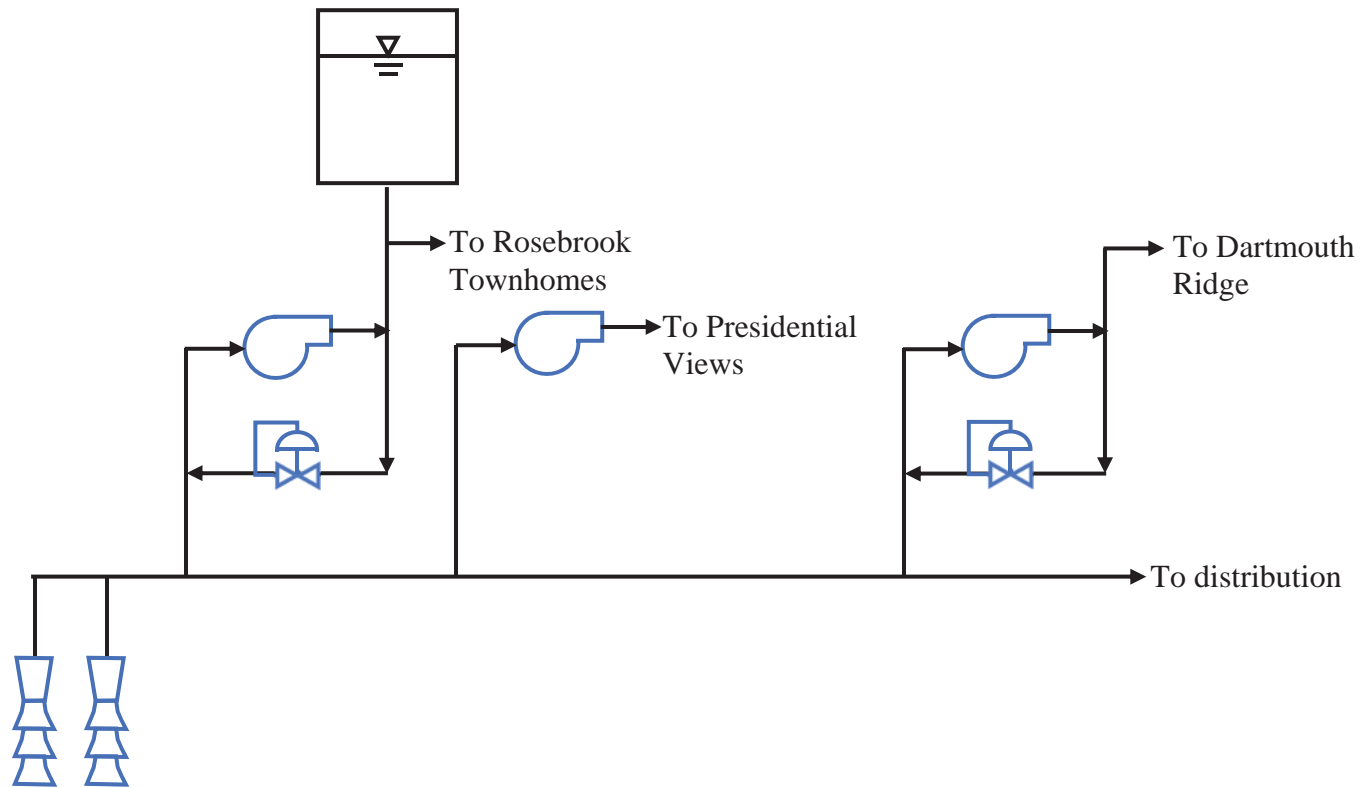
**ALTERNATIVE 1 – EXISTING TANK, BOOSTER PUMP STATIONS/PRVs:** Modify the existing well pumps to serve the lowest pressure zone (Zone 1) and install three booster stations to serve higher elevations (Zones 2CR, 2MWP, and 2RT). The well pump modifications would include a minimum of adding a variable frequency drive (VFD) to Pump 2 and replacing the Pump 2 motor with an inverter-duty motor to be compatible with a VFD. The wells would pump into Zone 1 based on storage tank elevation setpoints, and the water storage tank would be filled by the Rosebrook Townhomes booster station. Based on the modeling results, it might be possible to continue to use the two existing well pumps, however complete replacement might be necessary to adequately reduce their flow and pressure capacity. A schematic representation of this configuration is provided in the following figure.

The performance listed above is theoretical and, if Alternative 1 will be pursued further, we recommend testing the existing Pump 1 by running its VFD at its minimum speed to confirm the limits of its capabilities if possible. Well pump 2 would require a variable speed drive and might require replacement of its pump with an inverter duty motor.

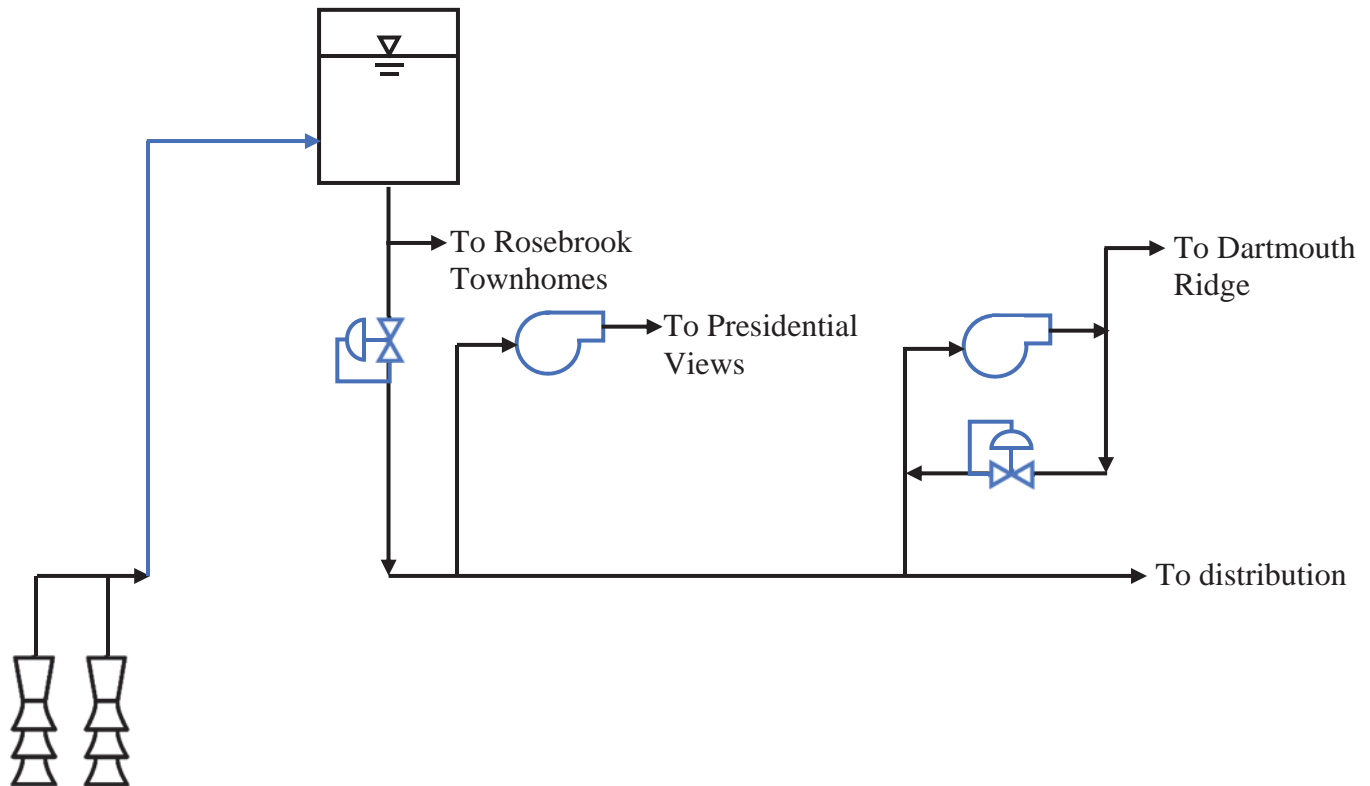
ALTERNATIVE 2 – EXISTING TANK, NEW SUPPLY PIPELINE/PRVs: Use the existing well pumps to pump directly to the existing water storage tank via a new dedicated pipeline. The distribution system would then be fed by gravity off the existing storage tank and would require two booster stations to serve higher elevations. The distribution system would have four separate pressure zones: Zone 1 (lowest elevation), Zone 2CR (fed by a new booster station), Zone 2MWP (fed by a new booster station), and Zone 2RT (fed by gravity from the existing storage tank). The dedicated pipeline between the wells and the storage tank would have no supply taps, would generally follow existing water pipeline alignments, and would require high pressure (~190 psi) at the existing well pump house. A schematic representation of this configuration is provided in the following figure.

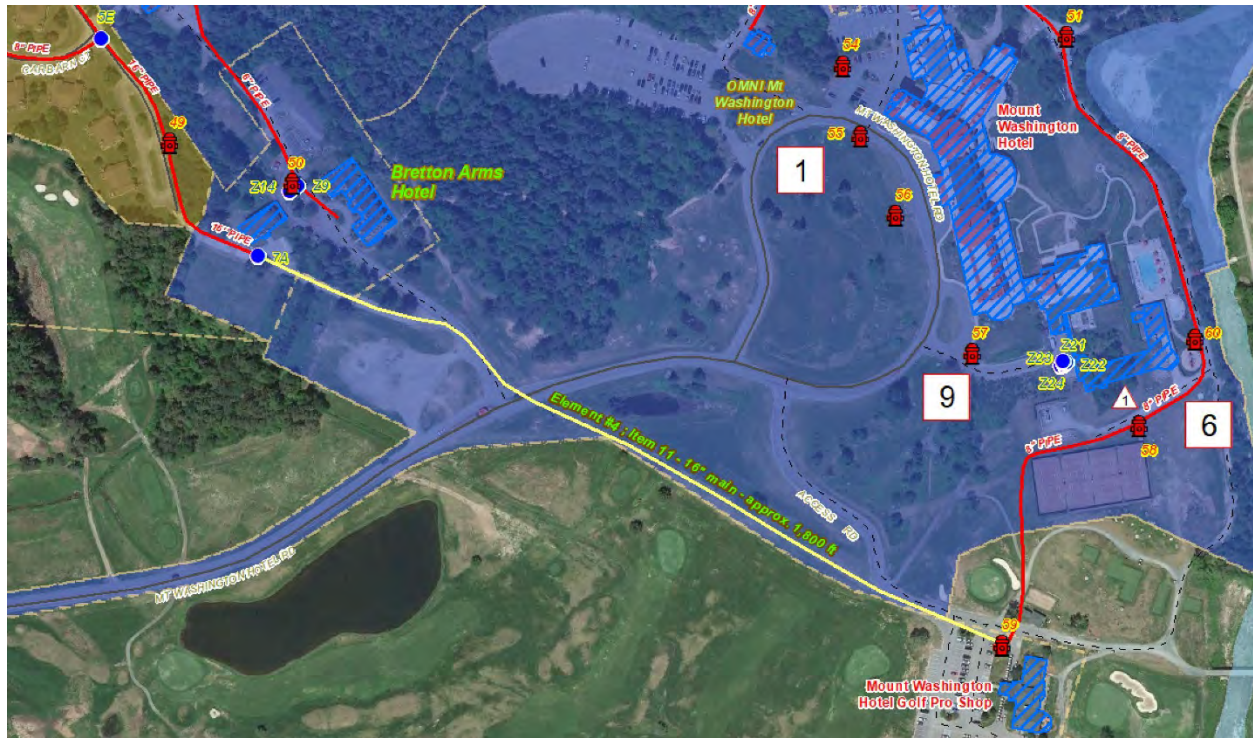
## Appendix H

Potential 1800 foot main 16" diameter water main extension from Fairway Village end of main to 8" diameter main on south side of OMNI hotel. This is based on Safety Staff's Attachment 1 Drawing with possible main extension shown in light yellow.
