National Transportation Safety Board

Natural Gas Pipeline Accident Manhattan, New York March 12, 2014

New England Pipeline
Safety Seminar
West Dover, VT
October 20, 2015

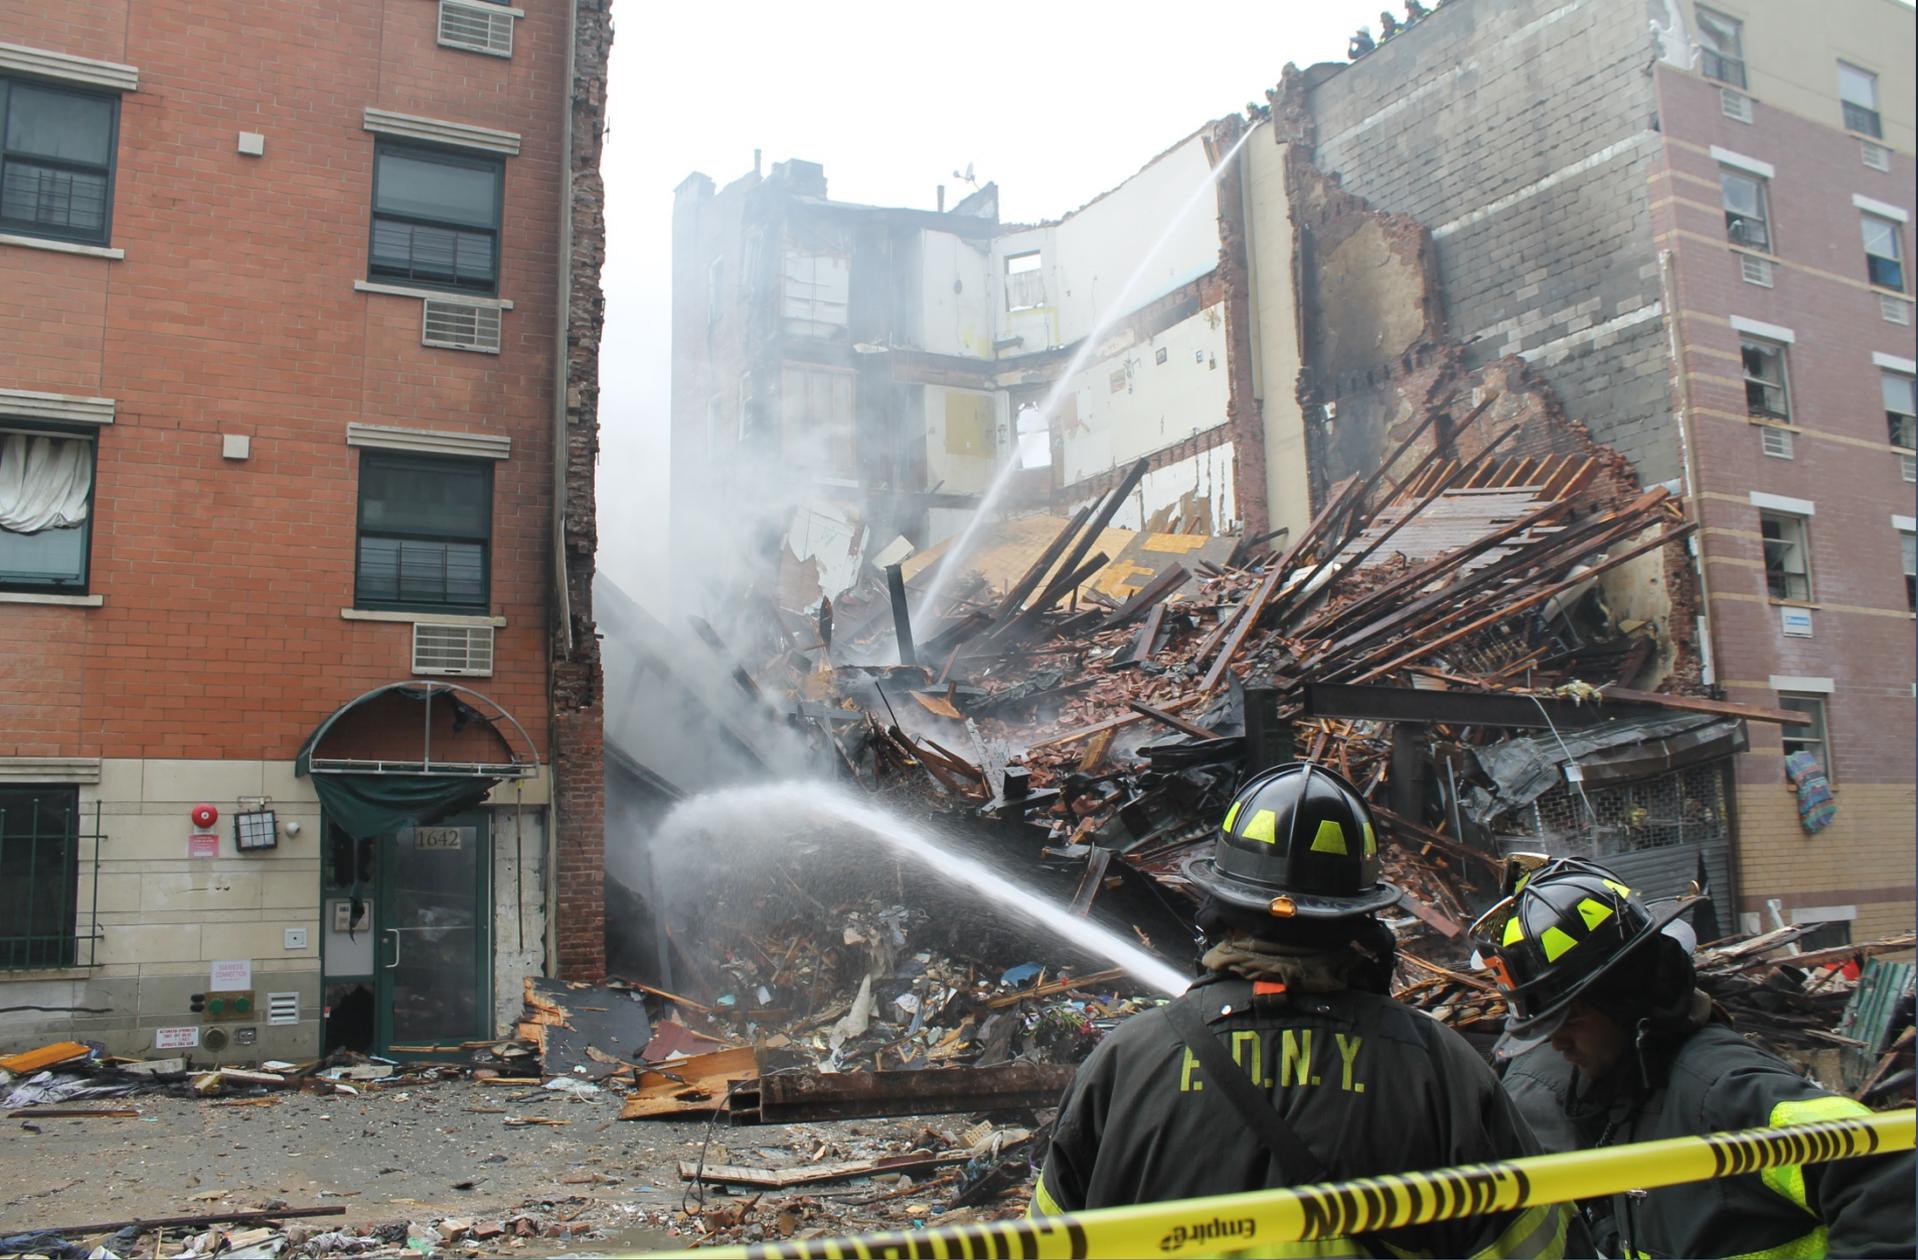
Utilities in the Accident Block

- Consolidated Edison
- 8-inch cast iron/plastic distribution line (1890 / 2011)
- 8 in wc MAOP, 6 in wc operating
- 8 Fatalities
- 48 injuries

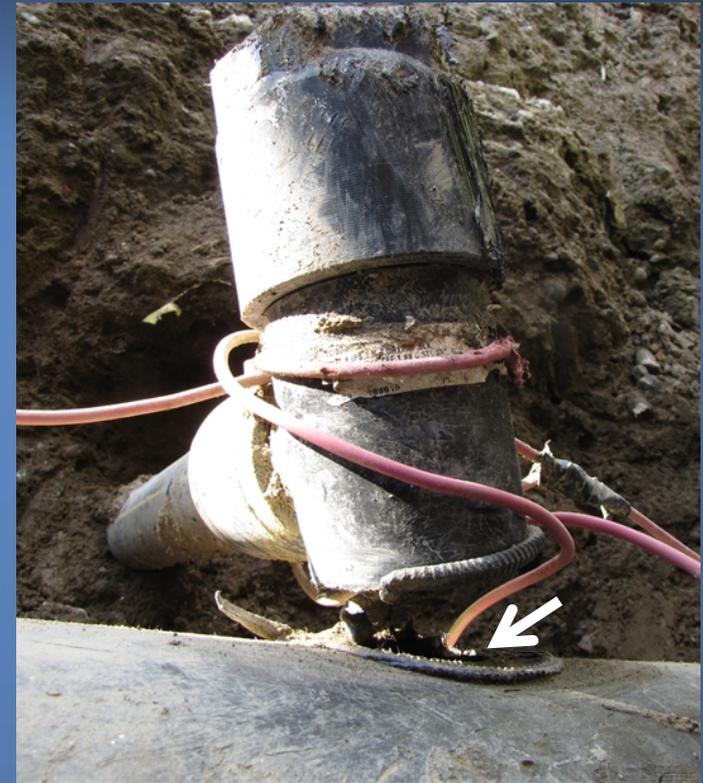
Fusion Joint – Incomplete Fusion

- Radial band pattern (60%)
- Is incomplete fusion
- Is a weld defect
- Weak bond strength
- Caused by contamination or inadequate surface preparation before fusion welding

- City of New York - Improve sewer main integrity process
- Consolidated Edison - Revise plastic pipe fusion procedure
 - Cleaning methods
 - Improve final visual inspection

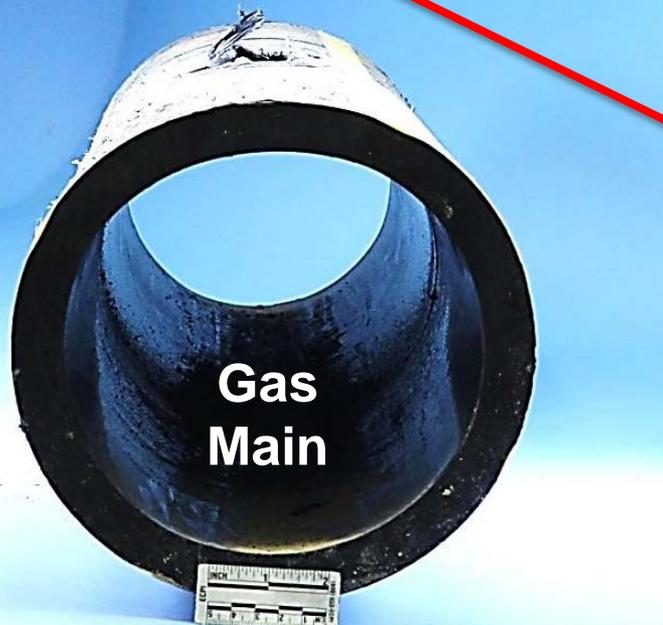
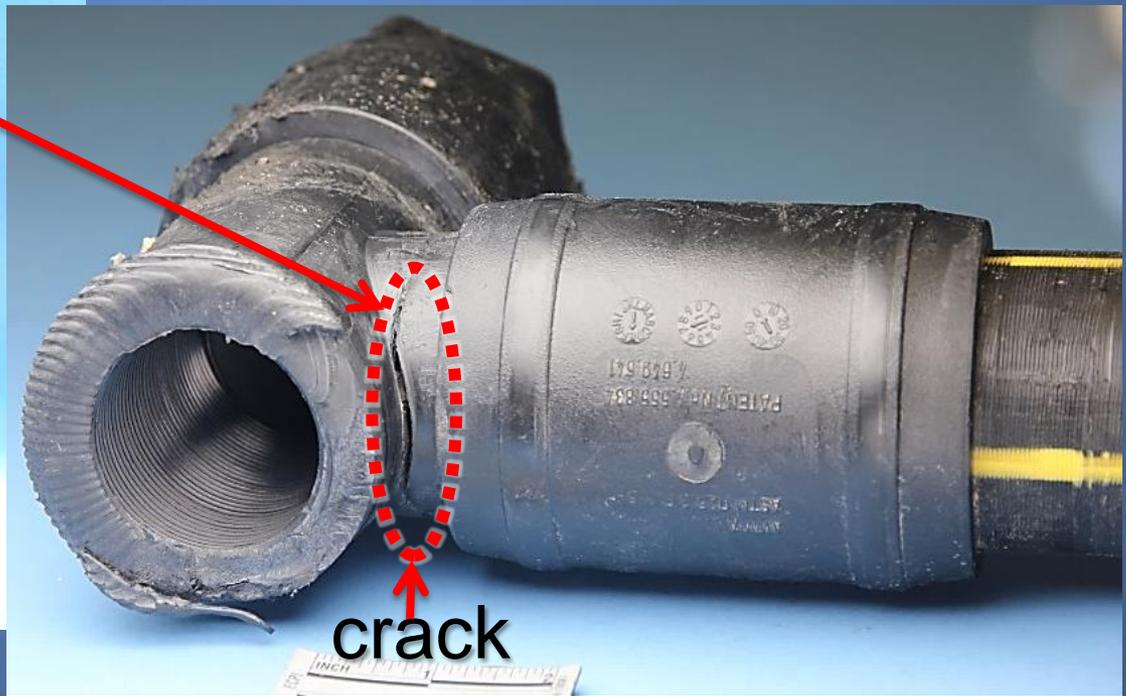
Service Tee – Crack at Outlet

- No evidence of pre-existing crack
- Rapid loading event from post-accident excavation

- Gas leak resulted when sagging gas main opened the defective weld
- Post-accident excavation work
 - Separated the service tee from the main
 - Cracked the branch outlet
- Water main cracked after the explosion
