# **WHS – Testimony Appendix A**

**Reference Outage: MK2 Turbine Overhaul**

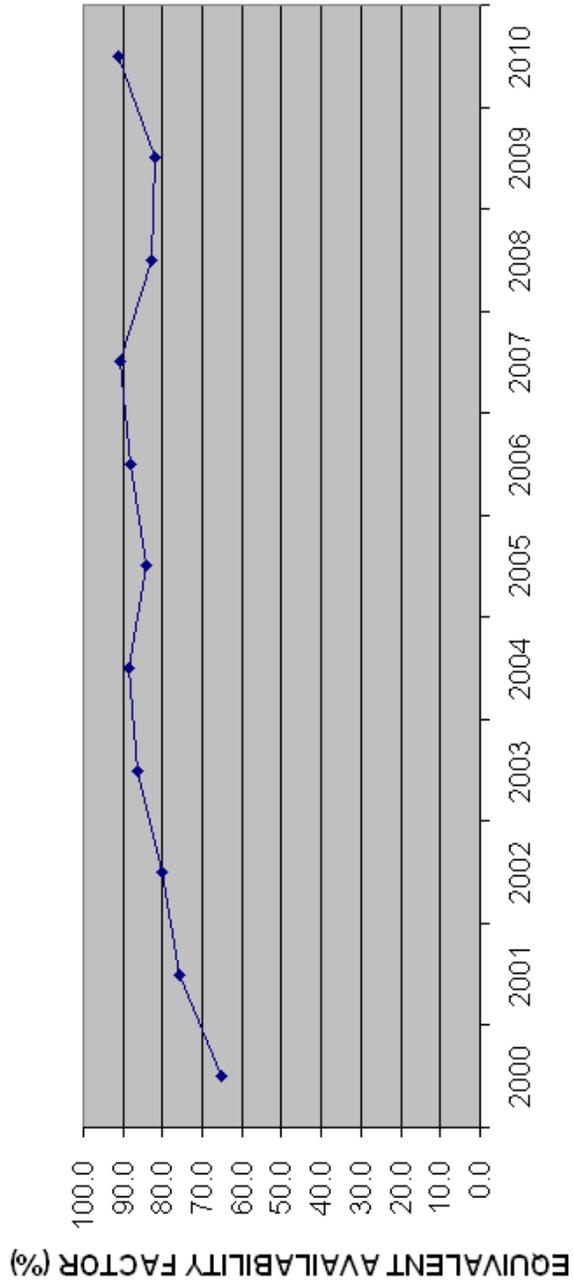
**PSNH FOSSIL SYSTEM WEIGHTED EAF  
2010**

$$\frac{(\text{Available Hours} + \text{Planned Outage Hours} - \text{Equiv. Unit Derated Hours} - \text{Equiv. Seasonal Derated Hours}) \times 100}{\text{Period Hours}}$$
