Unitil Energy Systems, Inc.
May 1, 2013 Step Adjustment

Explanation of Filing

REP and VMP Annual Report 2012

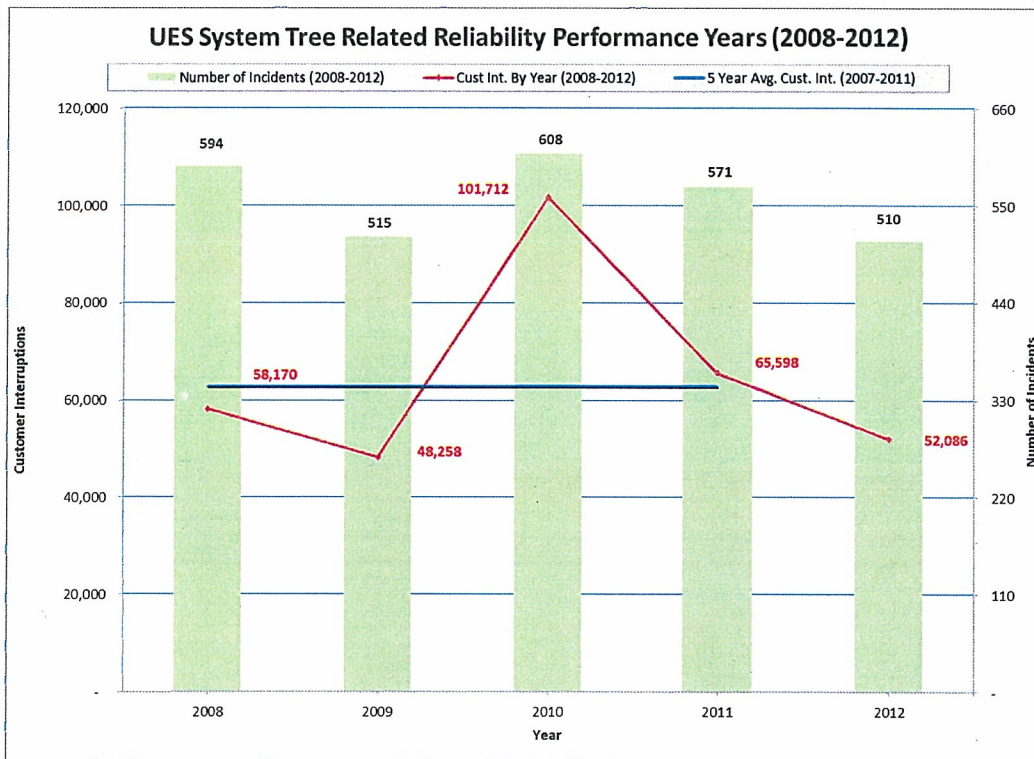
Chart 1

As the Vegetation Management Program progresses through its first five year prune and hazard tree cycles, the effects of these programs on reliability have begun to emerge. In order to study the results of these programs and the combination of VM components that have the largest reliability effect, the Company has developed VM Program reliability analysis. Overall New Hampshire system tree related reliability performance was reviewed, as well as the individual circuits and program components that were undertaken. Chart 1, shown below, displays the number of customers interrupted per year from tree related incidents from 2008 to 2012 against the 5 year average of tree related incidents from 2007 to 2011.

The chart shows a decline in customers interrupted as well as a decline in tree related incidents from 2010 through 2012. It also shows the number of customers interrupted in 2012 is below the historic 5 year average. Although the VM program is still in its infancy, the Company believes this trend is indicative of overall positive program results.

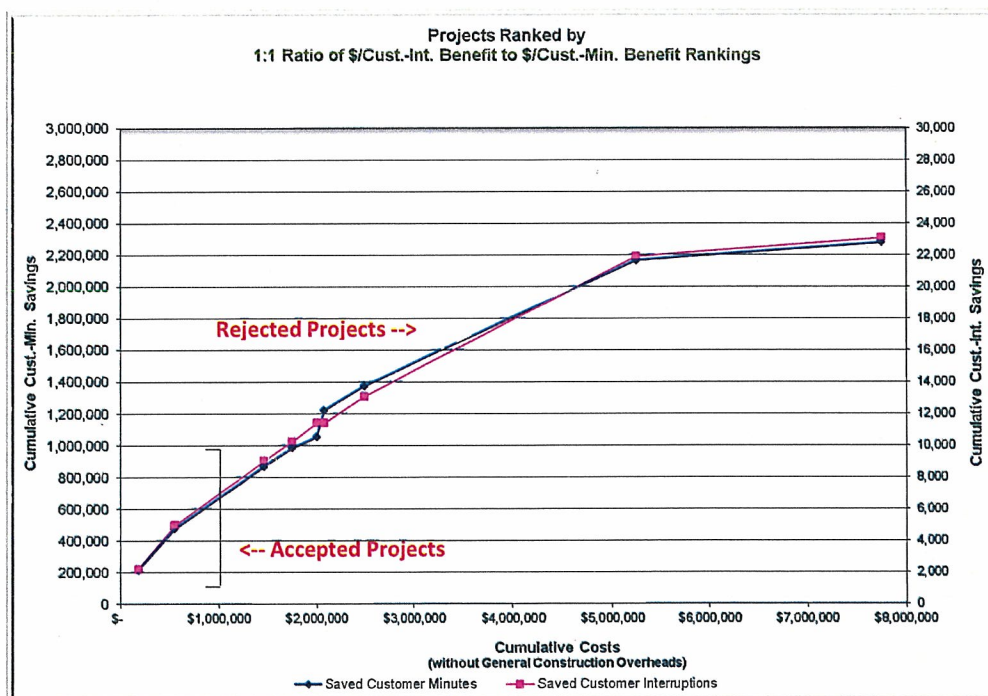
An overall project rank is derived from the sum of these two cost benefit rankings. In general, projects with low construction cost and high saved customer minutes or high saved customer interruptions are ranked highest on the list while those projects with high construction cost and low saved customer minutes or saved customer interruptions are ranked low on the list. Another way these projects are analyzed by Distribution Engineering is shown in Chart 7 below. This chart displays the cumulative project cost compared to the anticipated reliability benefits of all projects. Each data point pair represents a specific project and its associated reliability benefits (saved customer minutes and saved customer interruptions). This chart is used to determine when there is a diminishing return of reliability benefits associated with project cost as indicated by the “knee” of the curve. Proposed projects to the left of the cutoff line are accepted in the 2012 Capital Budget and those to the right have been rejected.
