UES Capital Reliability Study 2022

Prepared By:
T. Vrettos
Unitil Service Corp.
9/15/2022

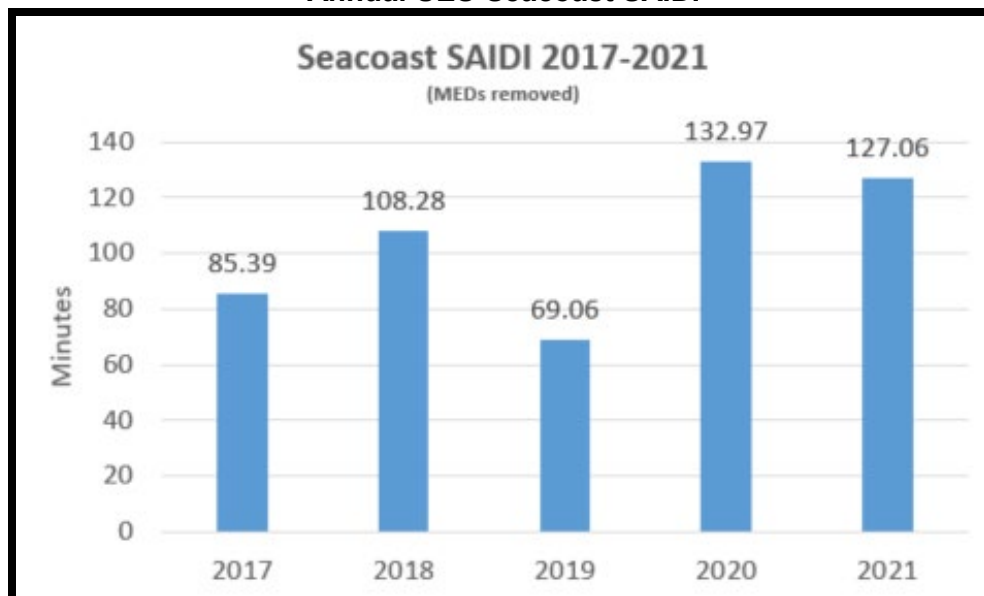
Chart 1
Annual UES-Seacoast SAIDI

The 2021 annual UES-Seacoast system reliability goal was set at 117.33 SAIDI minutes, after removing exclusionary outages. UES-Seacoast's SAIDI performance in 2021 was 127.06 minutes. Charts 1, 2, and 3 below show UES-Seacoast's SAIDI, SAIFI, and CAIDI performance over the past five years.

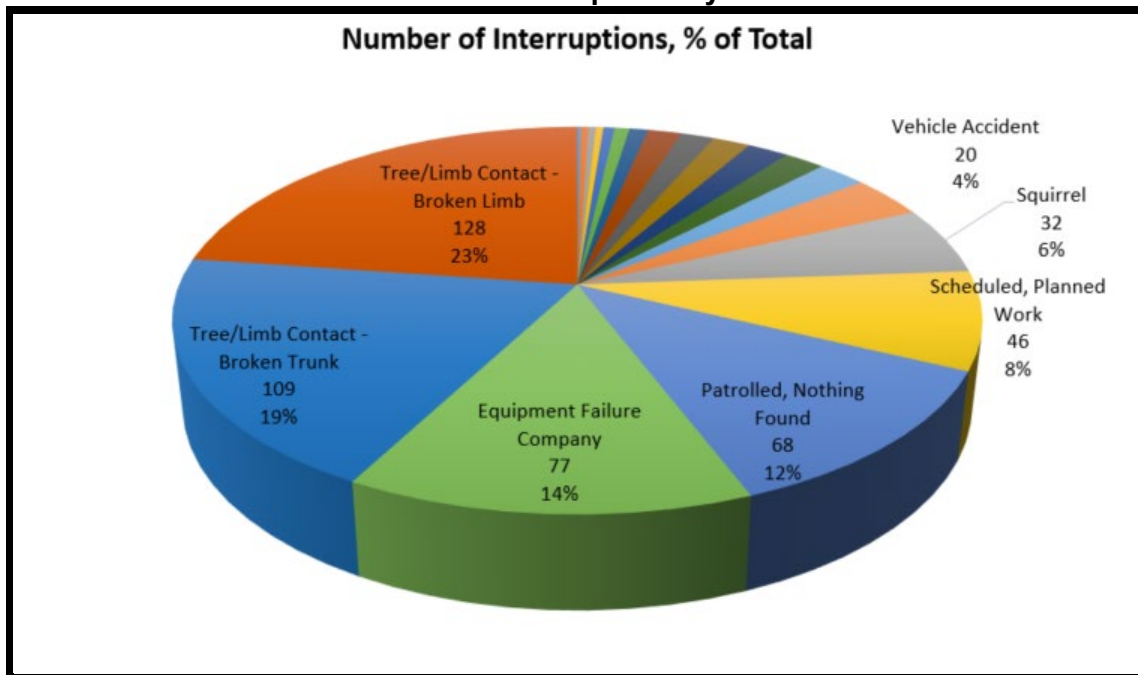
Chart 4
Number of Interruptions by Cause

This section provides a breakdown of all outages by cause code experienced during 2021. Charts 4, 5, and 6 list the number of interruptions, the number of customer interruptions, and total customer-minutes of interruption due to each cause respectively. Only the causes contributing 3% or greater of the total are labeled. Table 1 shows the number of interruptions for the top three trouble causes for the previous five years.

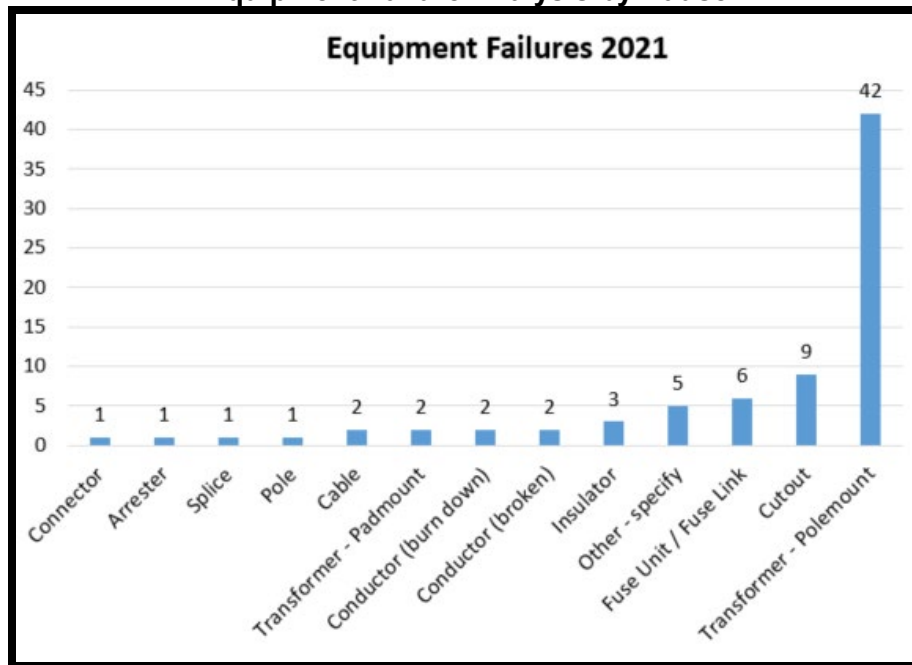
Chart 7
Equipment Failure Analysis by Cause

This section is intended to clearly show all equipment failures throughout the study period from January 1, 2021 through December 31, 2021. Chart 7 shows all equipment failures throughout the study period. Chart 8 shows each equipment failure as a percentage of the total failures within this same study period. The number of equipment failures in each of the top three categories of failed equipment for the past five years are shown below in Chart 9.
